# Inspection Report

## Suspended Access & Fall Protection System

**2025**  
REPORT#: IRPT102136

**Project Address:** 17201 Collins Avenue

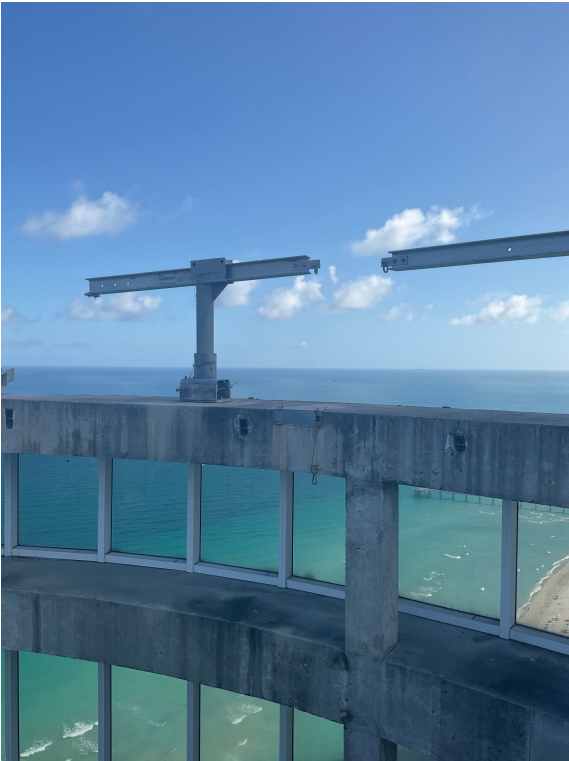
- Typical davit assemblies on site.

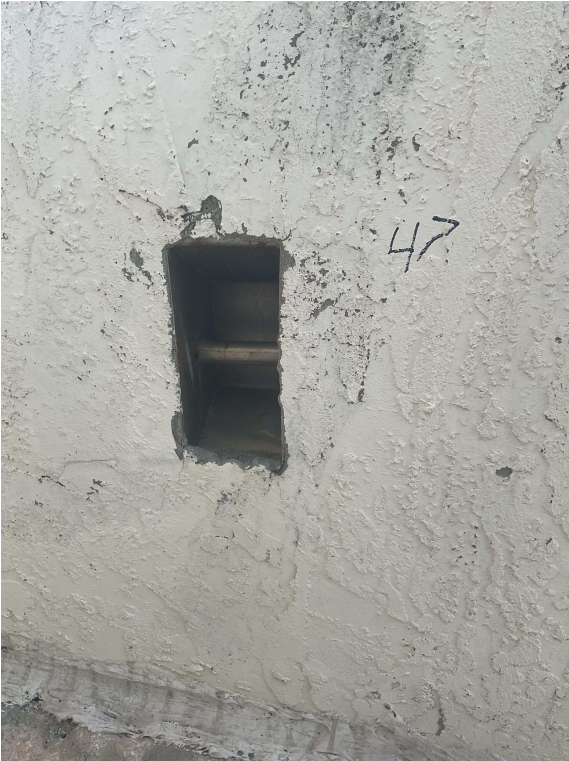
- Typical wall anchor on site.
