**Island Place at North Bay Village C.A.**  
**SIRS Components**  
***North Bay Village, FL***

Report #: 52795-0  
Beginning: January 1, 2025  
Expires: December 31, 2025

**RESERVE STUDY**  
**"Full"**

October 21, 2024

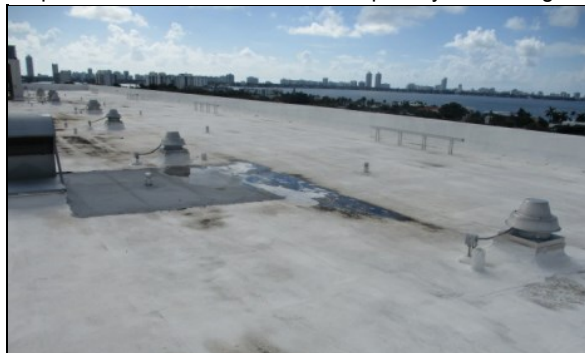
### Comp #: 2377 Modified Bitumen Roofing - Replace

Useful Life:  
20 years

Remaining Life:  
1 years

Best Case: \$ 320,000
