**Corinthian Condominium  
Other Components  
*Fort Lauderdale, FL***

Report #: 48946-0  
Beginning: January 1, 2024  
Expires: December 31, 2024

**RESERVE STUDY**  
**"Full"**

February 10, 2024

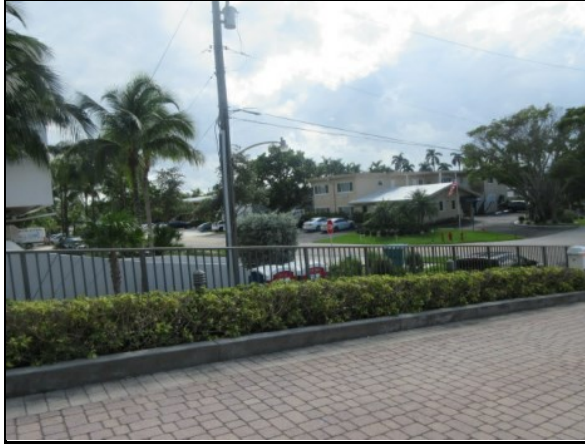
Useful Life:  
30 years

Remaining Life:  
10 years

Lower estimate to replace

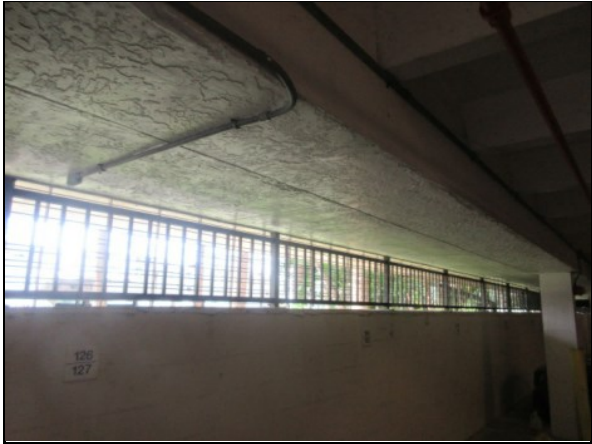
Useful Life:  
25 years

Remaining Life:  
24 years

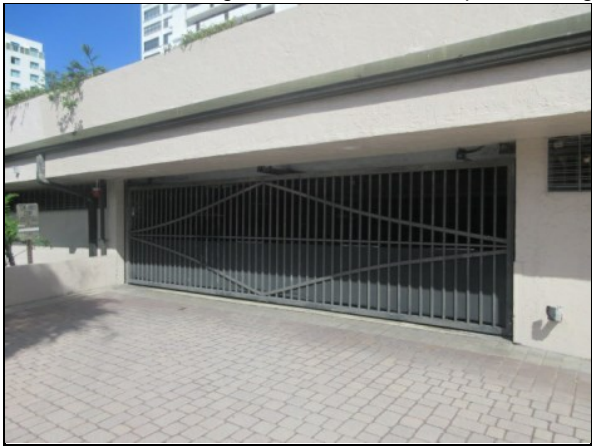
Useful Life:  
25 years

Remaining Life:  
10 years

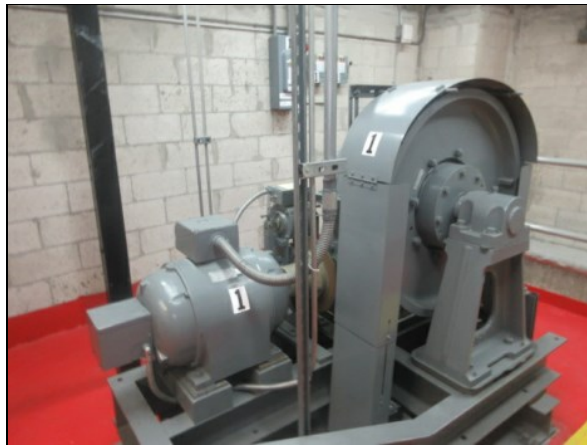
Useful Life:  
25 years

Remaining Life:  
7 years

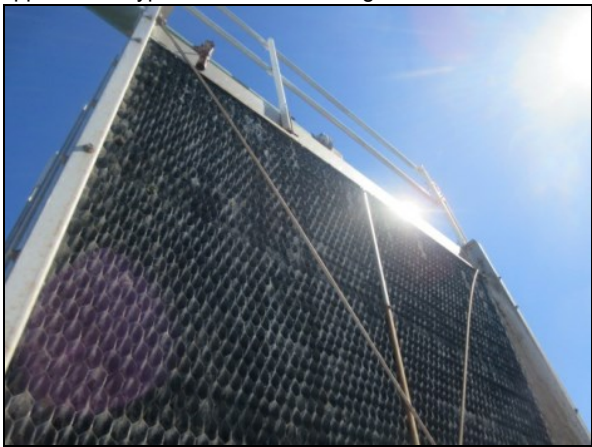
Useful Life:  
35 years

Remaining Life:  
8 years
