**Corinthian Condominium  
SIRS Components  
*Fort Lauderdale, FL***

Report #: 48946-0  
Beginning: January 1, 2024  
Expires: December 31, 2024

**RESERVE STUDY**  
**"Full"**

February 10, 2024

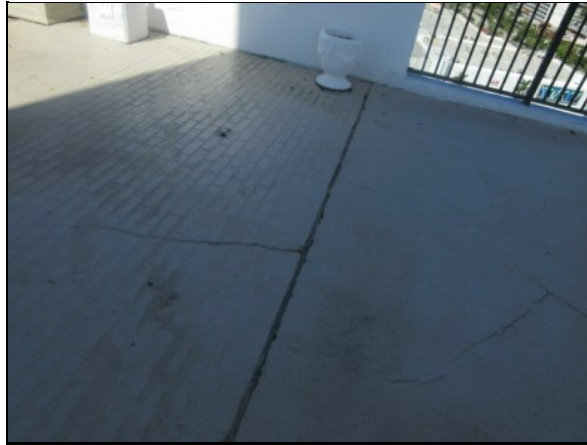
### Comp #: 2315 Roof/Pool Decks - Repair/Re-coat

Useful Life:  
5 years

Remaining Life:  
8 years

Best Case: \$ 35,000

Worst Case: \$ 48,520
