**Alton Star C.A.**  
**SIRS Components**  
***Miami Beach, FL***

Report #: 49717-0  
Beginning: February 1, 2026  
Expires: January 31, 2027

**RESERVE STUDY**  
**"Full"**

October 30, 2025

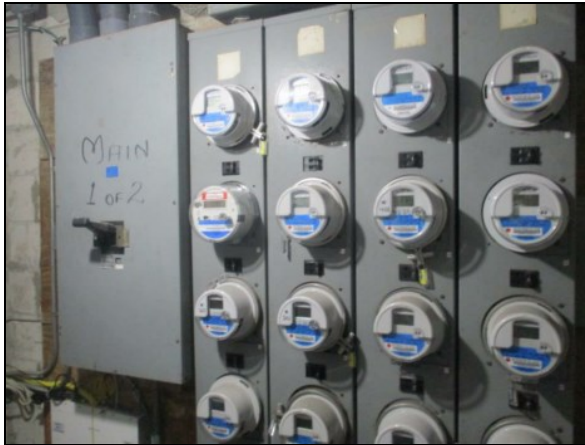
In accordance with Florida Statutes, a Structural Integrity Reserve Study is based only on a visual inspection. However, thorough analysis of electrical components requires testing beyond visual inspection (such as the use of infrared imaging equipment) in order to properly diagnose and detect problems which may require immediate repair or replacement. We recommend that the client consult with a qualified professional (i.e. electrician or other contractor) to more thoroughly evaluate the existing system(s) and to more accurately determine replacement timelines and cost estimates. In our experience, manufacturing defects may become apparent from time to time and certain site conditions can contribute to premature deterioration of system components. An allowance for repairs/replacement is recommended below based on our experience working with similar properties. However, these recommendations may be adjusted in subsequent revisions or in future updates if dictated by vendor recommendations.

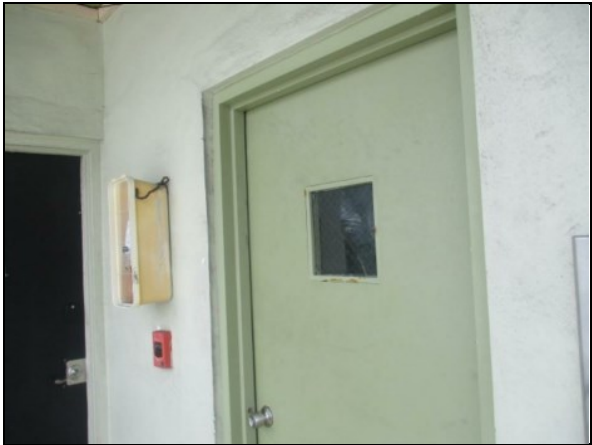
**Useful Life:**  
8 years

**Remaining Life:**  
8 years

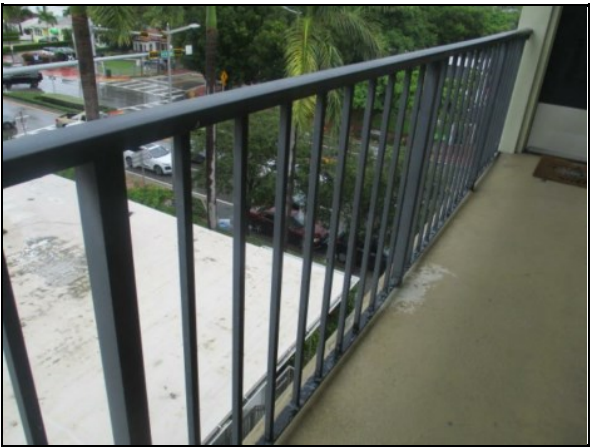
Useful Life:  
30 years

Remaining Life:  
16 years

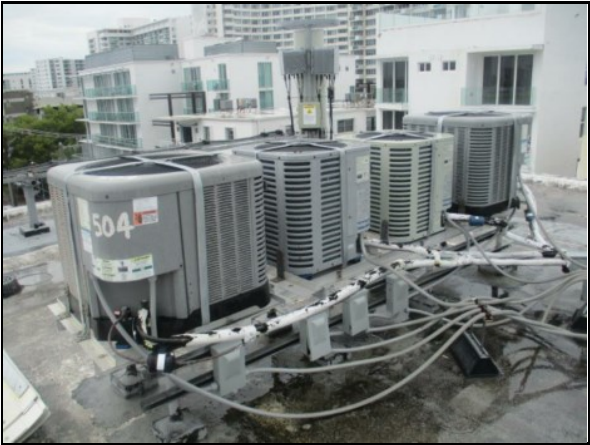
**Useful Life:**  
40 years

**Remaining Life:**  
20 years
