# **BUILDING SAFETY INSPECTION – STRUCTURAL**

## **-PHOTO REPORT-**

MYSTIC POINTE CONDOMINIUM No. TWO  
19195 MYSTIC POINTE DRIVE  
AVENTURA, FL 33180

FEBRUARY 17, 2026

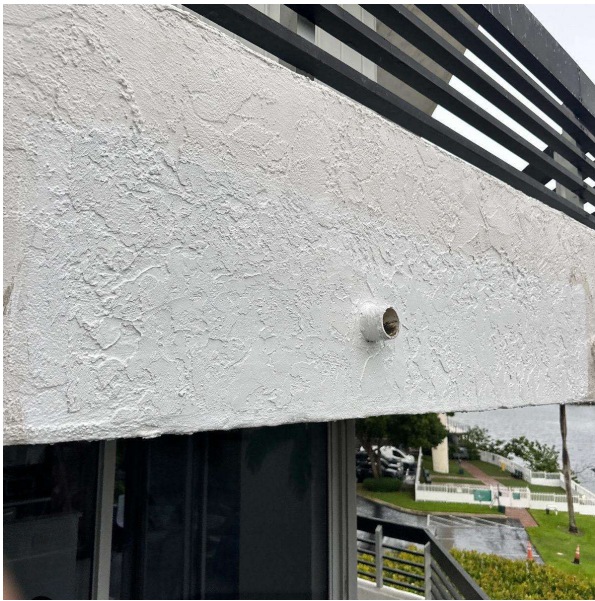
1. Concrete and Stucco Repair

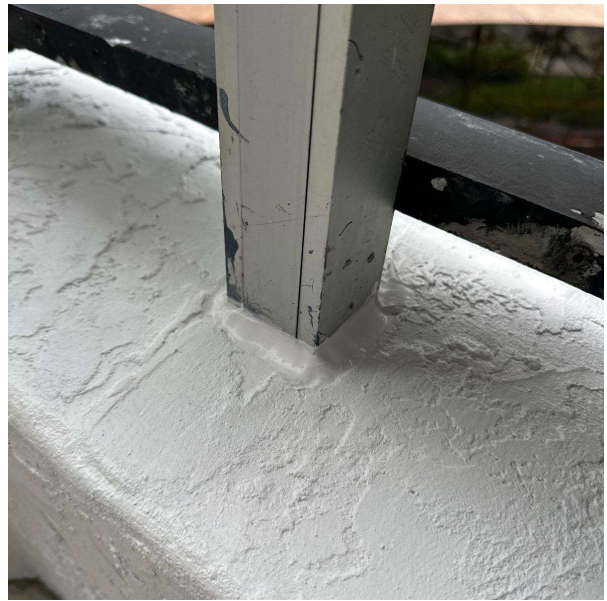
2. Post Pocket Repair

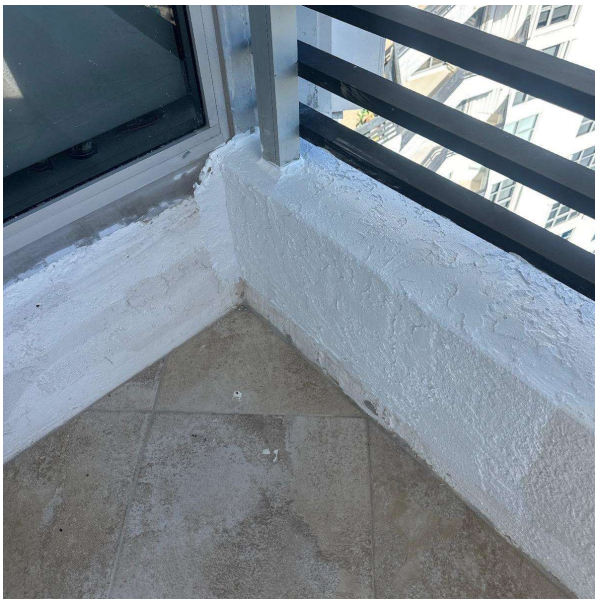
3. Knee Wall Repair

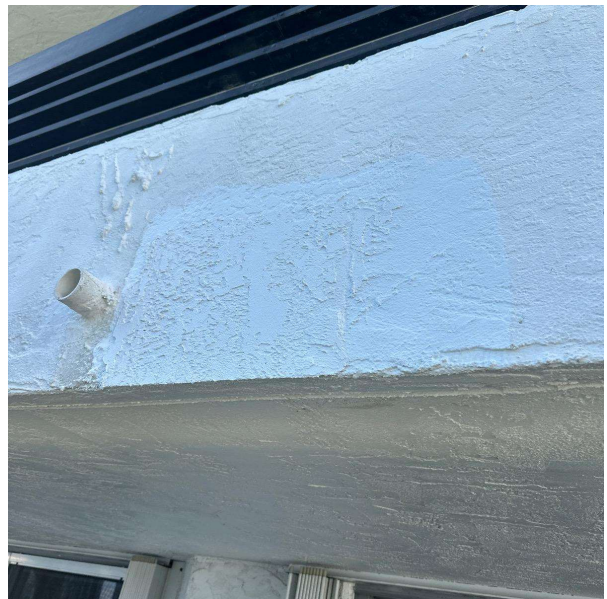
4. Stucco Repair

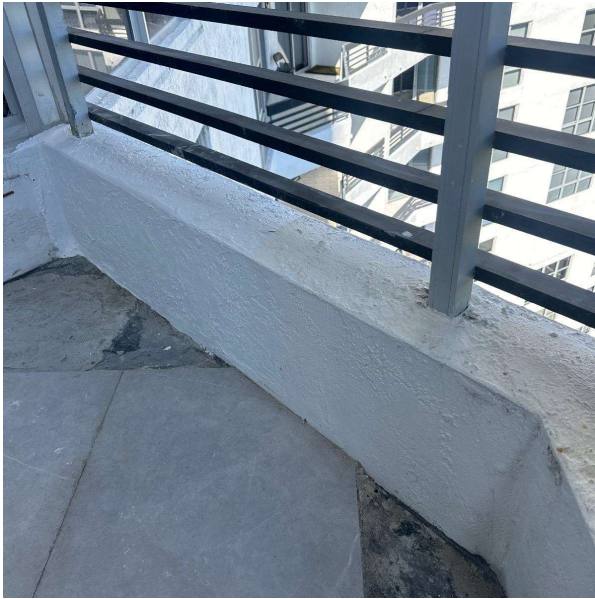
5. Knee Wall Repair

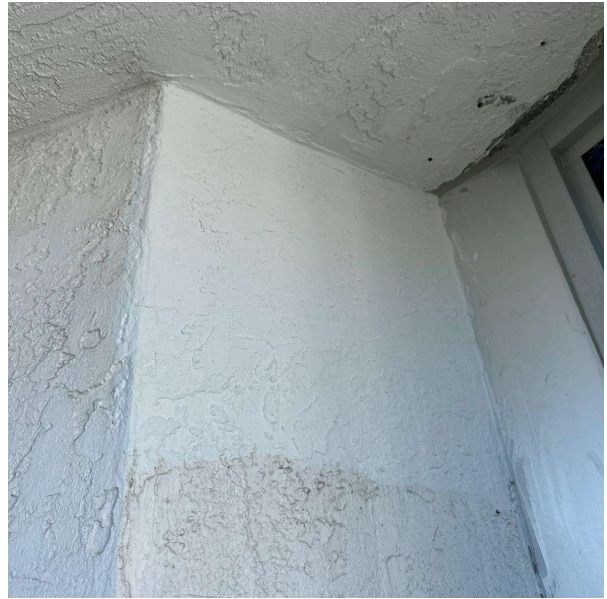
6. Wall Repair

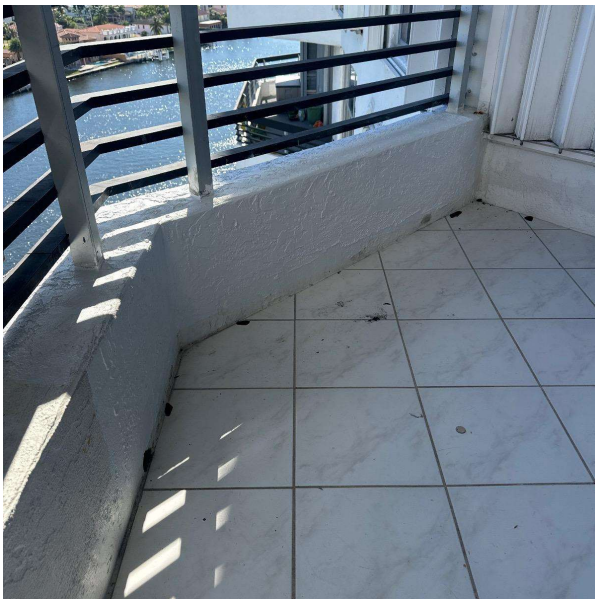
7. Knee Wall Repair

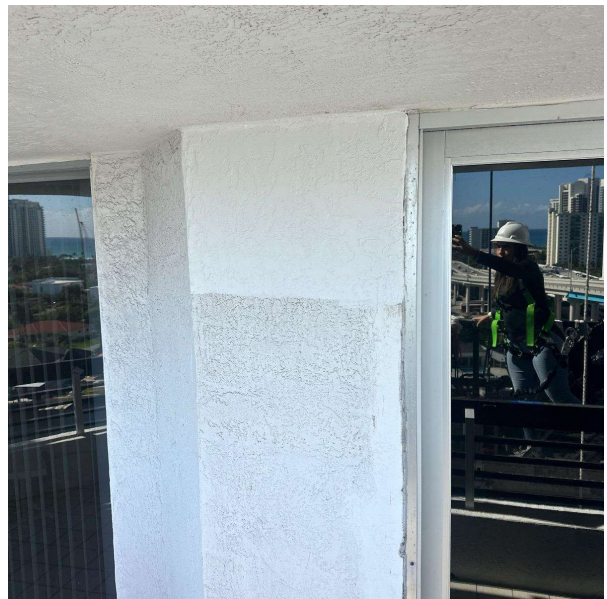
8. Wall Repair

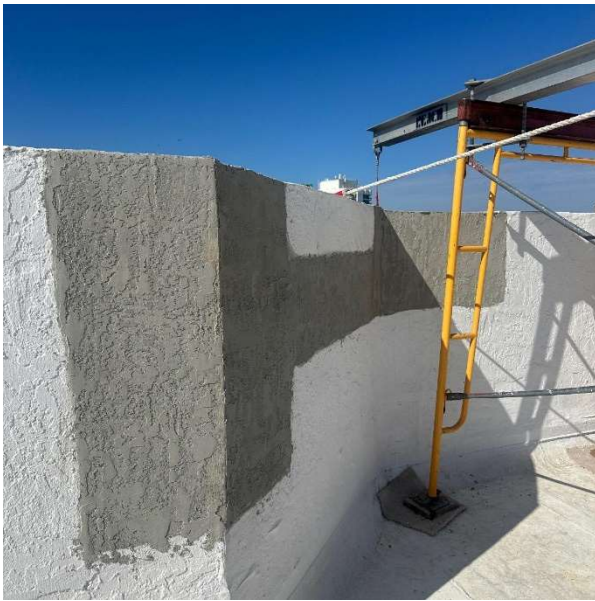
9. Parapet Wall Repair

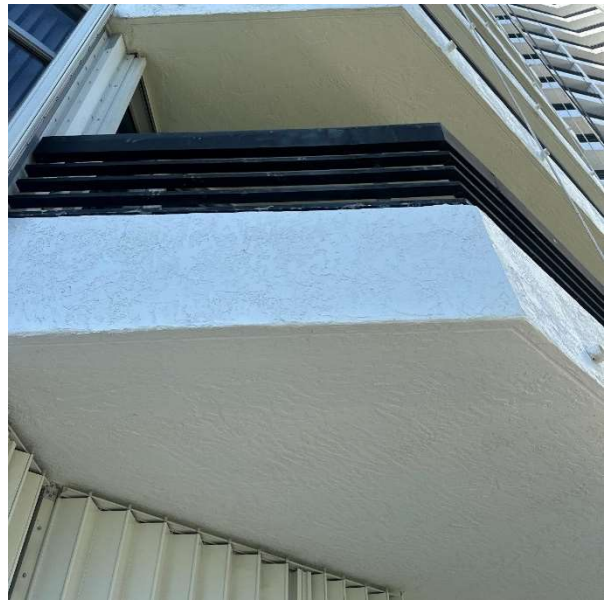
10. Edge of Slab and Knee Wall Repair

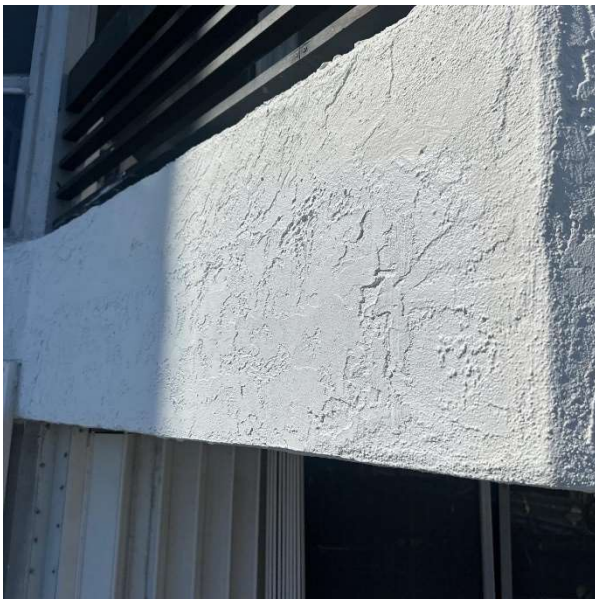
11. Edge of Slab and Knee Wall Repair

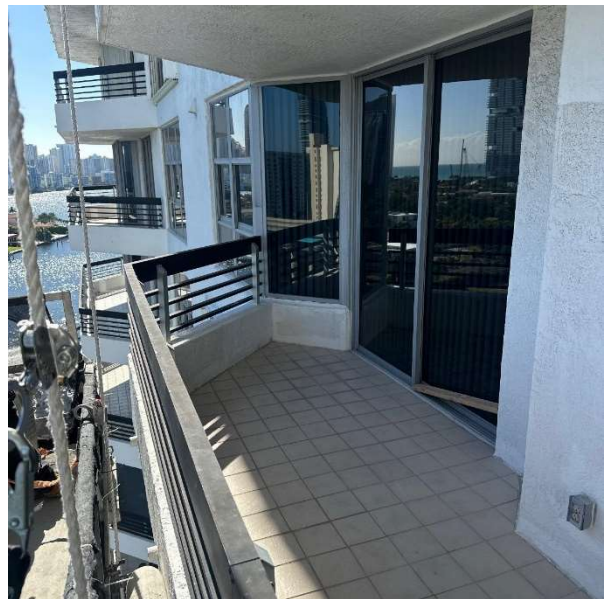
12. Overview of Repairs

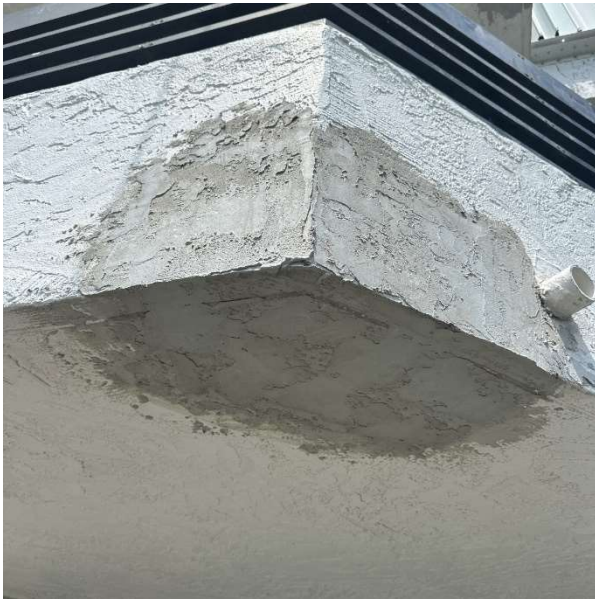
13. Stucco Repair

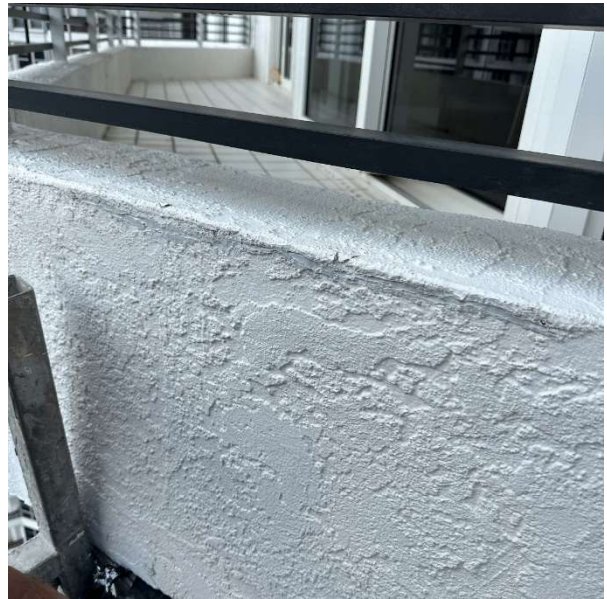
14. Crack Repair

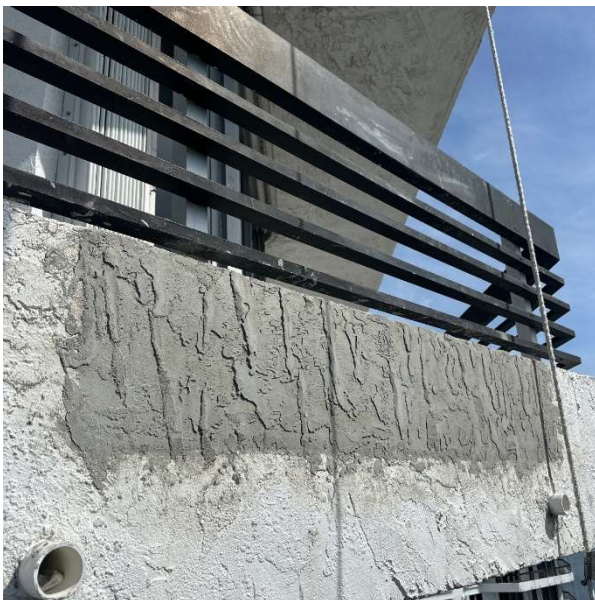
15. Knee Wall Repair

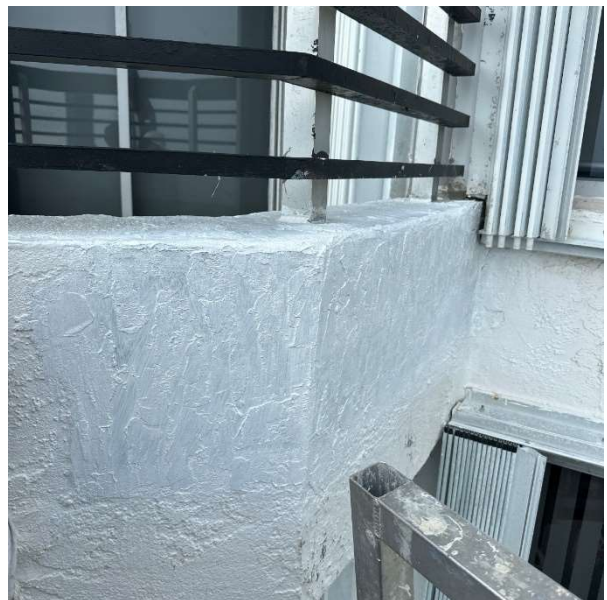
16. Knee Wall Repair

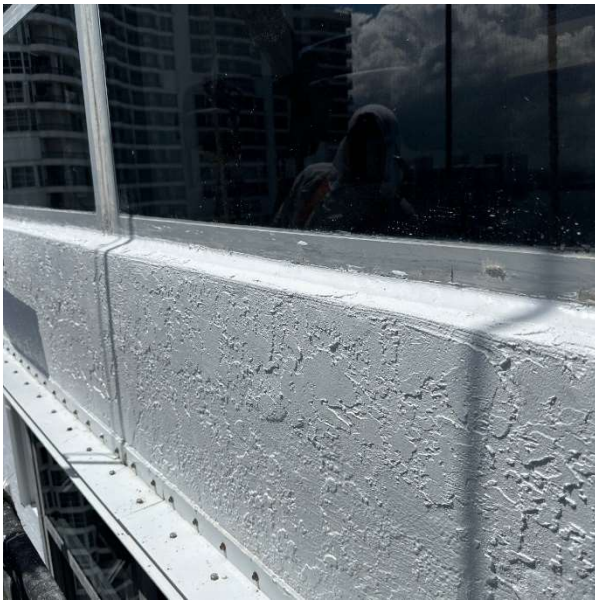
17. Wall Repair

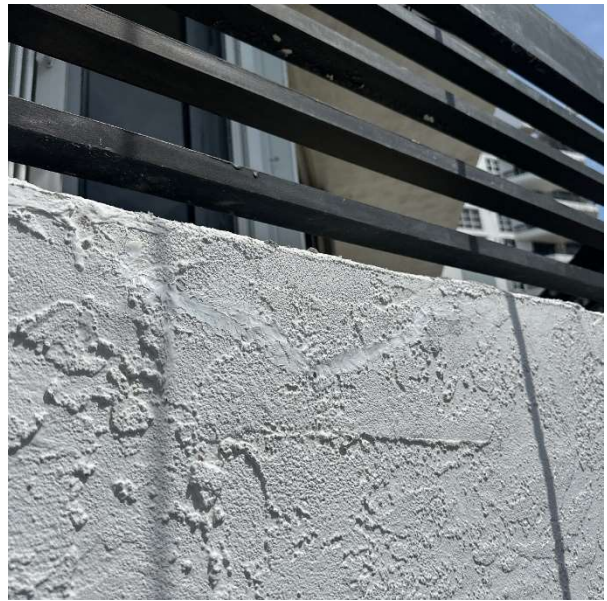
18. Crack Repair

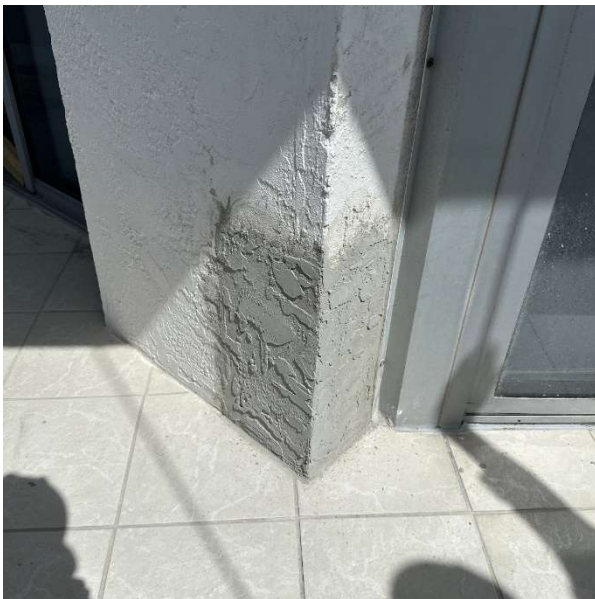
19. Column Repair

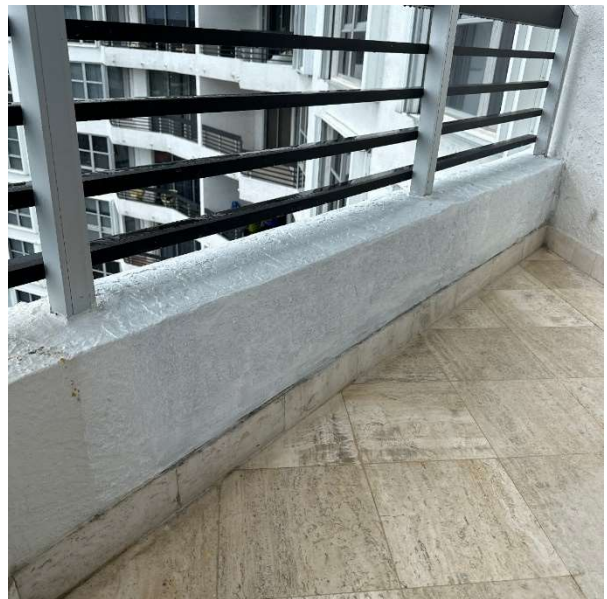
20. Knee Wall Repair
