**Gables Waterway Towers Condominium Inc.**  
**SIRS Components**  
***Coral Gables, FL***

Report #: 49054-0  
Beginning: January 1, 2025  
Expires: December 31, 2025

**RESERVE STUDY**  
**"Full"**

May 13, 2024

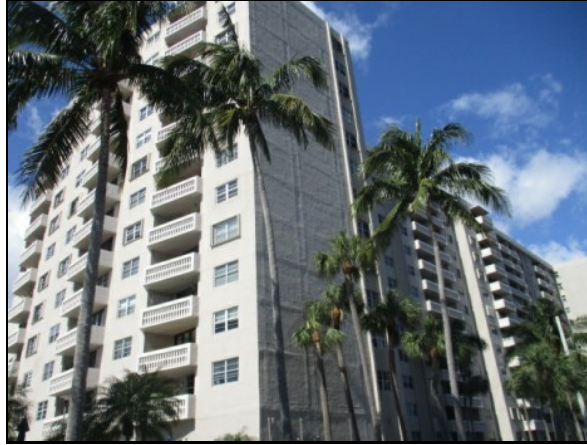
Useful Life:  
10 years

Remaining Life:  
1 years

Best Case: \$ 241,700

Worst Case: \$ 295,400

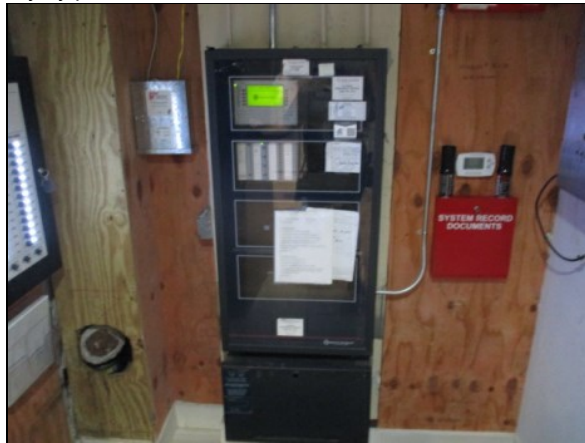
Useful Life:  
25 years

Remaining Life:  
8 years

Best Case: \$ 403,800

Worst Case: \$ 605,600

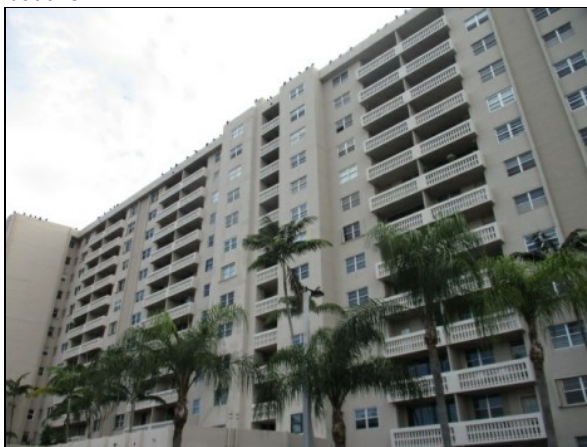
Useful Life:  
10 years

Remaining Life:  
4 years

Best Case: \$ 241,700

Worst Case: \$ 295,400

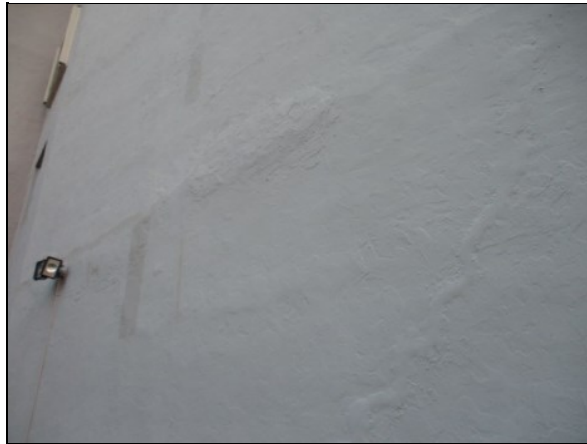
Useful Life:  
10 years

Remaining Life:  
1 years

Best Case: \$ 348,500

Worst Case: \$ 426,000

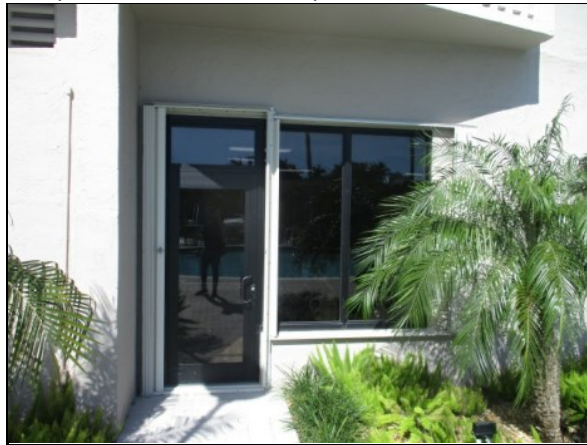
Useful Life:  
40 years

Remaining Life:  
13 years

Best Case: \$ 32,400

Worst Case: \$ 48,600

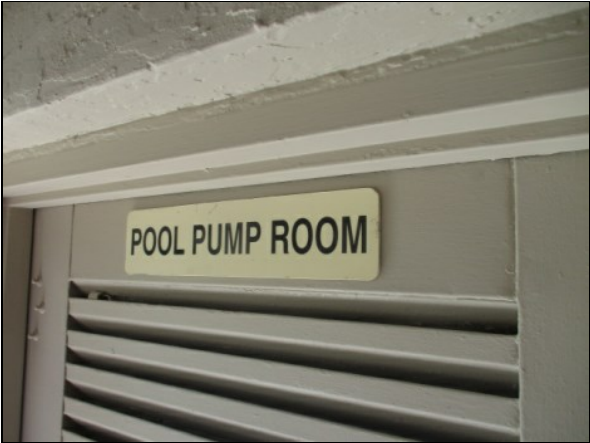
Useful Life:  
30 years

Remaining Life:  
15 years

Best Case:    \$ 31,500

Worst Case:    \$ 38,500

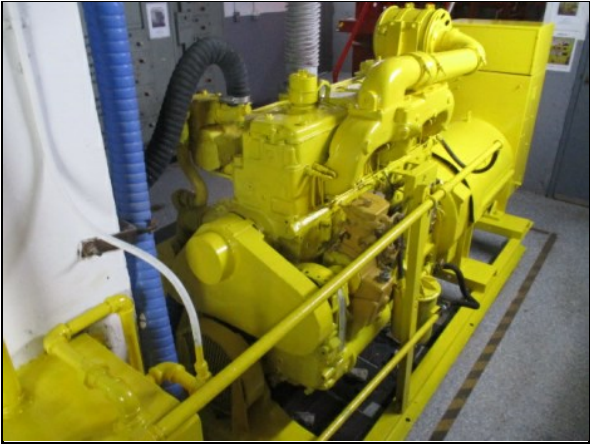
Useful Life:  
40 years

Remaining Life:  
6 years

Best Case: \$ 108,000

Worst Case: \$ 132,000
