**HORIZONS WEST**

**The Horizons West Condominium #9**  
**SIRS Components**  
***Miami, FL***

Report #: 50193-0  
Beginning: January 1, 2025  
Expires: December 31, 2025

**RESERVE STUDY**  
**"Full"**

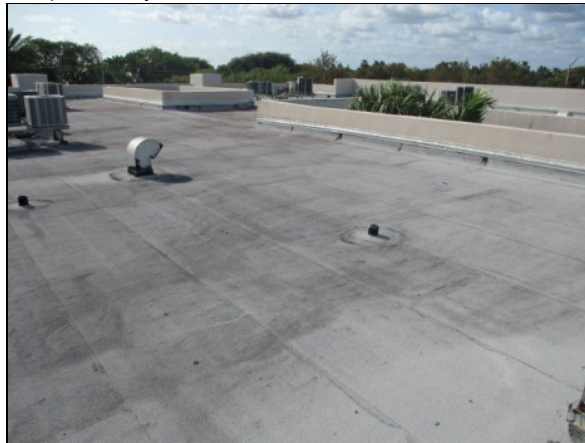
### Comp #: 2377 Modified Bitumen Roofing - Replace

Useful Life:  
15 years

Remaining Life:  
11 years

Best Case: \$ 400,000

Worst Case: \$ 600,000

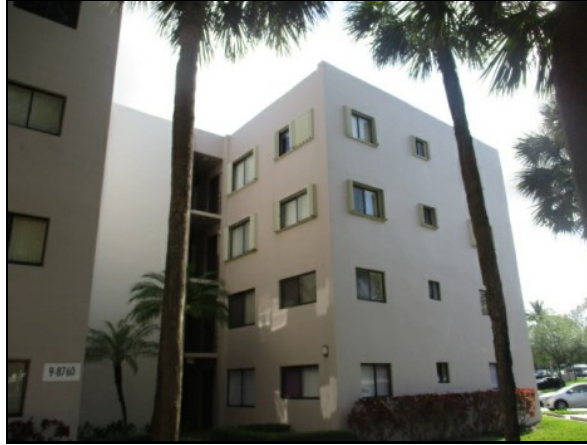
Useful Life:  
10 years

Remaining Life:  
8 years

Best Case: \$ 150,000

Worst Case: \$ 250,000

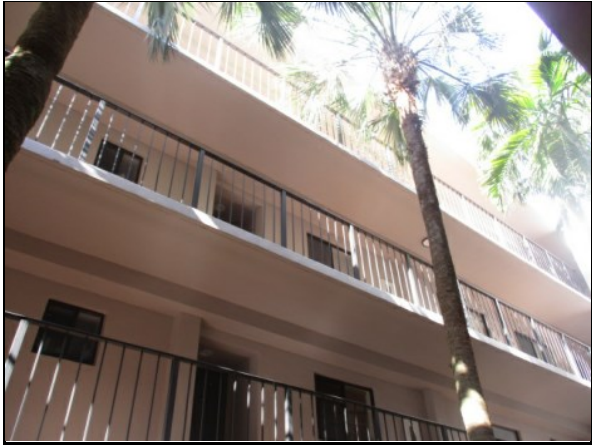
Useful Life:  
10 years

Remaining Life:  
7 years

Best Case: \$ 35,000

Worst Case: \$ 55,000

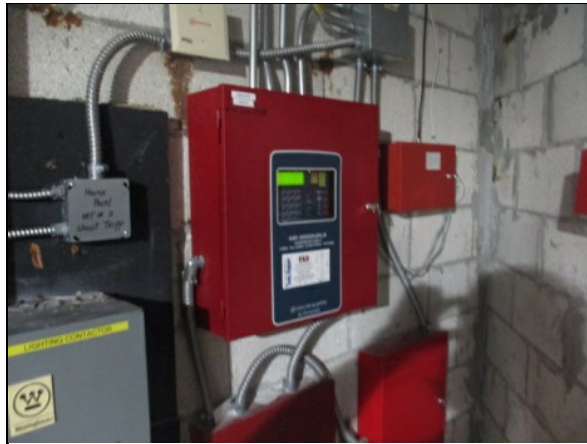
Remaining Life:

12 years

Best Case: \$ 52,000

Worst Case: \$ 78,000

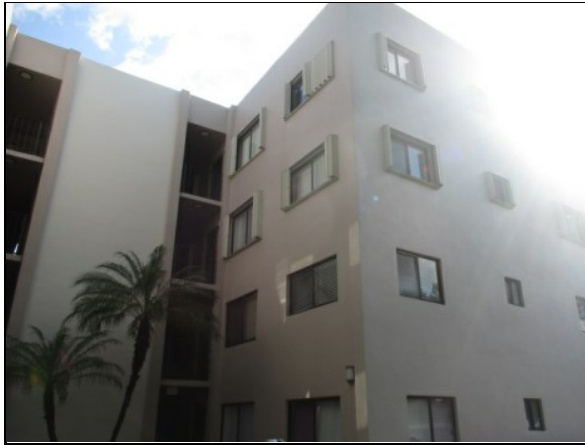
Useful Life:  
10 years

Remaining Life:  
7 years

Best Case: \$ 86,400

Worst Case: \$ 106,400

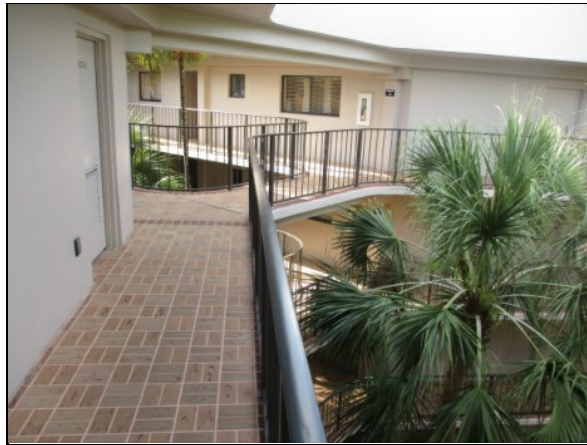
Useful Life:  
30 years

Remaining Life:  
7 years

Best Case: \$ 515,700

Worst Case: \$ 630,500

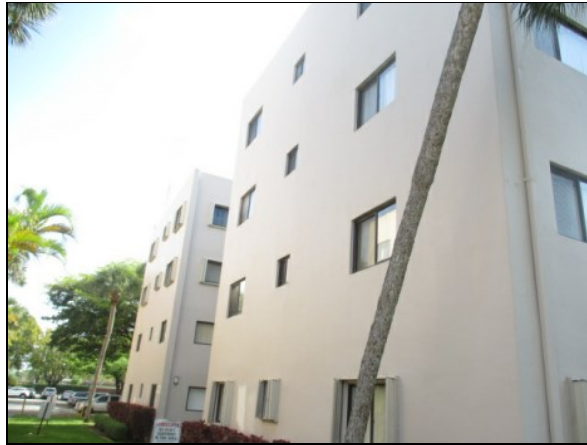
Useful Life:  
10 years

Remaining Life:  
7 years

Best Case: \$ 200,000

Worst Case: \$ 270,000

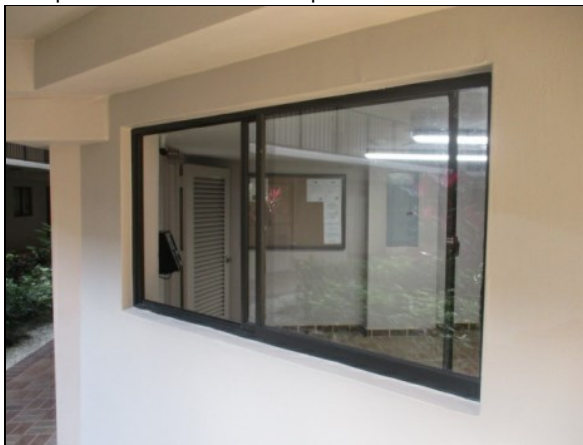
Useful Life:  
40 years

Remaining Life:  
7 years

Best Case: \$ 76,000

Worst Case: \$ 114,500

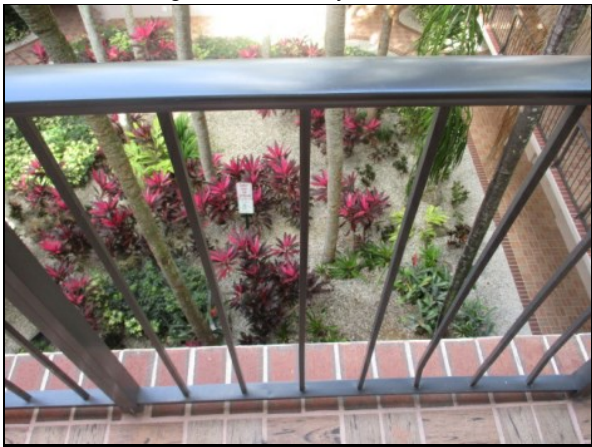
Useful Life:  
30 years

Remaining Life:  
7 years

Best Case: \$ 384,000

Worst Case: \$ 471,000

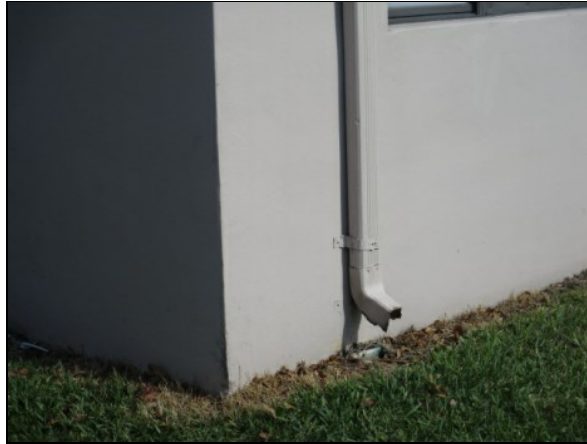
Useful Life:  
40 years

Remaining Life:  
20 years

Best Case: \$ 11,500

Worst Case: \$ 14,000

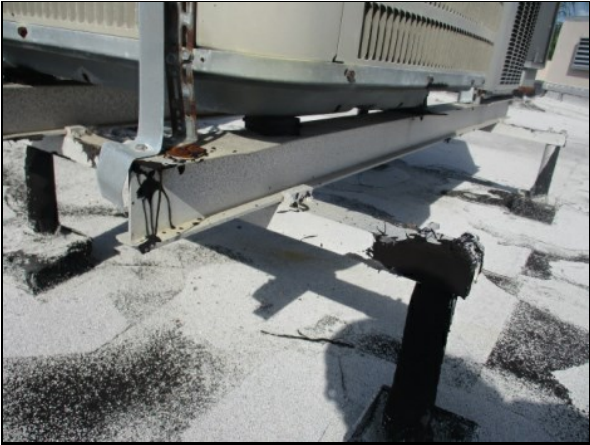
Useful Life:  
30 years

Remaining Life:  
11 years

Best Case: \$ 148,000

Worst Case: \$ 188,000
