## 40-Year Structural Recertification

**Meadowbrook Lakes Condominium,  
Building H**  
301 SE 3rd St,  
Dania Beach, FL, 33004

June 25, 2025

# **301 SE 3rd St BUILDING SAFETY INSPECTION CERTIFICATION OF 40-YEAR-OLD BUILDING**

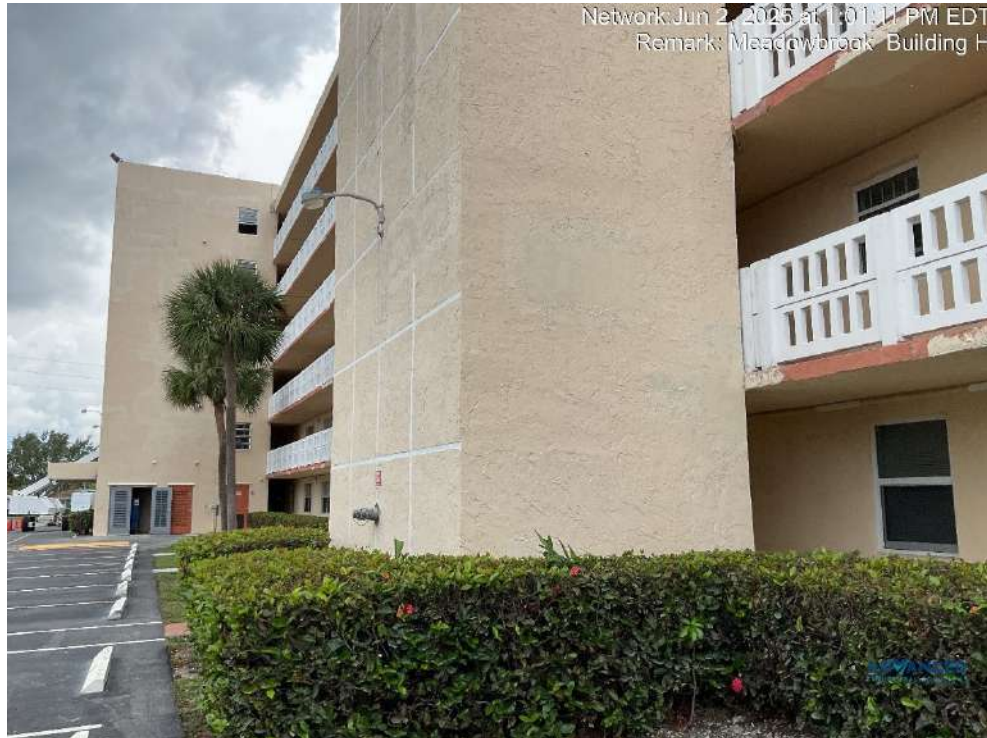
**Figure 1. Building Overall Conditions - Good.**

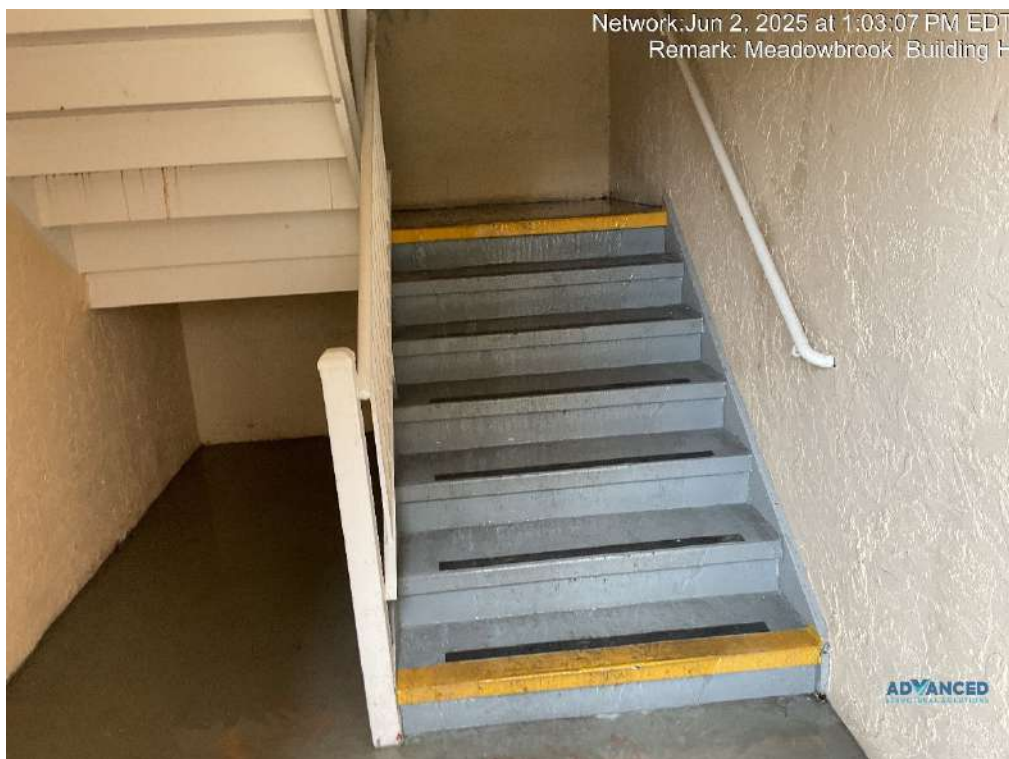
STAIRS ARE LOCATED ON EACH END OF THE BUILDING (NORTH AND SOUTH). STAIRS ARE COMPOSED OF CAST IN PLACE REINFORCED CONCRETE. NO ISSUES OBSERVED.

**Figure 2. Staircases in Good Condition.**

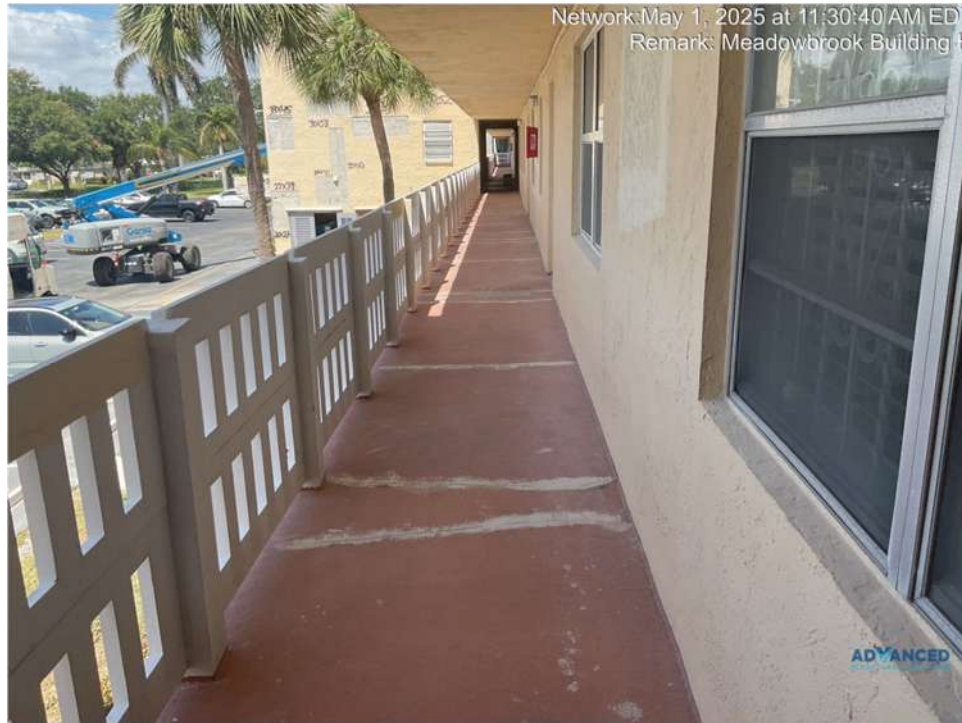
EXPANSION JOIN ON ELEVATED CATWALKS IN GOOD CONDITIONS.

**Figure 3. Walkways in Good Conditions.**

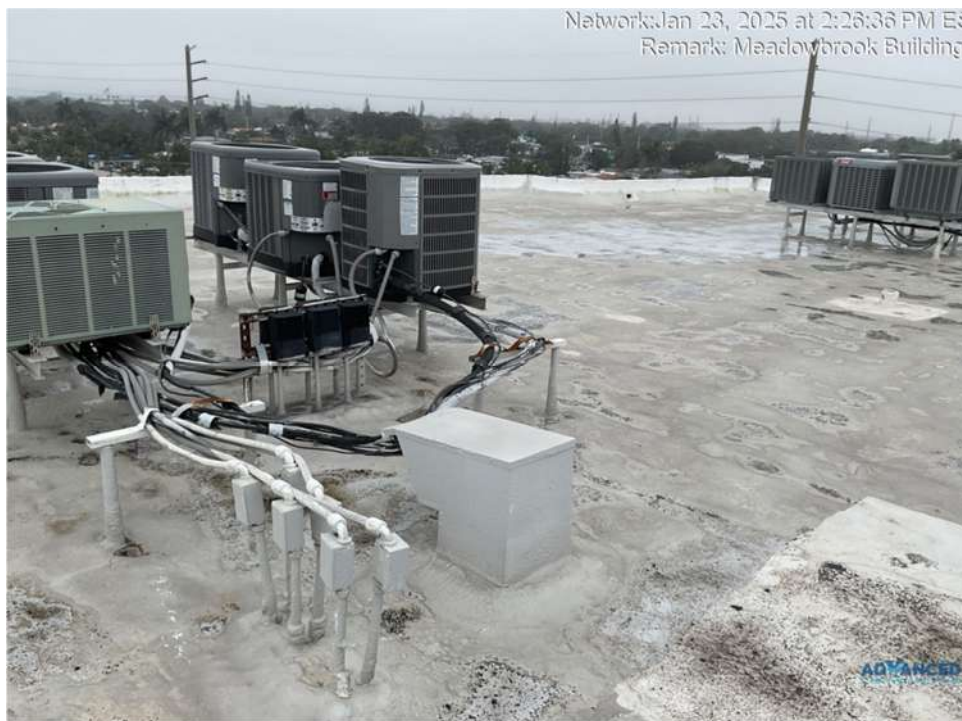
INTERNAL PRIMARY DRAINS AND OVERFLOW SCUPPERS OBSERVED

**Figure 4. Roof and scooper in Good Conditions.**
