## **TRADITIONAL RESERVE STUDY STRUCTURAL INTEGRITY RESERVE STUDY**

**White Sands Beach Homes II**  
344 Elm Street  
Hollywood, Florida 33019

**Project Number 24036110**

May 29, 2024

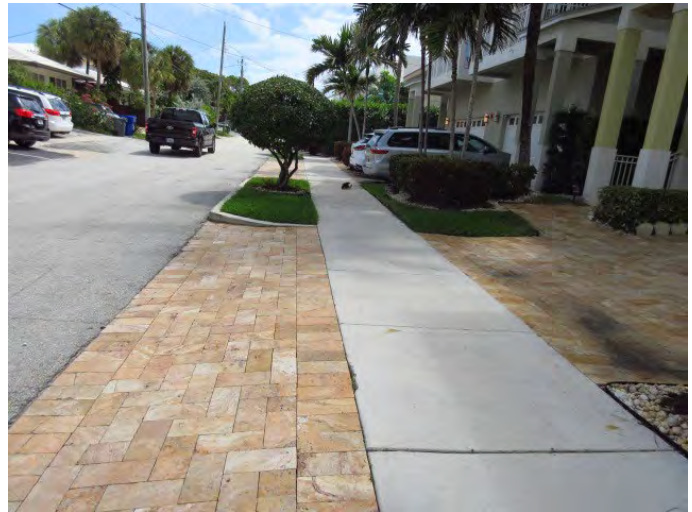
## PHOTO 2

| Item | Description/Observations/Comments |
|---|---|
| <b>Sidewalks</b> | <p>Property pedestrian walkways and flatwork consist of concrete.</p> <p><b>The sidewalks appeared to be in good condition with no significant deficiencies noted.</b></p> |

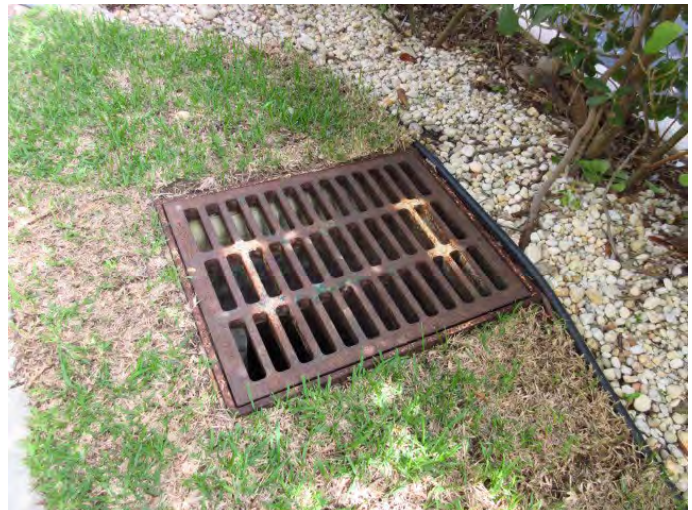
## PHOTO 3

| Item | Description/Observations/Comments |
|---|---|
| <b>Drainage Systems</b> | <p>The site is drained via sheeting action to storm drain inlets with underground piping connected to the municipal storm drain system.</p> <p><b>Due to hidden conditions, the site storm water drainage system could not be evaluated.</b></p> |

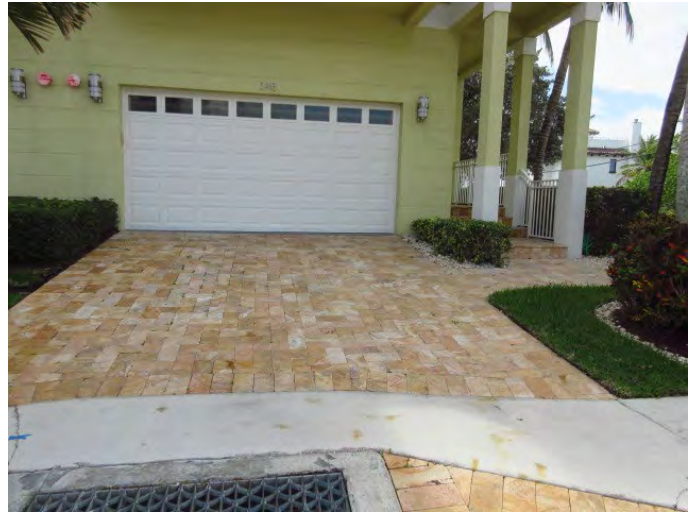
## PHOTO 4

| Item | Description/Observations/Comments |
|---|---|
| <b>Parking/Paving</b> | <p>Vehicular access to the Property is via individual driveways, consisting of interlocking pavers.</p> <p><b>The driveways were noted to be in good condition. Based on the Expected Useful Life (EUL) of 25 years, funds have been spread throughout the Replacement Reserves Cost Estimate Table, adopting the straight-line accounting method to ensure the availability of funds at the end of the replaced element's EUL, beyond the evaluation period of this assessment.</b></p> |

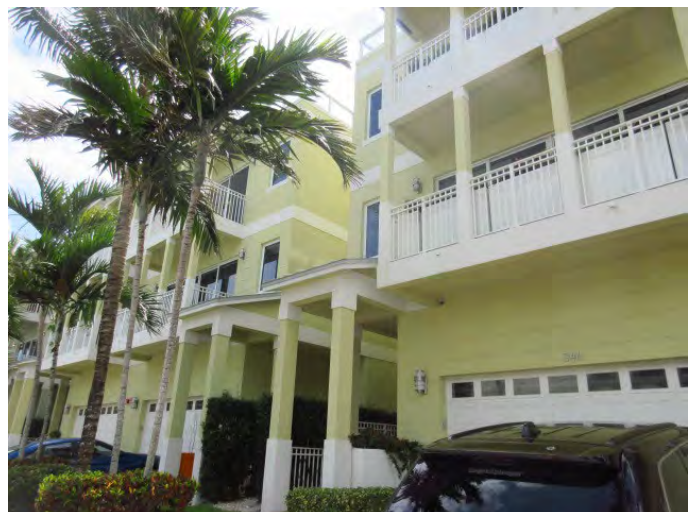
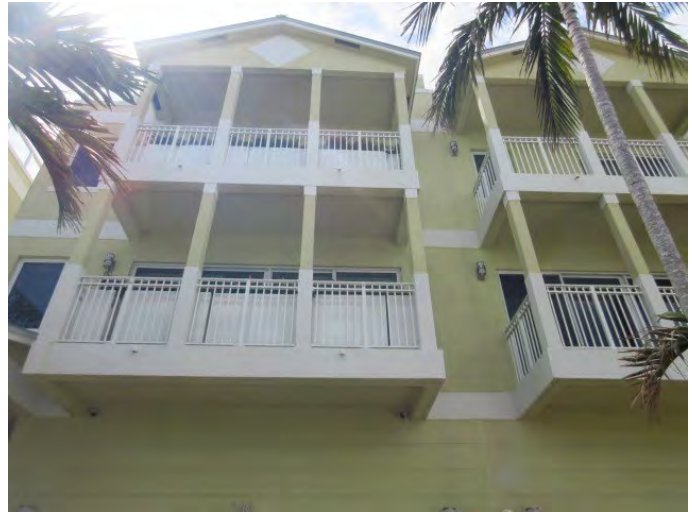
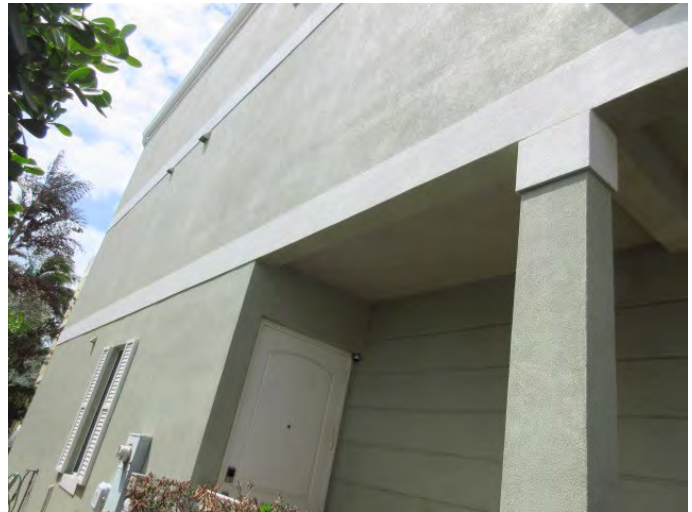
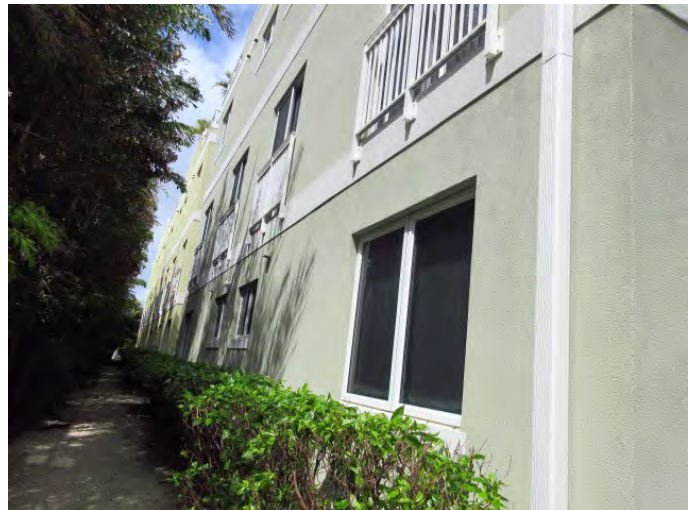
| Item | Description/Observations/Comments |
|---|---|
| Exterior Walls | <p>The exterior walls typically consist of concrete masonry unit (CMU) construction finished with painted stucco.</p> <p><b>The exterior walls were noted to be in generally good condition, with no significant deficiencies noted. Based on the EUL of 10 years, repainting, waterproofing and periodic stucco restoration of the exterior surfaces are anticipated during the evaluation period. Funds have been spread throughout the Replacement Reserves Cost Estimate Table, adopting the straight-line accounting method to ensure the availability of funds at the end of the replaced element's EUL, beyond the evaluation period of this assessment.</b></p> <p><b>Please note that the extent of the exterior walls' evaluation did not include sampling or testing, therefore comments made regarding the condition of the façade components are limited to visual observation. Should a more comprehensive investigation be required, further assessment that includes destructive to determine the extent of the deficiencies is recommended.</b></p> |

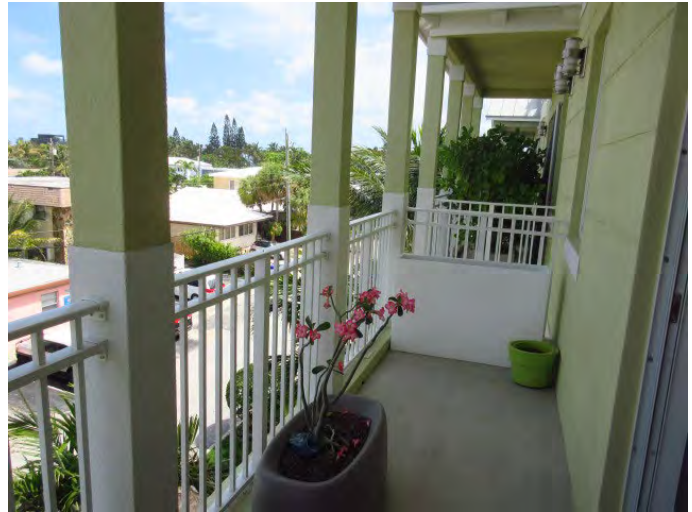
**PHOTO 10**

| Item | Description/Observations/Comments |
|---|---|
| <b>Patios / Balconies</b> | <p data-bbox="610 306 1435 531">Please note that the extent of the roof evaluation did not include any sampling and/or testing involved therefore comments made regarding the condition of the roof are limited to visual observation as well as historical information provided by site contact and/or Property respondent. Should a more comprehensive investigation be required, the services of a certified roofing consultant should be considered.</p> <p data-bbox="610 554 1435 615">The balconies are supported by the building structural system and include concrete decking. Fall protection is provided by aluminum railing.</p> <p data-bbox="610 636 1435 730"><b>The balcony decking was noted to be in generally good condition. These components are generally addressed in conjunction with the exterior façade painting and waterproofing applications.</b></p> |

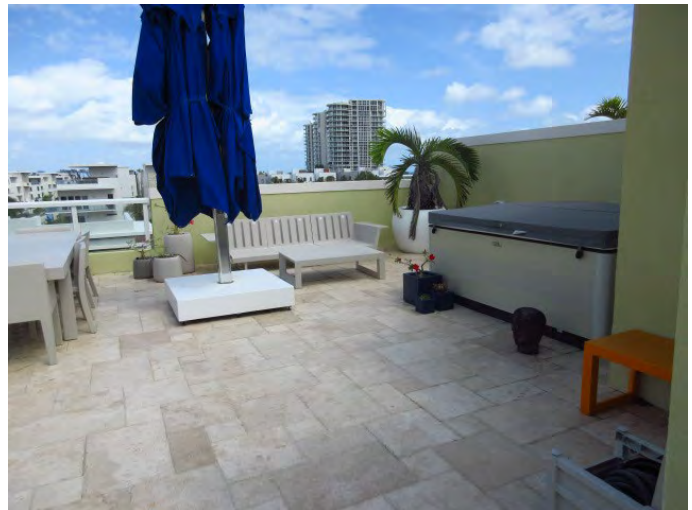
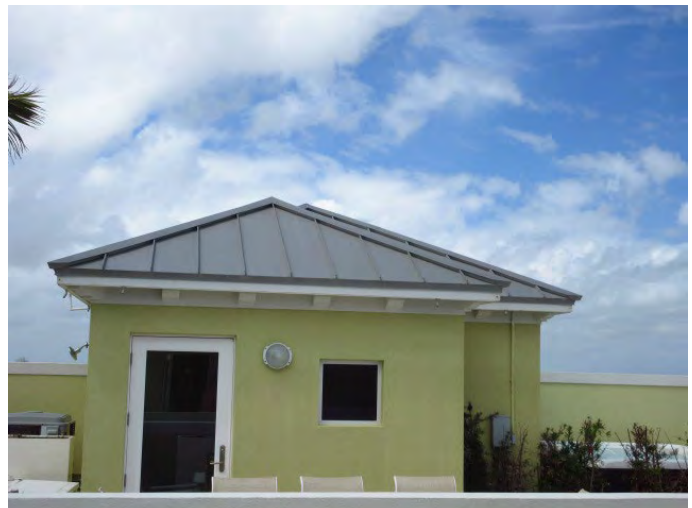
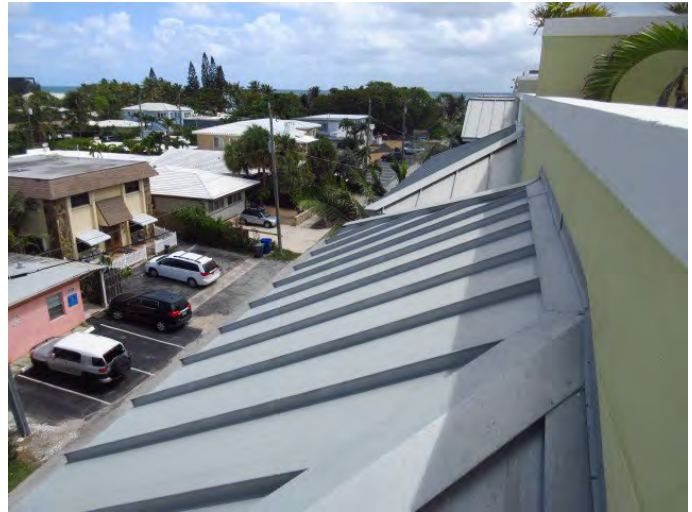
| Item | Description/Observations/Comments |
|---|---|
| Roof | <p>The roof coverings consist of a combination of low-slope (flat) inverted system at the penthouse level terrace, topped with tile ballast, and pitched standing-seam metal system.</p> <p><b>The roof coverings were noted to be in generally good condition. Based on the EUL of 25 years for inverted roofs, and 40 years for pitched standing-seam metal systems, funds for replacement have been spread throughout the Replacement Reserves Cost Estimate Table, adopting the straight-line accounting method to ensure the availability of funds at the end of the replaced element's EUL, beyond the evaluation period of this assessment.</b></p> |

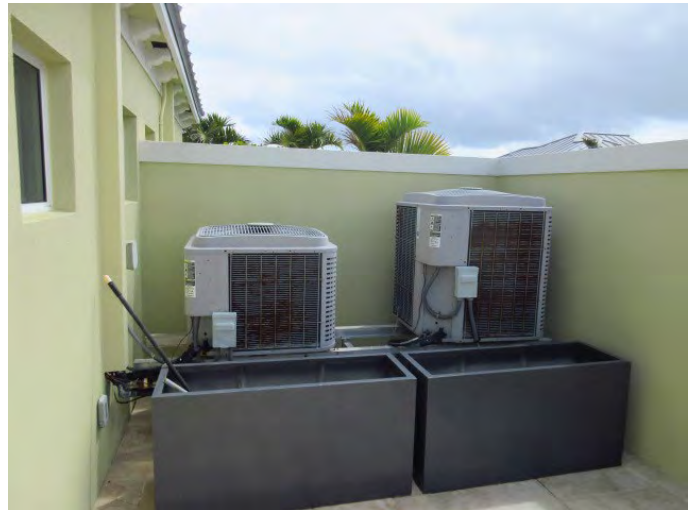
**PHOTO 14**

| Item | Description/Observations/Comments |
|---|---|
| HVAC | <p>Cooling and heating are supplied by individual electric forced-air furnaces with split-system air-conditioning condensing units.</p> <p><b>HVAC at the dwelling units is the responsibility of the condominium owners to maintain and replace.</b></p> |

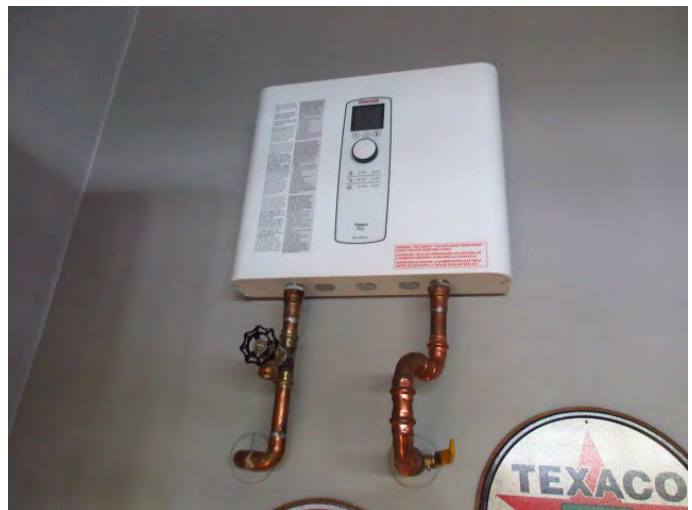
**PHOTO 15**

| Item | Description/Observations/Comments |
|---|---|
| Water Heaters | <p>Domestic hot water is provided by individual residential-grade heaters in each of the units.</p> <p><b>The water heaters at the dwelling units are the responsibility of the condominium owners to maintain and replace.</b></p> |

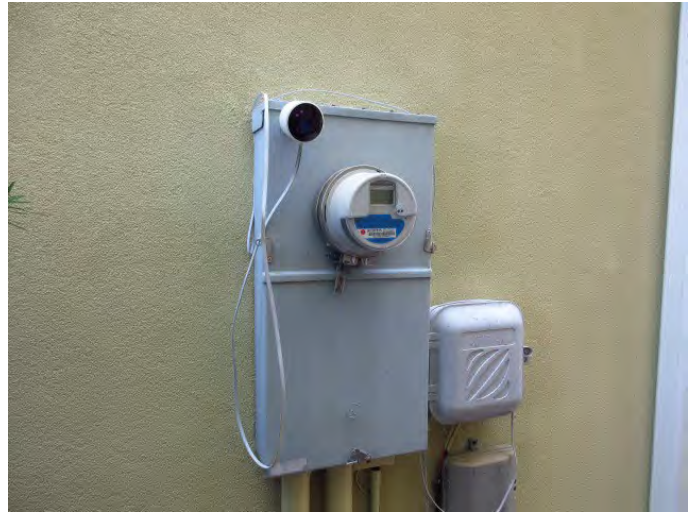
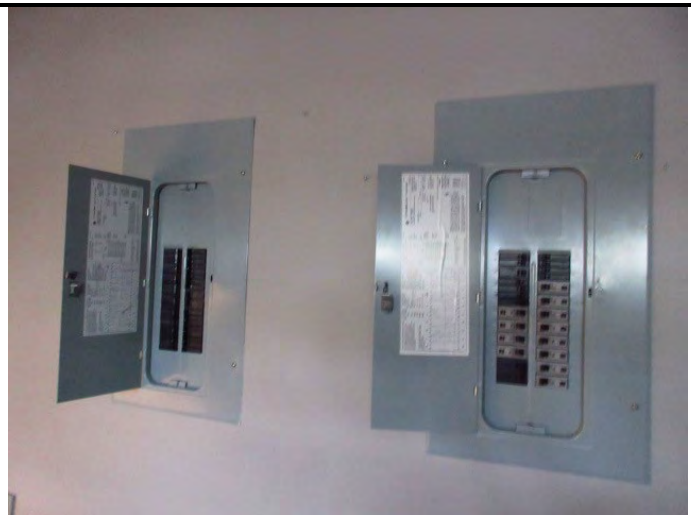
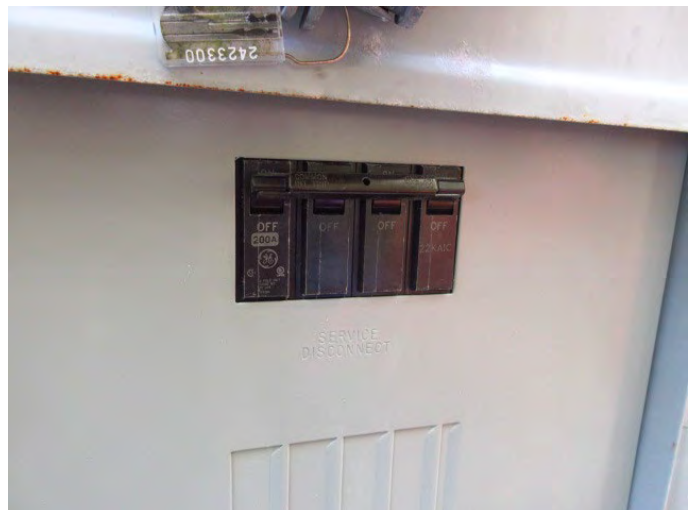
| Item | Description/Observations/Comments |
|---|---|
| Electrical Service | <p>Electrical service typically provides 200-Ampere minimum, 120/240-Volt, single-phase, three-wire service to the individual units. The distribution wiring was noted to be copper.</p> <p><b>Electrical systems and installations within the dwelling units are reported to be the responsibility of the respective condominium unit owner to maintain and replace.</b></p> <p><b>Funds for replacements and upgrades for primary electrical systems outside the units have been spread throughout the Replacement Reserves Cost Estimate Table, adopting the straight-line accounting method to ensure the availability of funds at the end of the replaced element's EUL, beyond the evaluation period of this assessment.</b></p> |

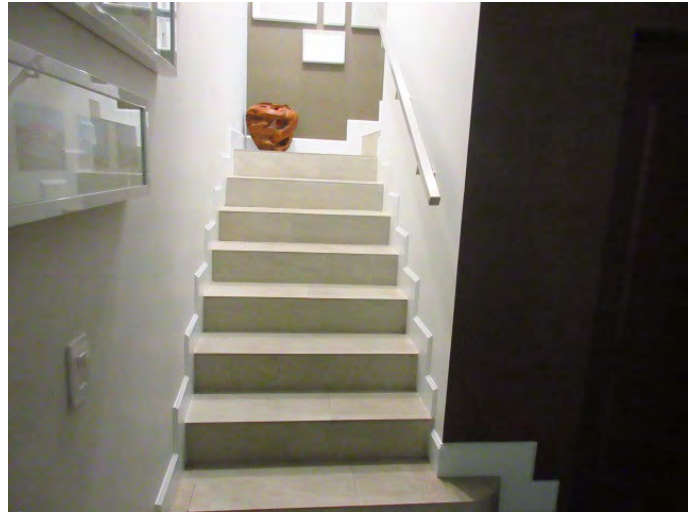
**PHOTO 19**

| Item | Description/Observations/Comments |
|---|---|
| Stairs | The stairs are located within the interior spaces of each condominium unit.<br><b>The stairs within the condominium units are the responsibility of the respective unit owners to maintain and replace.</b> |

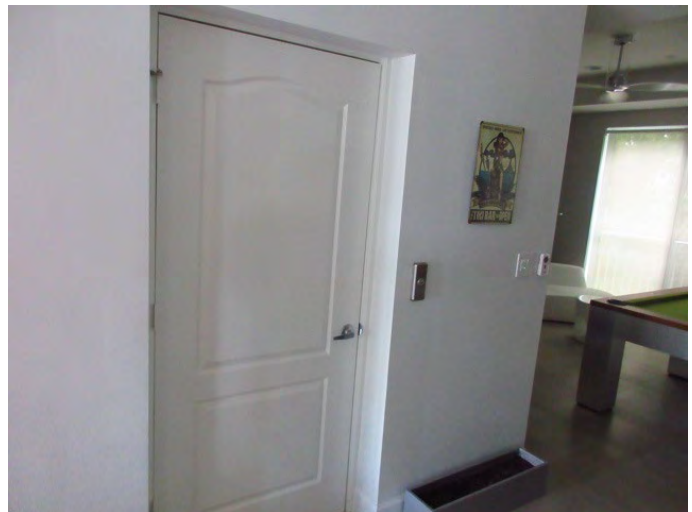
**PHOTO 20**

| Item | Description/Observations/Comments |
|---|---|
| Elevators | Each dwelling unit is equipped with its own individual elevator.<br><b>Elevators within the condominium units are the responsibility of the respective unit owners to maintain and replace.</b> |

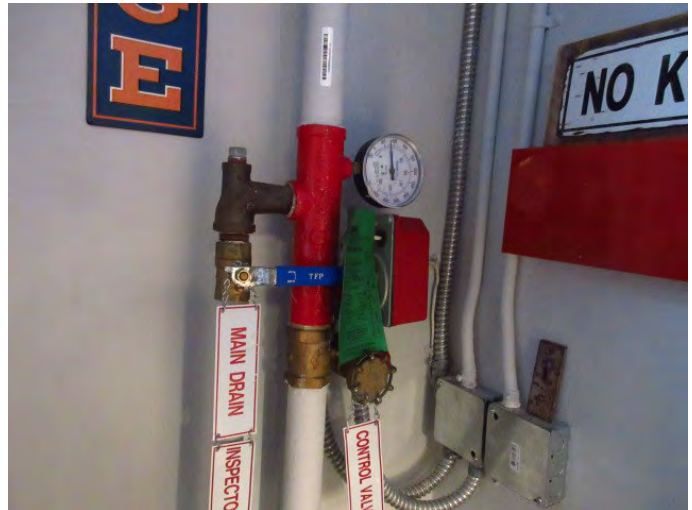
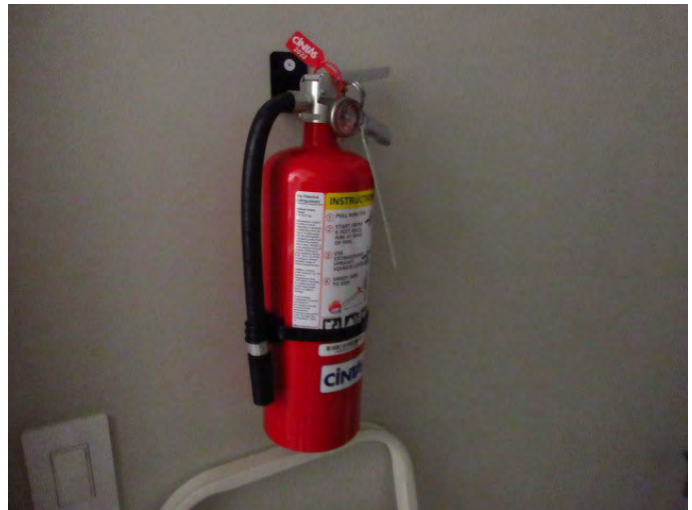
| Item | Description/Observations/Comments |
|---|---|
| <b>Fire Protection</b> | <p>The dwelling units are protected by individual pipe fire sprinkler suppression systems, dry chemical fire extinguishers and carbon monoxide and smoke detectors.</p> <p>The fire systems were noted to be in good operating condition. Funds for component replacement have been spread throughout the Replacement Reserves Cost Estimate Table, adopting the straight-line accounting method to ensure the availability of funds at the end of the replaced element's EUL, beyond the evaluation period of this assessment.</p> |
