**Centro Downtown C.A., Inc.**  
**SIRS Components**  
***Miami, FL***

Report #: 31648-2  
Beginning: January 1, 2025  
Expires: December 31, 2025

**RESERVE STUDY**  
**Update "With-Site-Visit"**

October 14, 2024

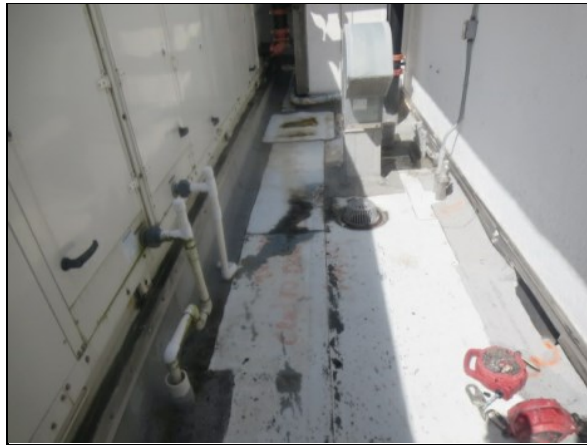
Useful Life:  
20 years

Remaining Life:  
11 years

Best Case: \$ 324,700

Worst Case: \$ 396,800

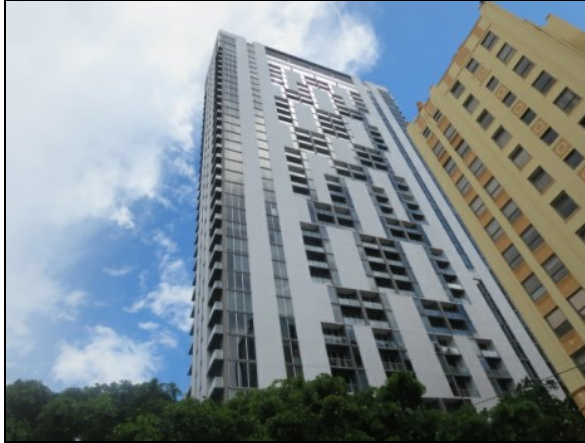
Useful Life:  
10 years

Remaining Life:  
1 years

Best Case: \$ 322,200

Worst Case: \$ 393,800

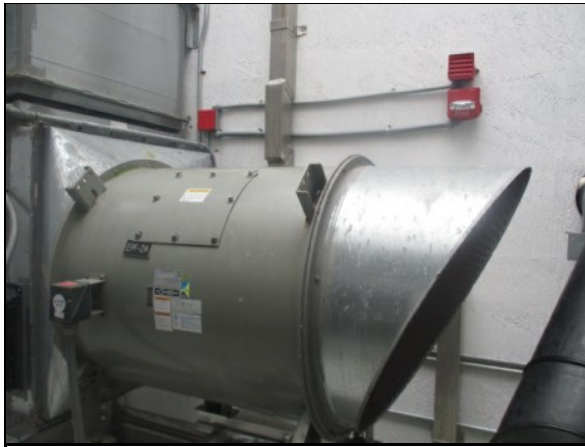
Useful Life:  
15 years

Remaining Life:  
6 years

Best Case: \$ 54,000

Worst Case: \$ 66,000

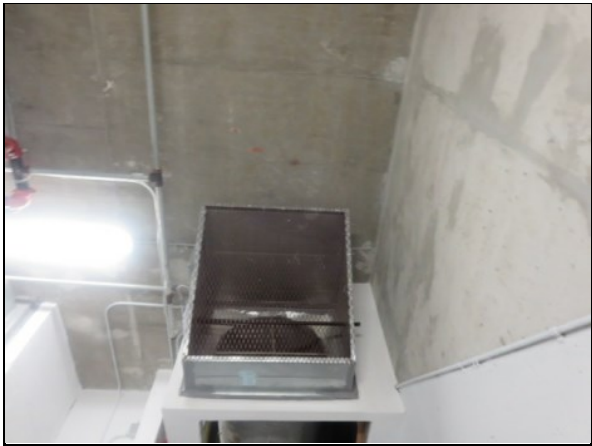
Useful Life:  
15 years

Remaining Life:  
6 years

Best Case: \$ 54,000

Worst Case: \$ 66,000

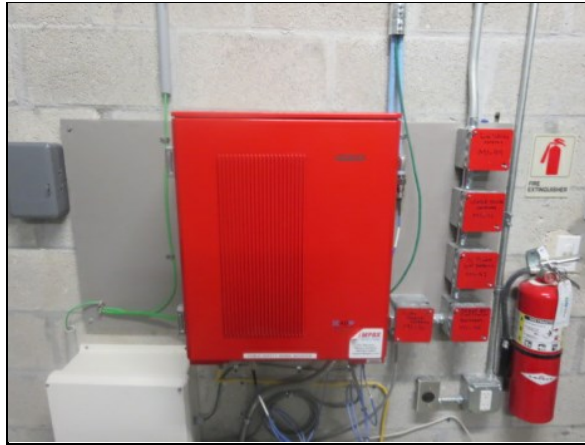
Useful Life:  
20 years

Remaining Life:  
11 years

Best Case: \$ 45,000

Worst Case: \$ 55,000

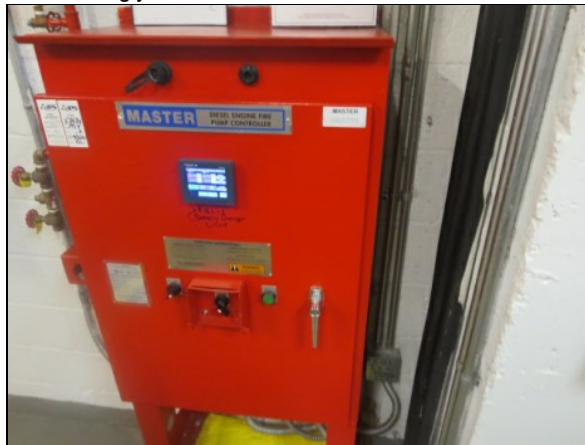
Remaining Life:

16 years

Best Case: \$ 356,000

Worst Case: \$ 534,000

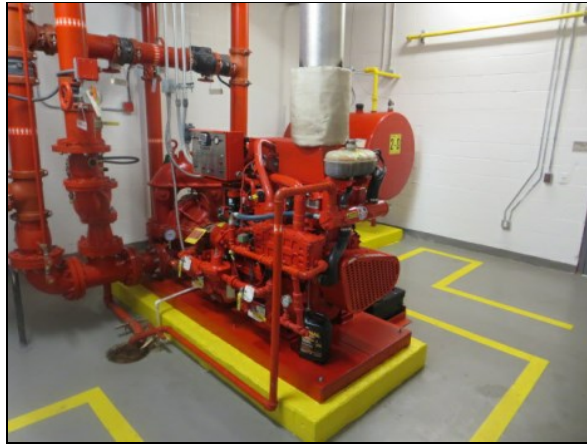
Remaining Life:

31 years

Best Case: \$ 99,000

Worst Case: \$ 121,000

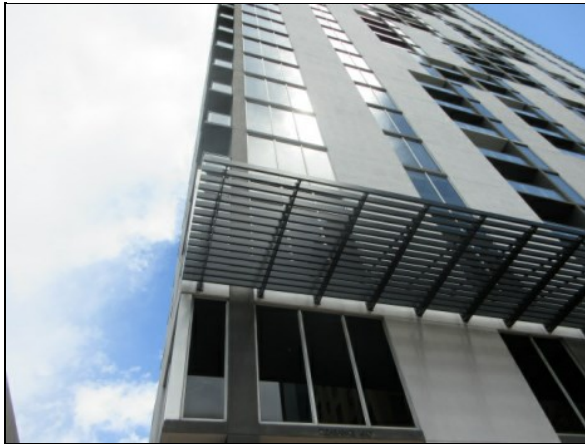
Useful Life:  
1 years

Remaining Life:  
0 years

Best Case: \$ 13,500

Worst Case: \$ 16,500

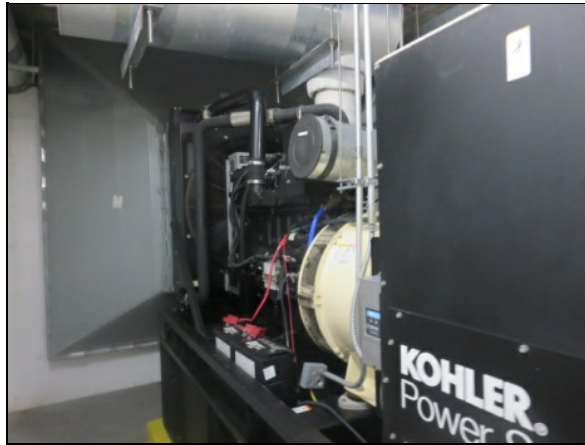
Remaining Life:

29 years

Best Case: \$ 225,000

Worst Case: \$ 275,000

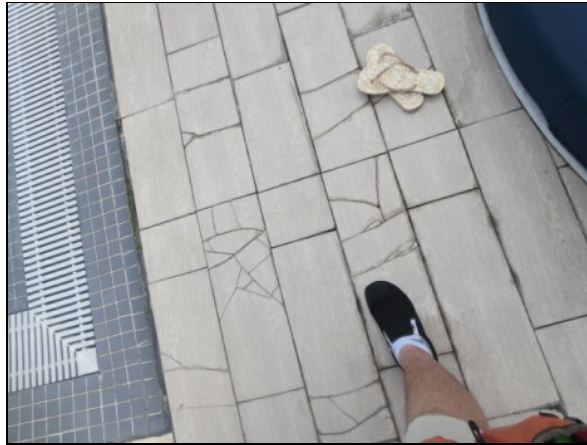
Useful Life:  
20 years

Remaining Life:  
11 years

Best Case: \$ 165,000

Worst Case: \$ 201,000

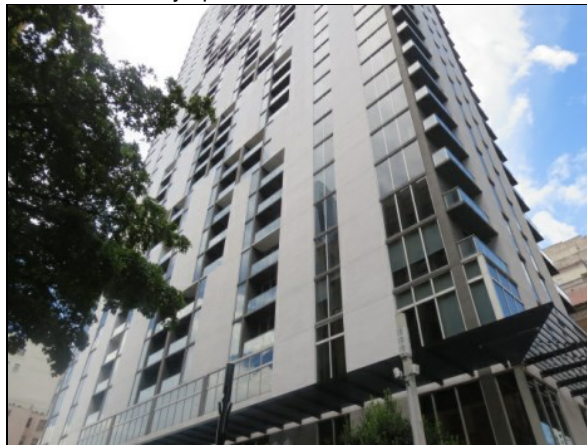
Remaining Life:

1 years

Best Case: \$ 739,700

Worst Case: \$ 904,000

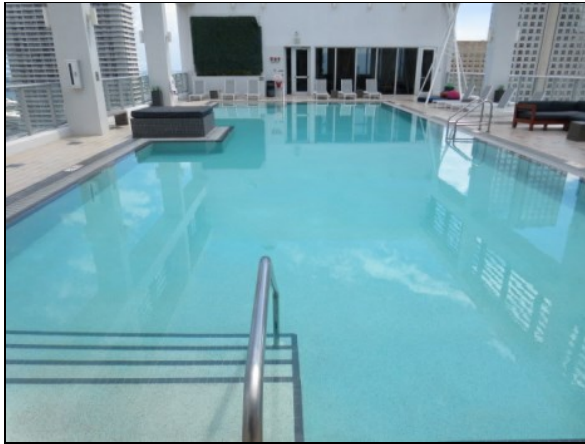
Remaining Life:

1 years

Best Case: \$ 51,300

Worst Case: \$ 62,700

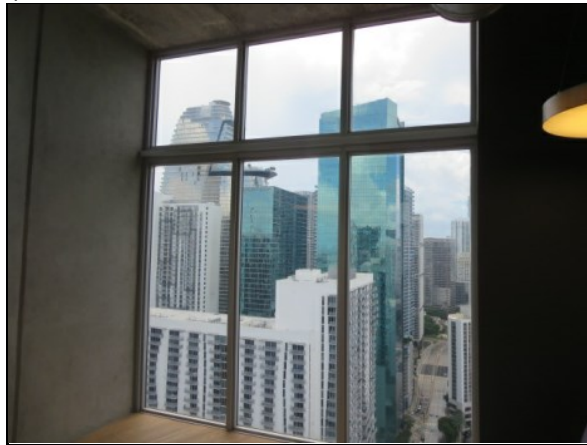
Useful Life:  
40 years

Remaining Life:  
31 years

Best Case: \$ 585,600

Worst Case: \$ 878,400

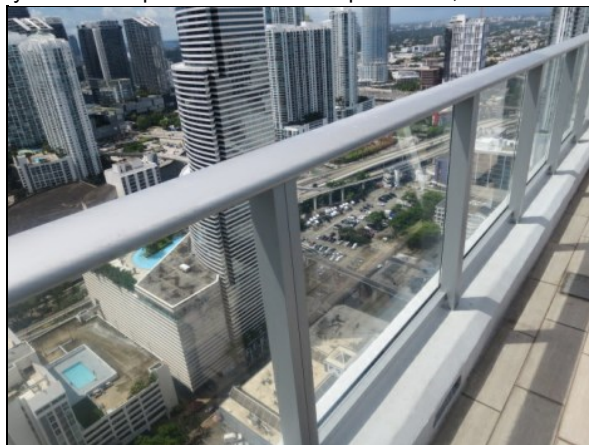
Useful Life:  
40 years

Remaining Life:  
31 years

Best Case: \$ 854,600

Worst Case: \$ 1,044,500

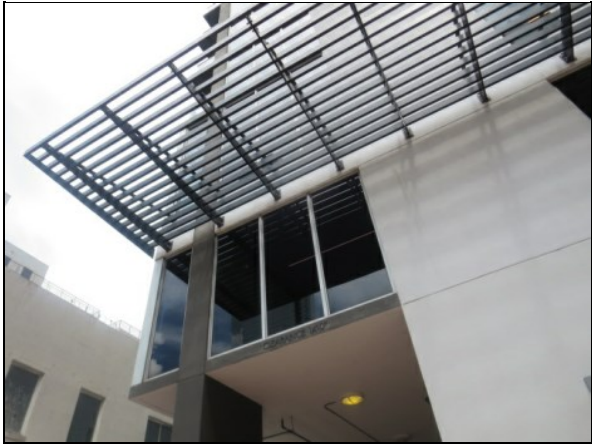
Useful Life:  
30 years

Remaining Life:  
21 years

Best Case:    \$ 182,300

Worst Case:    \$ 222,800
