## STRUCTURAL INTEGRITY RESERVE STUDY

**Country Club Towers Association, Inc.**

**2500 NE 48<sup>th</sup> Lane  
Fort Lauderdale, Florida 33308**

**Project Number: 2410116**

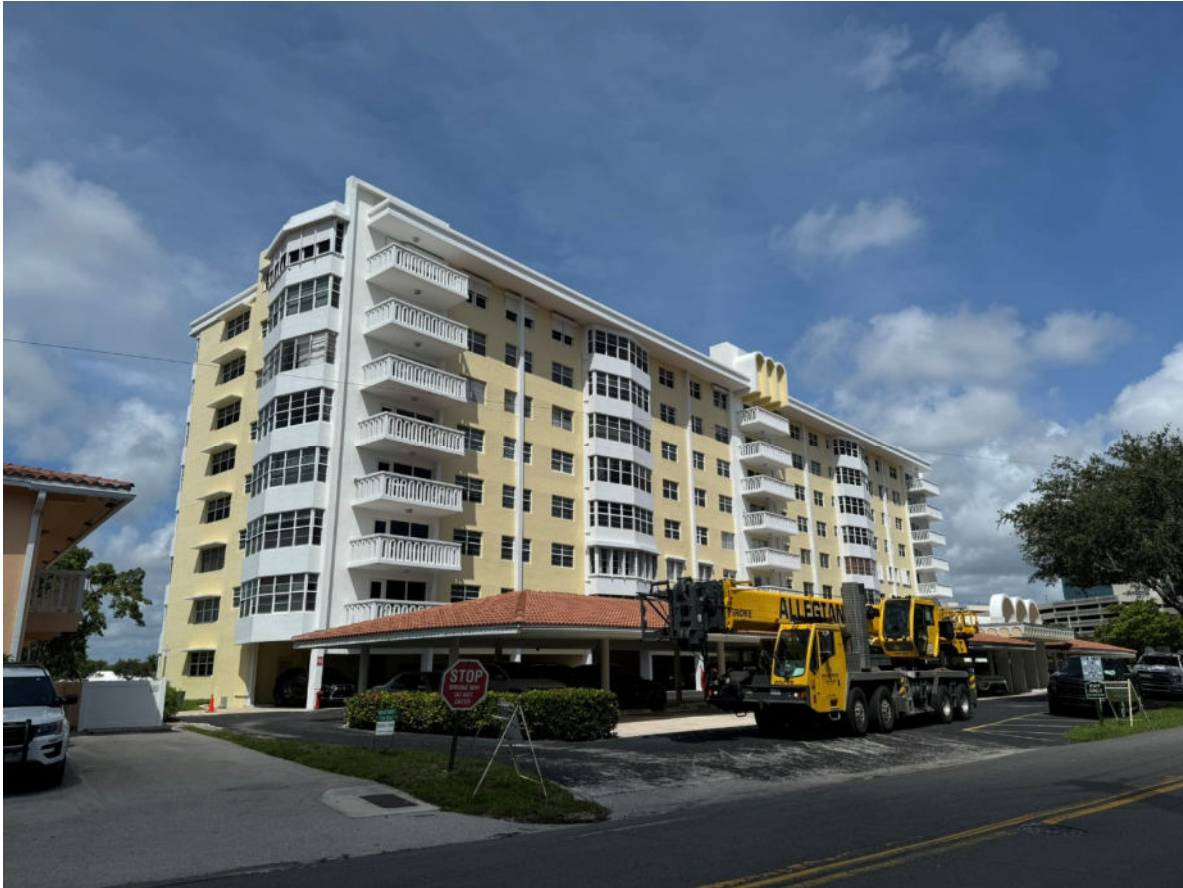
Image 1: General view of the buildings and layout. COUNTRY CLUB TOWERS.

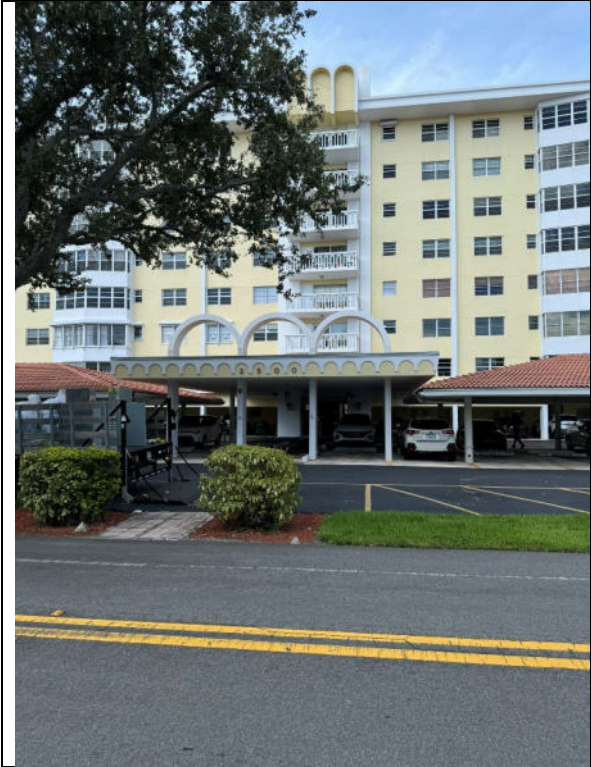
Image 2: Building Port-cochere.

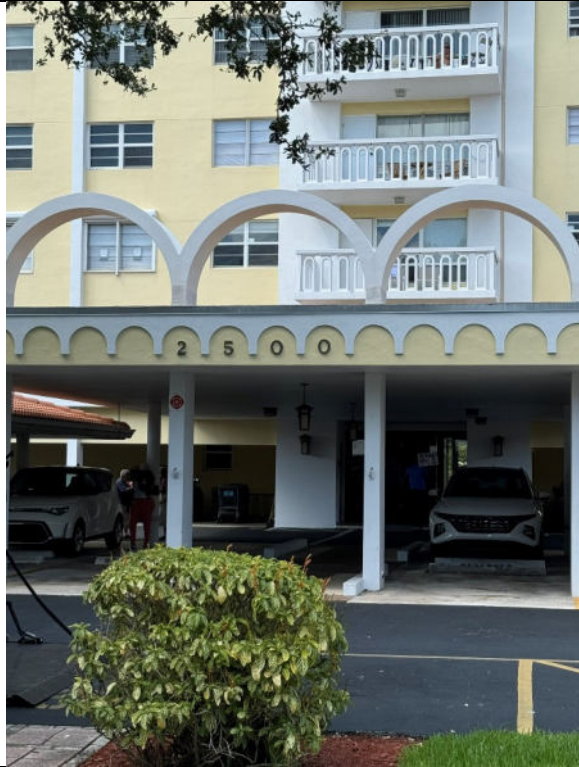
Image 3: Building architectural details.

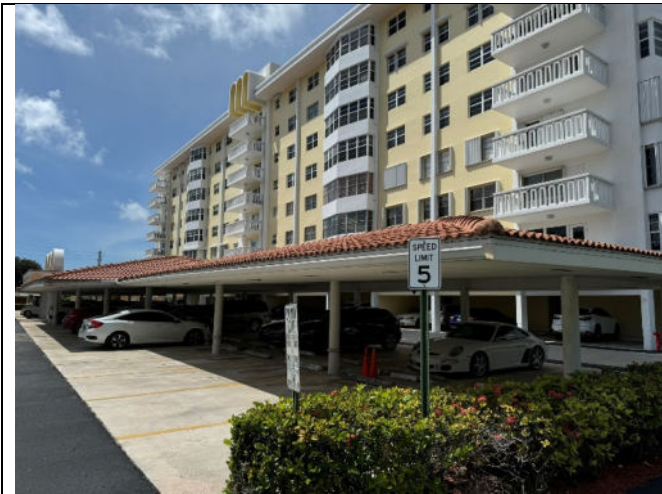
Image 4: Building elevation and carports.

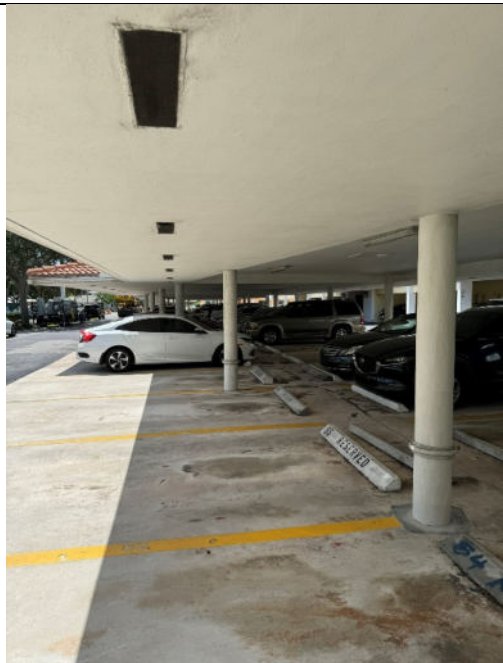
Image 5: Building carports.

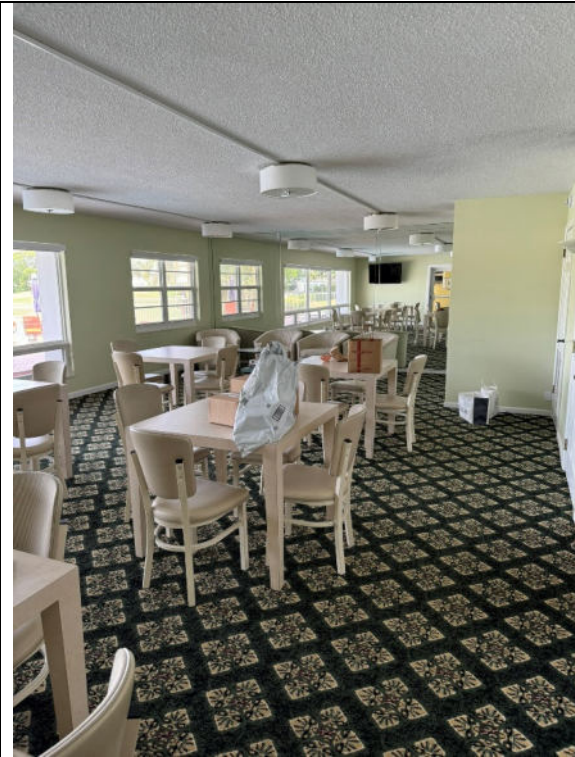
Image 6: Common areas. Club room.

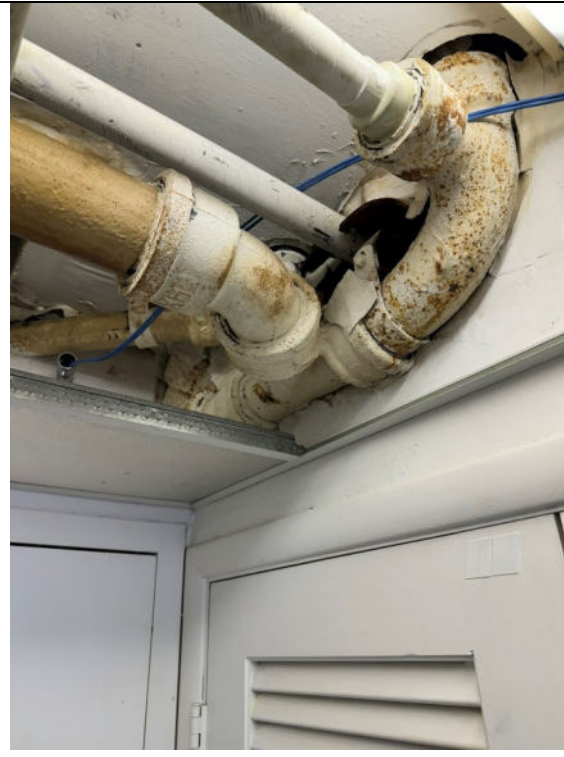
Image 7: Building sewer lines are cast iron.

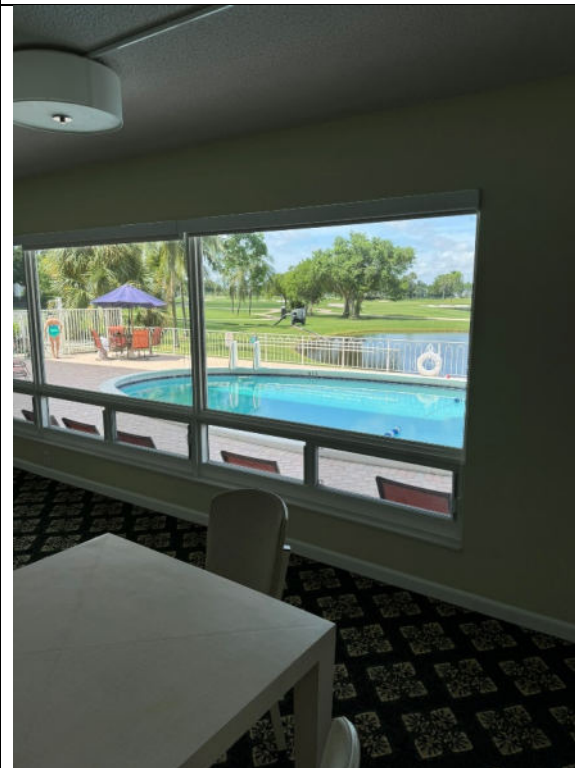
| Item | Description/Observations/Comments |
|---|---|
| Windows | <p>The windows consist of a mix of aluminum (original) and impact rated (new) units.</p> <p><b>The windows appeared to be in generally good condition with no significant deficiencies noted, requiring only routine maintenance over the evaluation period.</b></p> <p><b>Windows at the condominiums are the responsibility of the respective unit owners to maintain and replace.</b></p> |

Image 8: Renovated impact windows in club room

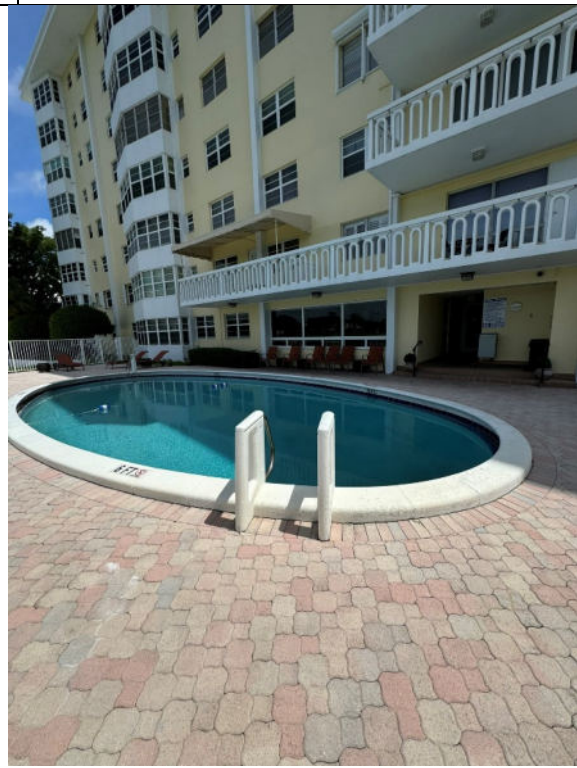
Image 9: Pool and deck.

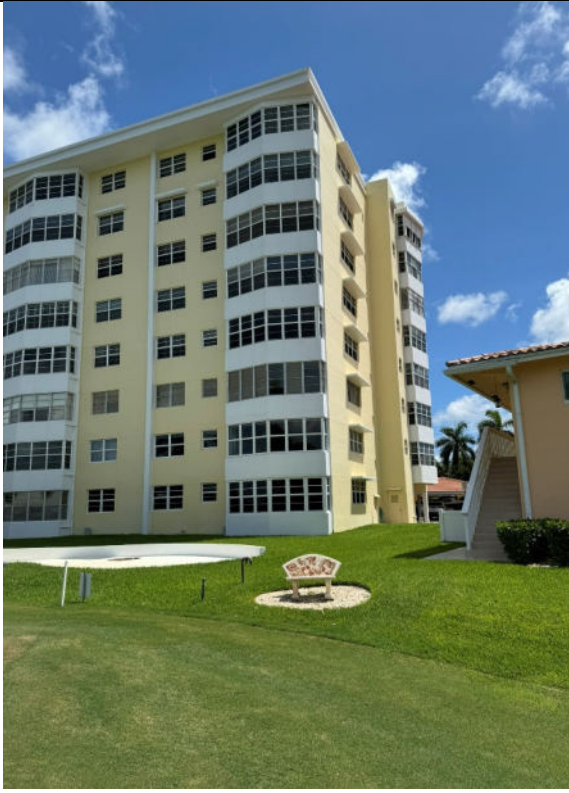
Image 10: Exterior elevation with corbel details-

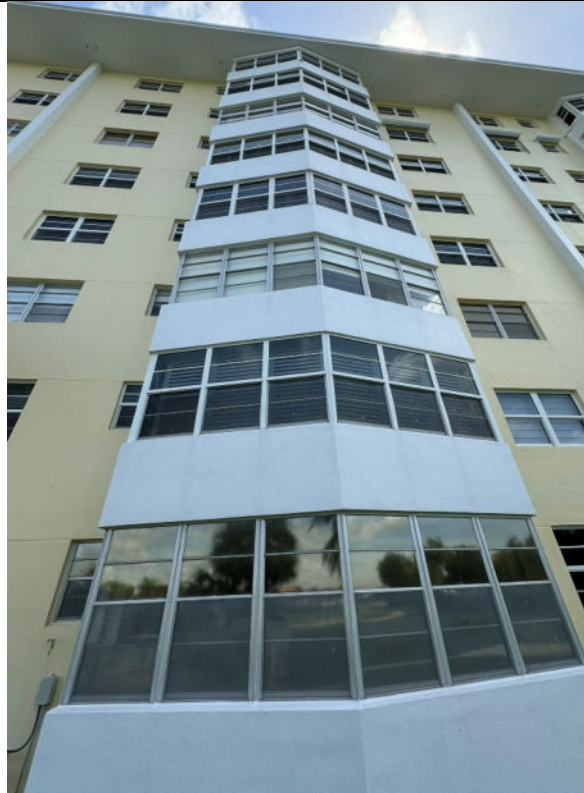
Image 11: Exterior elevations.

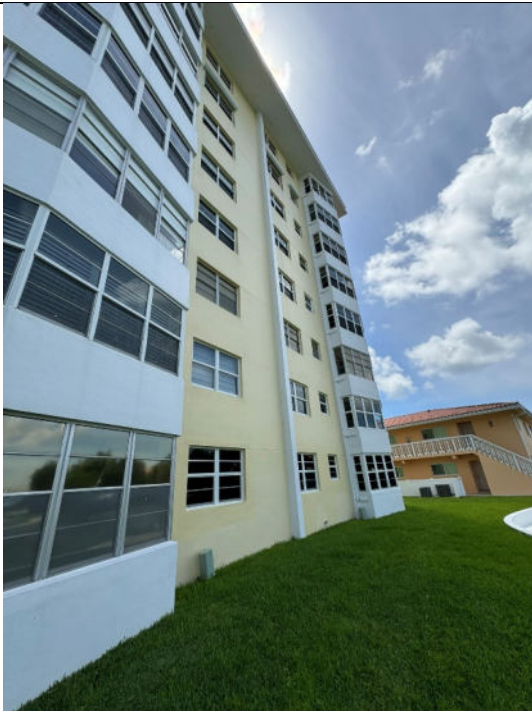
Image 12: Exterior elevations and details.

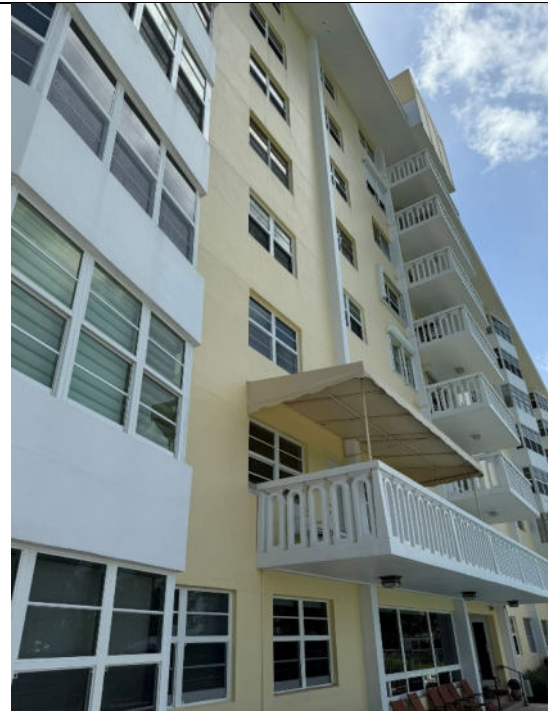
| Item | Description/Observations/Comments |
|---|---|
| Balconies | <p>The balconies are concrete and supported by the structural systems of the building.</p> <p>Observed to be in good condition.</p> |

Image 13: Exterior balconies.

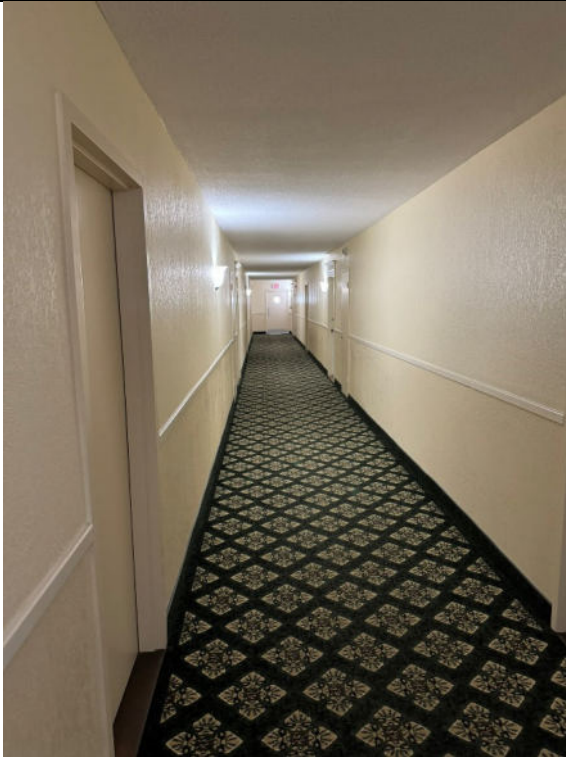
Image 14: Typical interior hallway.

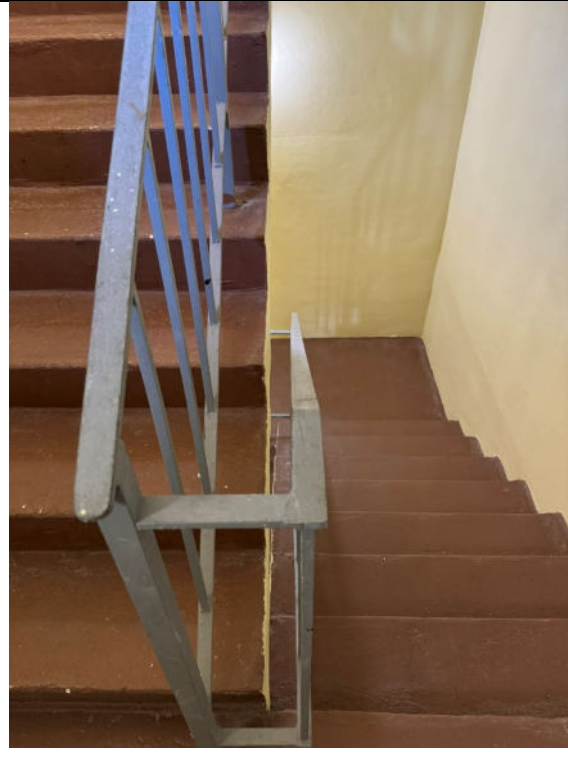
| Item | Description/Observations/Comments |
|---|---|
| Stairs | <p>There are sets of concrete stairs with aluminum handrails that are located at the ends of the building.</p> <p>The stairs appeared to be in good condition.</p> <p>In addition, periodic repainting and waterproofing of the stairs, including any anticipated repairs, are addressed as part of the Structural recommendations discussed above.</p> |

Image 15: Interior emergency stairs.

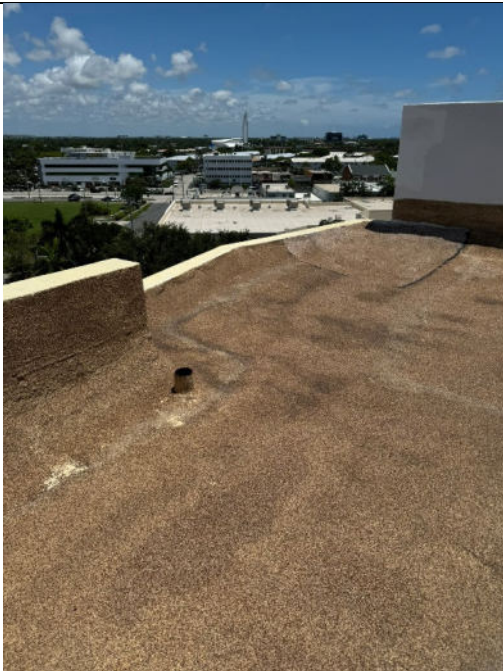
Image 16: Roof parapet detail.

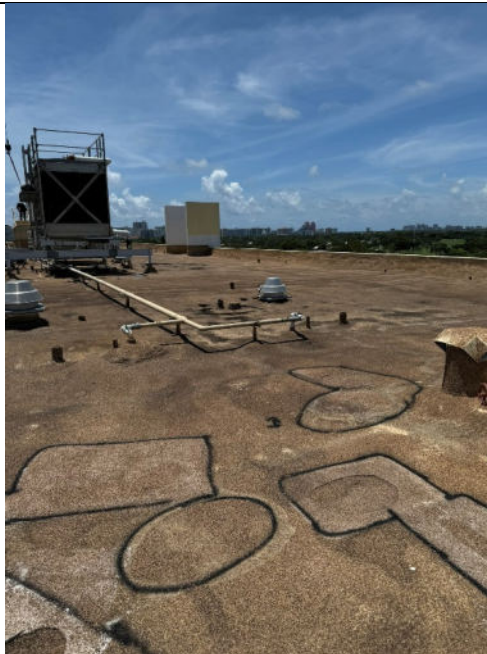
Image 17: Roof details.

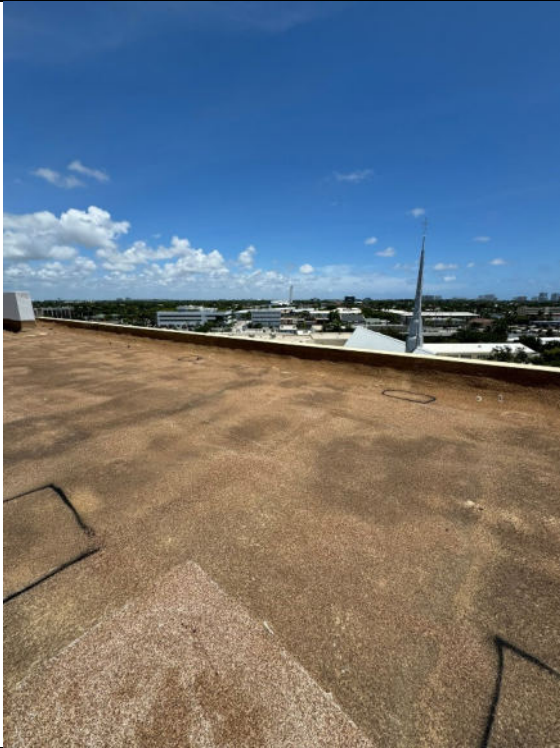
The roof is flat (low-sloped) with a concrete roof deck and modified bitumen covering. The roof coverings were reported to have been replaced in 2019. No roof replacement is anticipated during the evaluation period. However, funds have been spread throughout the Reserves Table to ensure the availability of funds at the end of the element's EUL. In general, the roof and roof coverings were observed to be in good condition with no significant deficiencies noted.

Image 18: General view of the roof.

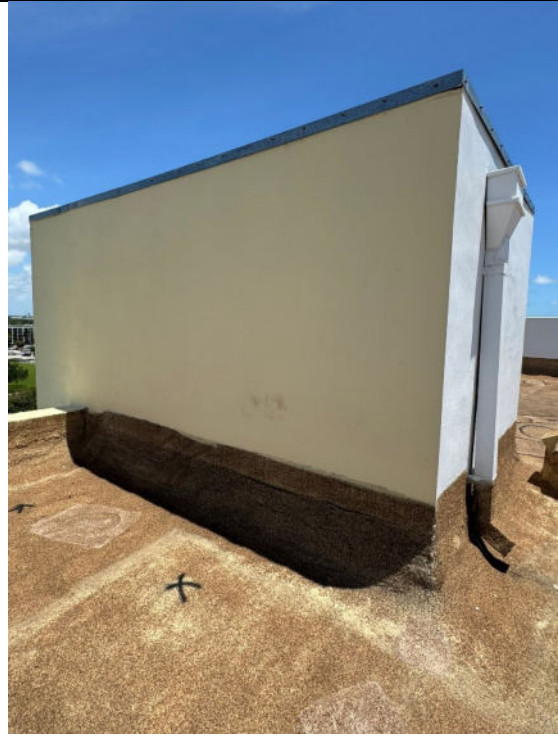
Image 19: Roof detail.

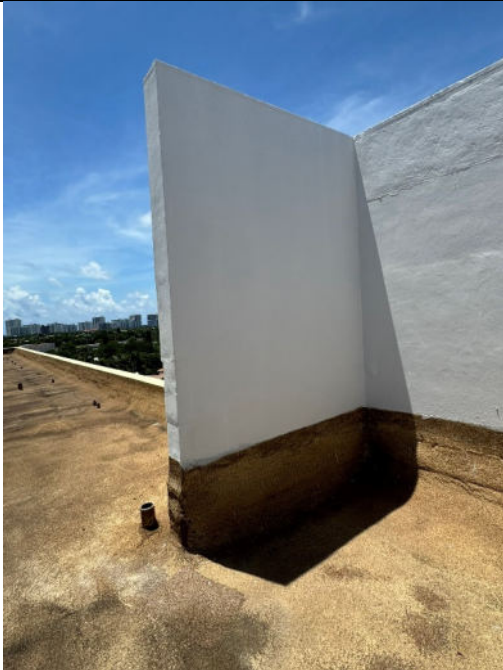
Image 20: Roof detail.

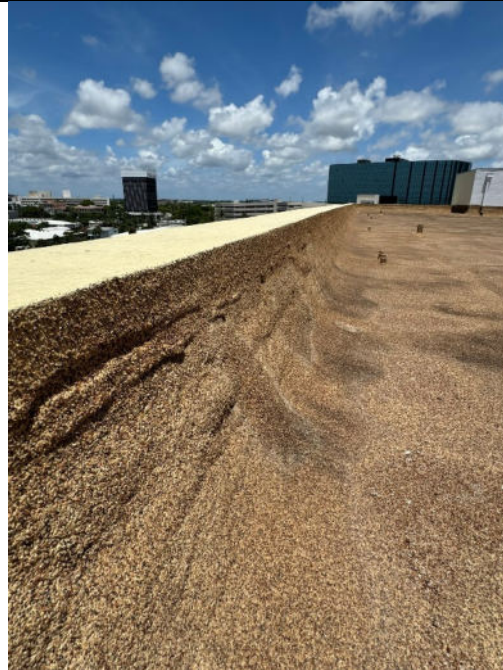
Image 21: Roof parapet.
