**Gables Waterway Towers Condominium Inc.**  
**SIRS Components**  
***Coral Gables, FL***

Report #: 49054-0  
Beginning: January 1, 2025  
Expires: December 31, 2025

**RESERVE STUDY**  
**"Full"**

May 13, 2024

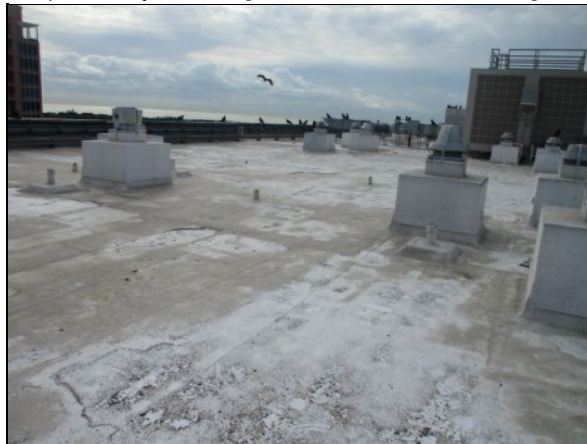
Useful Life:  
20 years

Remaining Life:  
0 years

Best Case: \$ 1,670,900

Worst Case: \$ 2,042,200

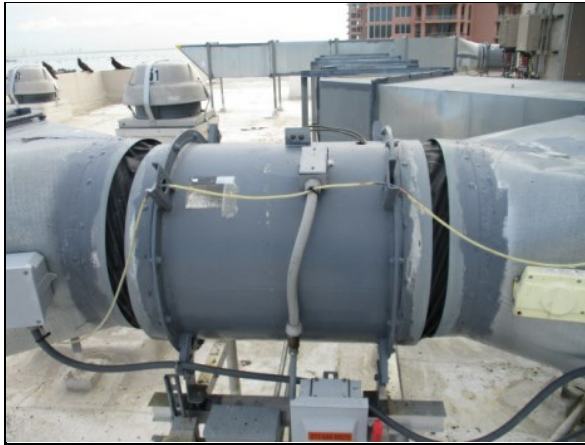
Useful Life:  
15 years

Remaining Life:  
8 years

Best Case: \$ 67,500

Worst Case: \$ 82,500

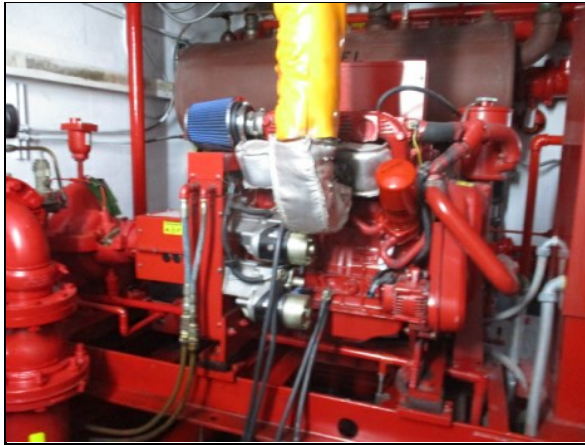
Useful Life:  
40 years

Remaining Life:  
14 years

Best Case: \$ 72,000

Worst Case: \$ 88,000

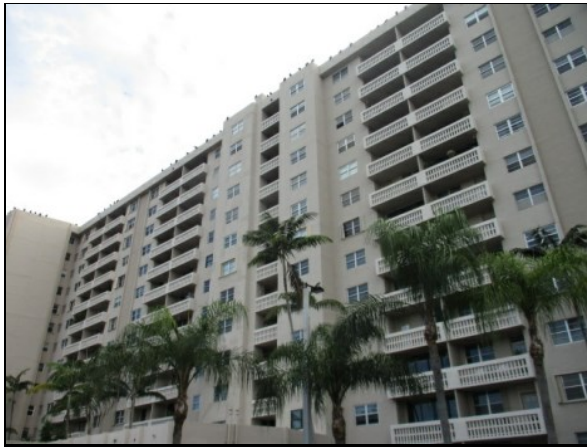
Useful Life:  
10 years

Remaining Life:  
4 years

Best Case: \$ 241,700

Worst Case: \$ 295,400

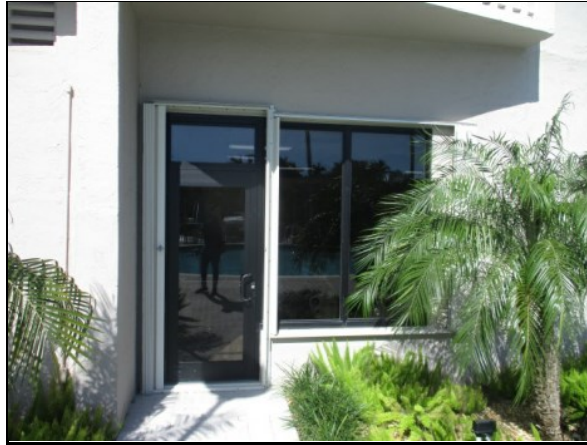
Useful Life:  
40 years

Remaining Life:  
13 years

Best Case: \$ 32,400

Worst Case: \$ 48,600

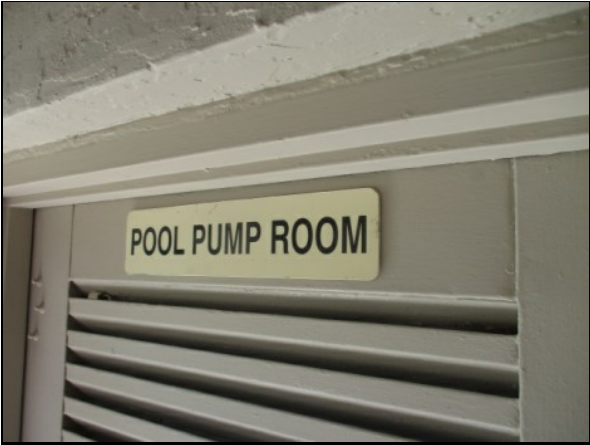
Useful Life:  
30 years

Remaining Life:  
15 years

Best Case:    \$ 31,500

Worst Case:    \$ 38,500

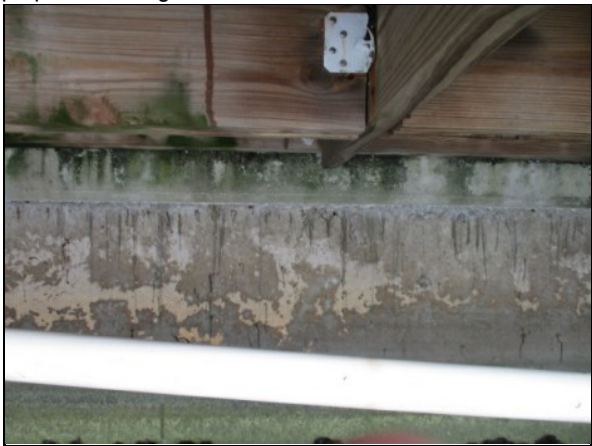
Useful Life:  
40 years

Remaining Life:  
20 years

Best Case: \$ 637,000

Worst Case: \$ 779,000

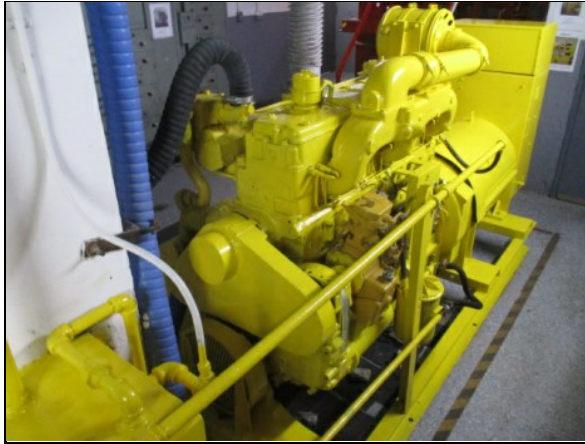
Useful Life:  
40 years

Remaining Life:  
6 years

Best Case: \$ 108,000

Worst Case: \$ 132,000
