## MINIMUM INSPECTION PROCEDURAL GUIDELINES FOR BUILDING RECERTIFICATION - ELECTRICAL

## 2. ELECTRIC SERVICE:

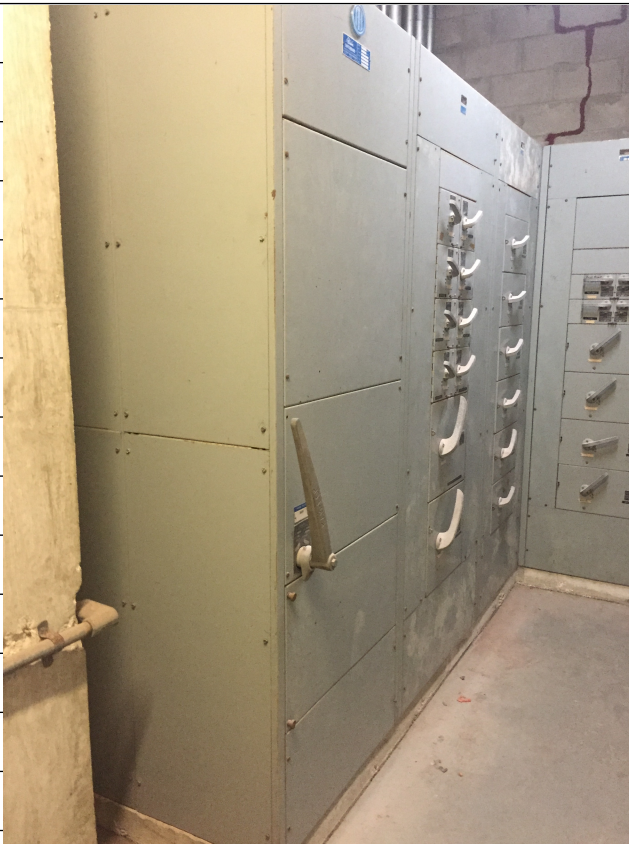
Photograph 1

- a. SIZE, AMPERAGE: ( ☒ ) FUSES: ( ☒ ) BREAKER: ( ☐ ) 2,500 amps
- b. PHASE: 30 ( ☐ ) 10 ( ☐ )  
3 phase, 120/208 volts
- c. CONDITION: GOOD: ( ☒ ) FAIR: ( ☐ ) NEEDS REPAIR: ( ☐ )
- d. COMMENTS: The electrical service comes from a FPL vault room located on the first floor. This service is 3 phase, 120/208 volts and feeds a 2,500 amps main disconnect switch in the main electrical room through wires in conduits, that main disconnect switch feeds several lower sized disconnect switches, and all the equipment is in good condition. See photograph 1.

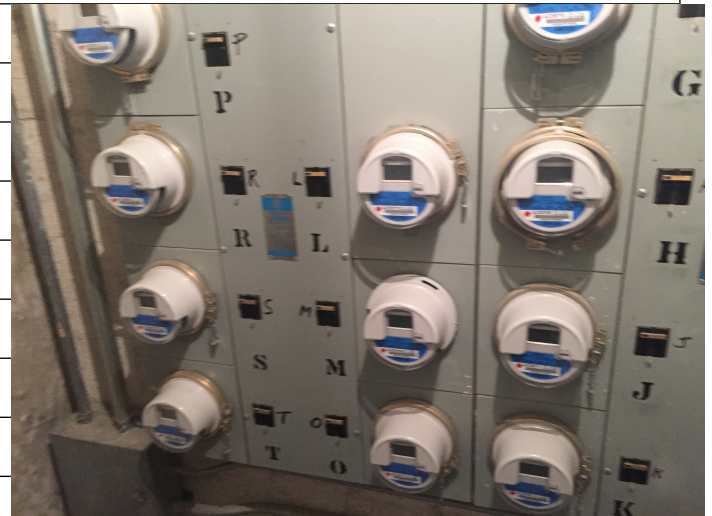
Photograph 2

- a. CLEARANCES: GOOD: ( ☒ ) FAIR: ( ☐ ) REQUIRES CORRECTION: ( ☐ )
- b. COMMENTS: All meter and electrical rooms are located at each floor with adequate clearances and are in good condition, without any storage in them. See photograph 2.
