**Keystone Villas II**  
**SIRS Components**  
***Coral Gables, FL***

Report #: 33045-2  
Beginning: January 1, 2025  
Expires: December 31, 2025

**RESERVE STUDY**  
**Update "With-Site-Visit"**

June 11, 2024

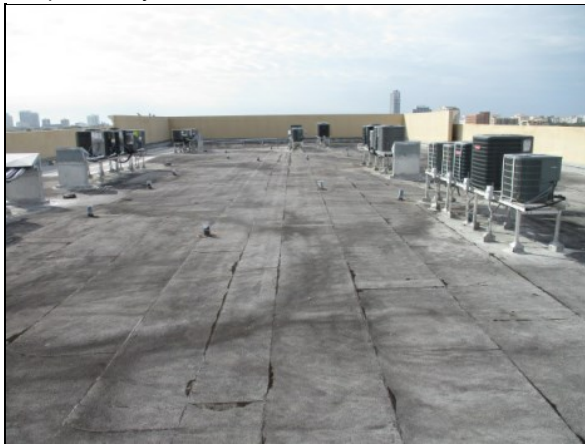
### Comp #: 2377 Roof(s) (Mod. Bitumen) - Replace

Useful Life:  
20 years

Remaining Life:  
2 years

Best Case: \$ 472,700

Worst Case: \$ 577,800

Lower estimate to replace

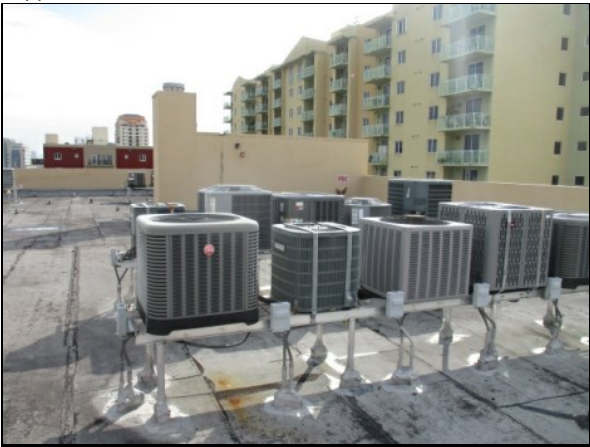
Useful Life:  
40 years

Remaining Life:  
22 years

Best Case: \$ 142,000

Worst Case: \$ 173,000

Lower estimate to replace

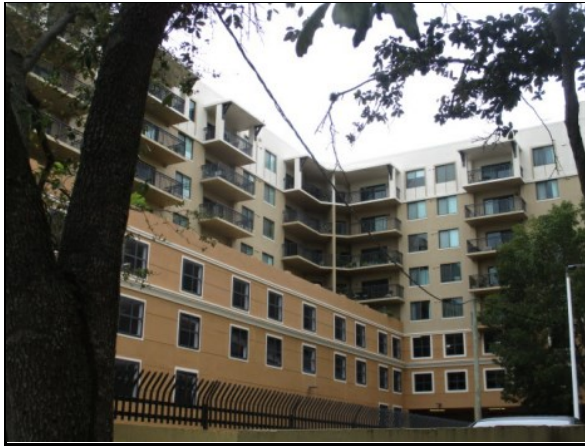
Remaining Life:

12 years

Best Case: \$ 28,700

Worst Case: \$ 53,300

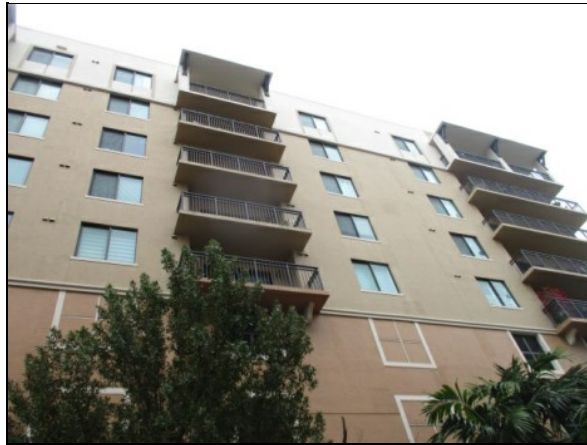
Useful Life:  
4 years

Remaining Life:  
0 years

Best Case: \$ 29,500

Worst Case: \$ 36,000

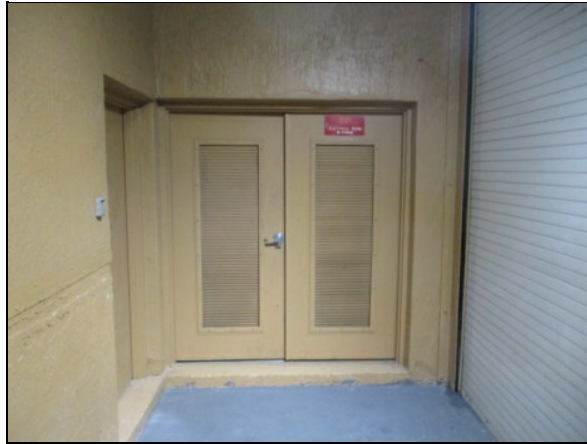
Useful Life:  
8 years

Remaining Life:  
3 years

Best Case: \$ 23,500

Worst Case: \$ 28,700

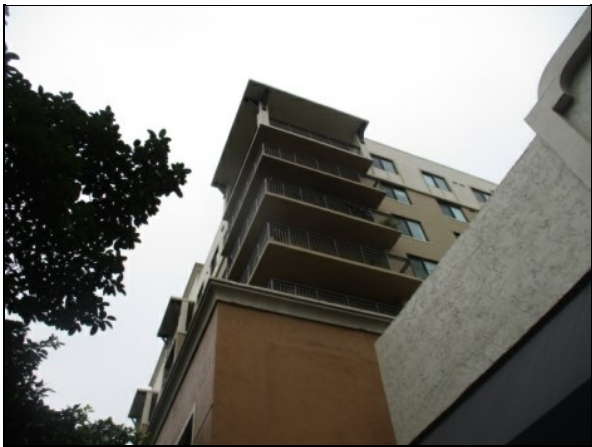
Useful Life:  
32 years

Remaining Life:  
11 years

Best Case: \$ 255,200

Worst Case: \$ 311,900
