# STRUCTURAL ASSESSMENT

3809 NE 170<sup>th</sup> Street,  
North Miami Beach, FL 33160  
Project Number: 223510

## Inspection Report

April 28, 2022

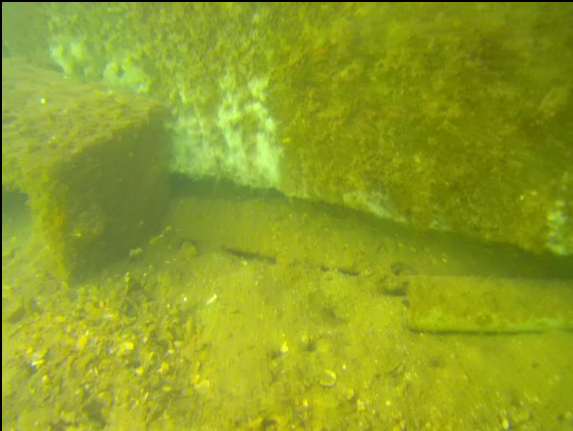
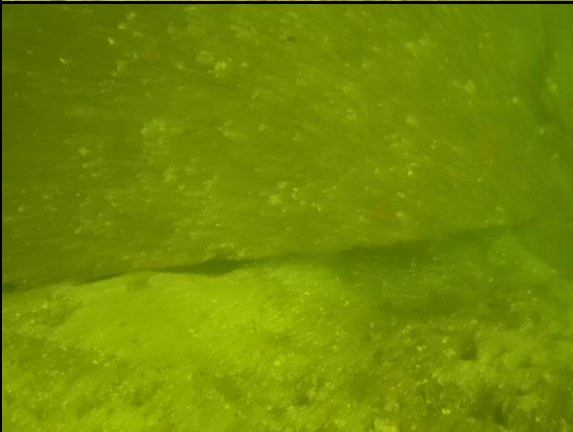
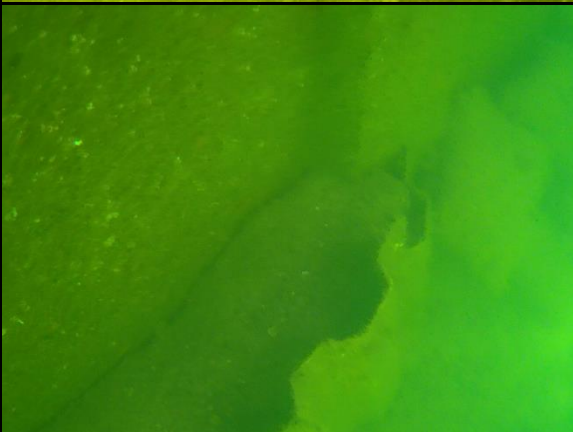
| Photograph | Observations and Recommendations |
|---|---|
| | <p><b><u>Item 1</u></b></p> <p><b>Observation:</b><br/>Undermining was observed along an estimated 150-ft length of seawall (top and center photo), as evident by the visible gap between the seawall and mudline.</p> <p>An estimated 250-ft length of seawall base was protected by a sheet pile footer or a cement bag footer (bottom photo). These items are used to prevent undermining and soil erosion underneath the seawall. The installed locations of the sheet pile and cement bag footers are intermittent.</p> <p><b>Recommendation:</b><br/>A sheet pile footer should be installed to stop soil erosion and undermining along unprotected areas of seawall.</p> |

3.1.3. An estimated length of 170-ft of new sheet pile footer should be installed to prevent further undermining and soil erosion along the seawall.

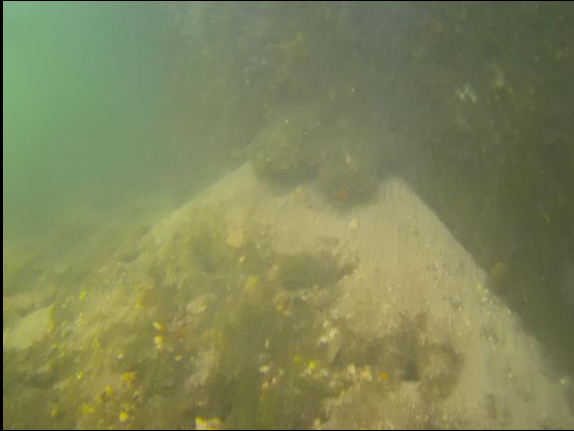
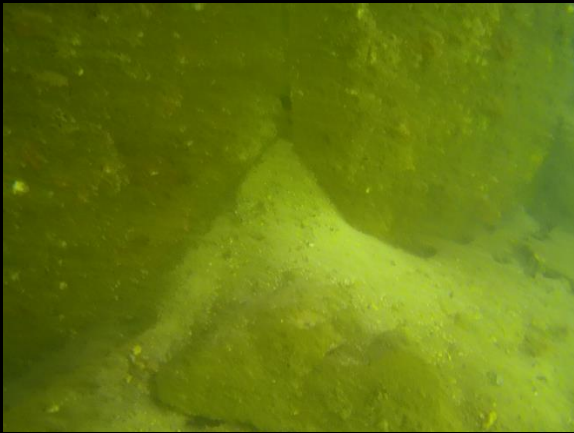
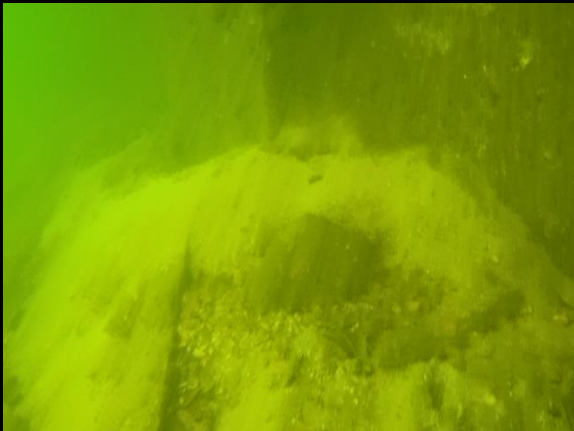
| Photograph | Observations and Recommendations |
|---|---|
| | <p><b><u>Item 2</u></b></p> <p><b>Observation:</b><br/>Active signs of soil erosion were observed in at least three locations along unprotected areas of seawall. This is evident by the visible piles of sand accumulating at the base of the seawall between seawall panels and T-piles.</p> <p><b>Recommendation:</b><br/>A sheet pile footer should be installed to stop soil erosion and undermining along unprotected areas of seawall.</p> <p>Additionally, the joints between the piles and wall panels should be sealed with an underwater grout to prevent erosion through the seawall. See Section 6 of this report for a diagram of the seawall components and facilitation of soil erosion.</p> |

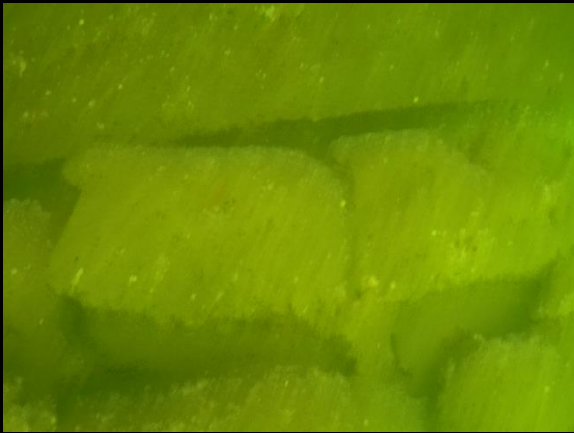
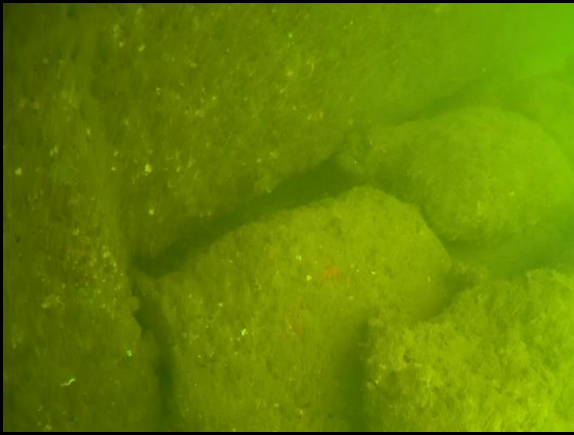
| Photograph | Observations and Recommendations |
|---|---|
| | <p><b><u>Item 3</u></b></p> <p><b>Observation:</b><br/>The existing cement bag footer installed at the base of the seawall to combat soil erosion and undermining is not adequately working, as evident by the gap between the bottom of the seawall and the mudline.</p> <p><b>Recommendation:</b><br/>An estimated 20-ft length of cement bag footers should be removed and replaced with a new sheet pile footer.</p> |

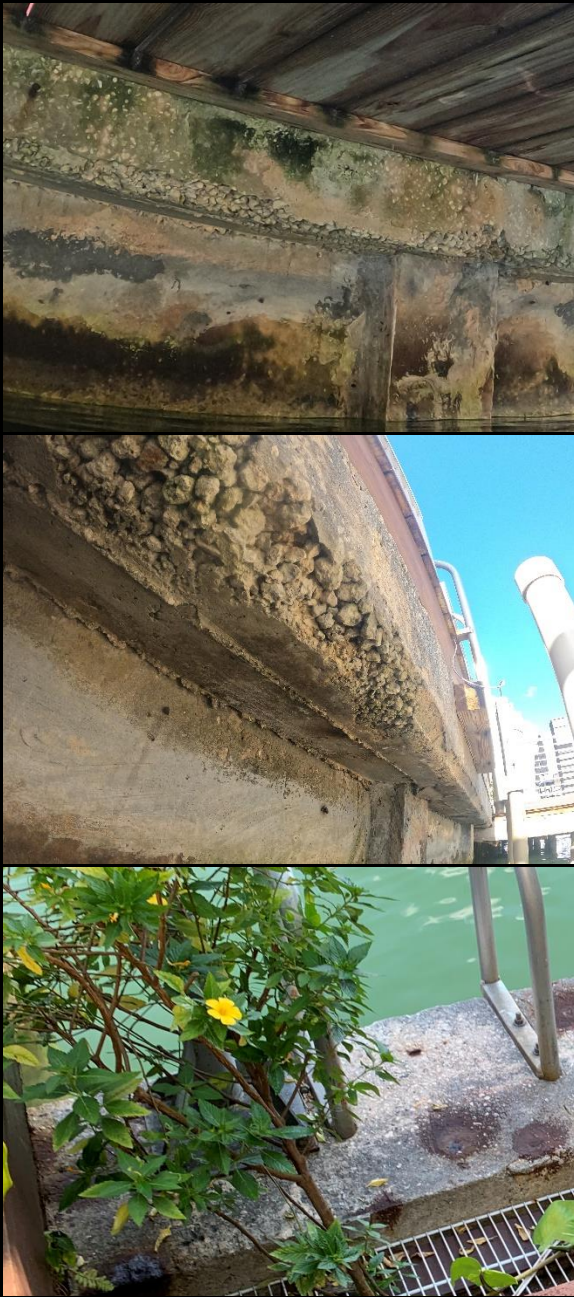
| Photograph | Observations and Recommendations |
|---|---|
| | <p><b><u>Item 4</u></b></p> <p><b>Observation:</b><br/>Surface corrosion and honeycombing (the separation of concrete aggregate and the binding cement mortar), are common along the underside of the seawall cap throughout the entire property. If the condition of the seawall cap is not maintained, deterioration can accelerate and compromise the structural integrity of the seawall.</p> <p><b>Recommendation:</b><br/>Repair all honeycombing and surface corrosion per the typical repair procedures described at the end of this report.</p> |

3.1.2. The seawall cap is in poor condition and requires repair work as described in Item 4.

- 1: Chip away all unsound and honeycombed concrete.
- 2: Patch all areas of chipped concrete with a 6-ksi non-shrink grout.

- 1: Chip away concrete in exposed area
- 2: Sandblast all corroded steel to remove all traces of corrosion and loose material.
- 3: Pressure wash steel and concrete to remove all traces of residual material.
- 4: Patch all areas of exposed steel and spalled concrete with a 6-ksi non-shrink grout.
- 5: Paint patched areas with at least two layers of a concrete waterproofing sealer.

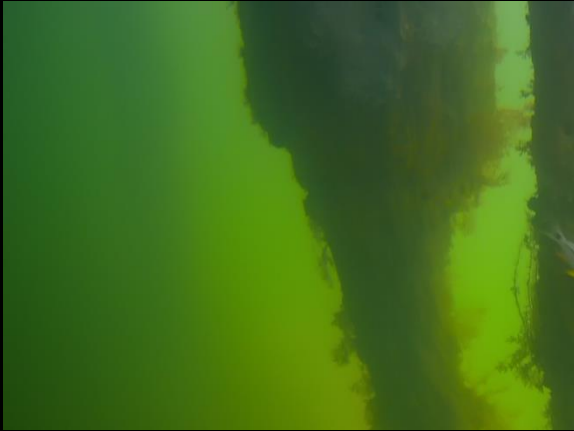
| Photograph | Observations and Recommendations |
|---|---|
| | <p><b><u>Item 5</u></b></p> <p><b>Observation:</b><br/>A timber dock pile at 3839 is severely deteriorated below the waterline.</p> <p><b>Recommendation:</b><br/>Replace deteriorated timber pile with a new pile.</p> |

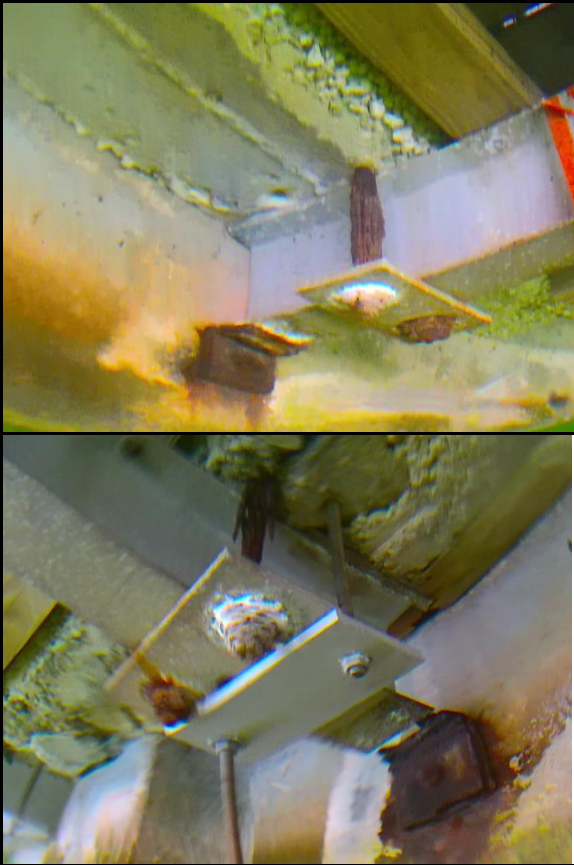
| Photograph | Observations and Recommendations |
|---|---|
| | <p><b><u>Item 6</u></b></p> <p><b>Observation:</b><br/>The dock at 3831 has severely corroded bolted connections on the steel beams connecting to the underside of the seawall cap.</p> <p><b>Recommendation:</b><br/>All corroded steel connections should be replaced with new hardware of equal size and stainless-steel grade.</p> |
