**Miller Gardens Condominium**  
**Non-SIRS Components**  
***Miami, FL***

Report #: 52032-0  
Beginning: July 1, 2026  
Expires: June 30, 2027

**RESERVE STUDY**  
**"Full"**

June 4, 2025

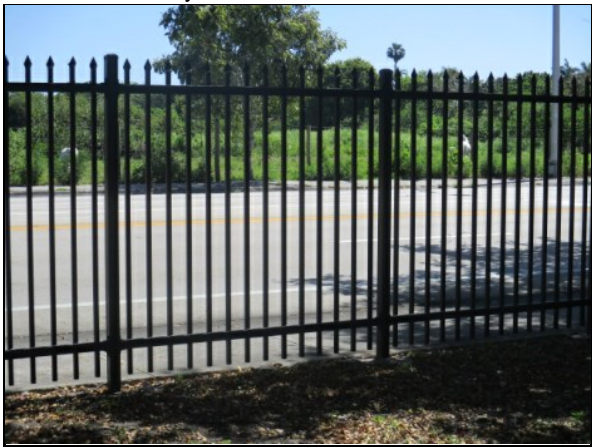
**Useful Life:**  
30 years

**Remaining Life:**  
18 years

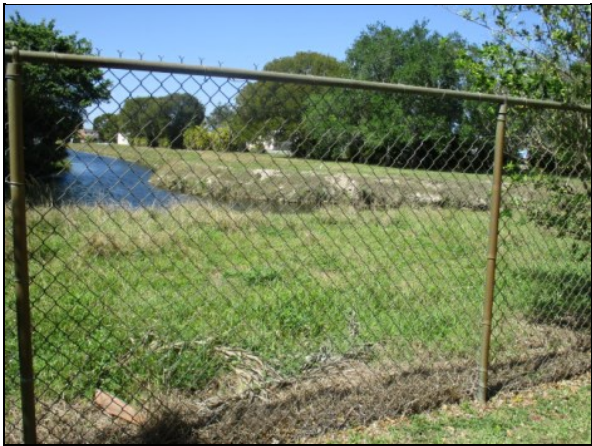
**Useful Life:**  
30 years

**Remaining Life:**  
5 years

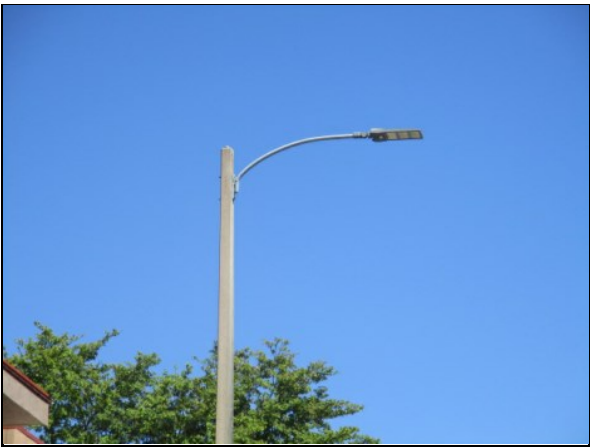
**Useful Life:**  
15 years

**Remaining Life:**  
10 years

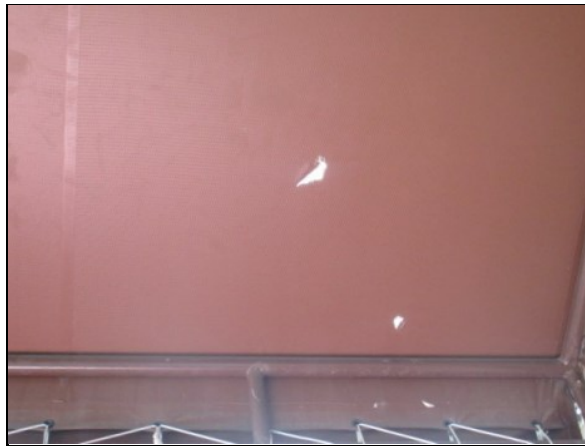
**Useful Life:**  
10 years

**Remaining Life:**  
1 years

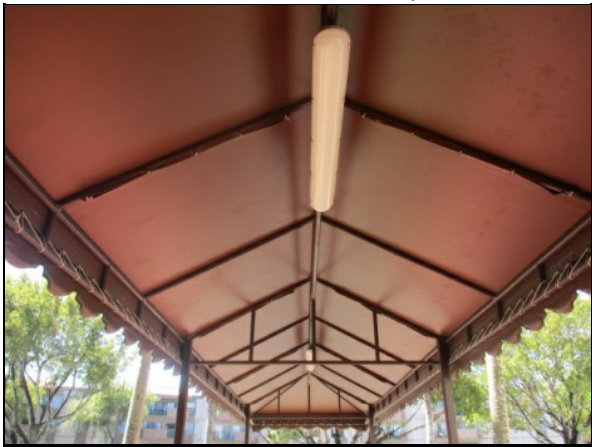
**Useful Life:**  
30 years

**Remaining Life:**  
21 years

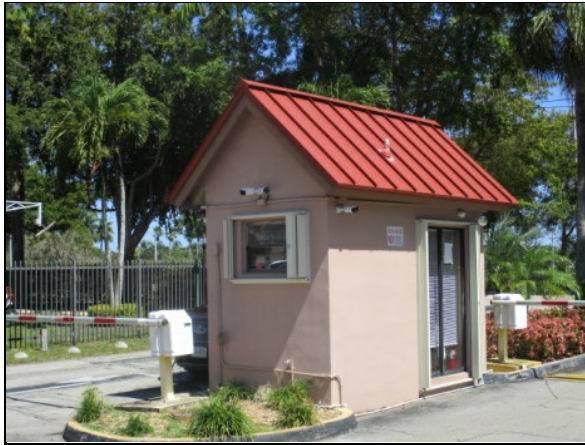
Unless otherwise noted, this component refers only to common exterior windows and doors. All are assumed to have been compliant with applicable building codes at time of installation. Inspect regularly for leaks and cracks around frame and repair as needed. Clean tracks and ensure hardware is functional to prevent accidental damage during opening/closing. With ordinary care and maintenance, useful life is typically long but often difficult to predict. Many factors affect useful life including quality of window currently installed, waterproofing details, exposure to wind and rain, etc. Individual windows and doors should be replaced as an Operating expense if damaged or broken. We recommend replacement at the approximate interval shown below based on consideration of installation/replacement dates, evident conditions, and/or our experience with similar Clients. Unless otherwise noted, cost estimates are based on replacement with current impact-resistant models.

**Useful Life:**  
40 years**Remaining Life:**  
9 years

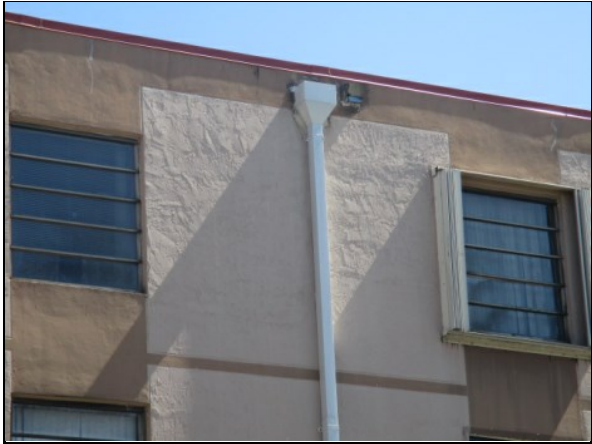
**Useful Life:**  
30 years

**Remaining Life:**  
25 years
