| <b>Address:</b> | 1843 NW 107 ST, MIAMI, FL 33167 | | |
| <b>Type of Inspection:</b> | Seller's Pre-Sale Inspection | | |

| <b>Type of Structure:</b> | Detached Single Family | <b>Year:</b> | 1946 | <b>Occupied:</b> | Yes |

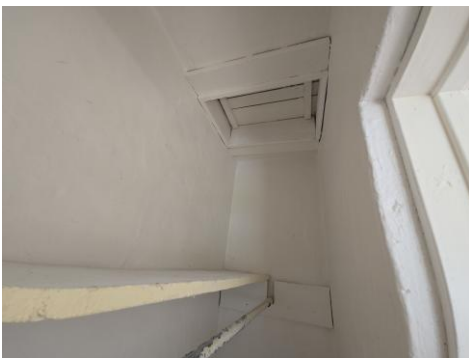
- The attic access is tucked in a bedroom closet and is mostly inaccessible

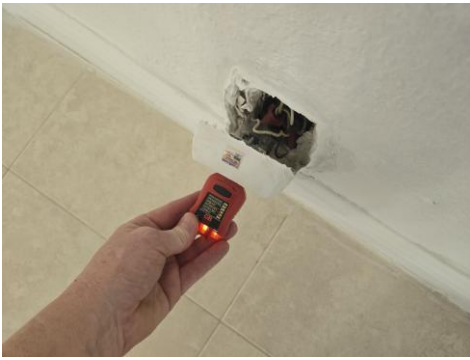
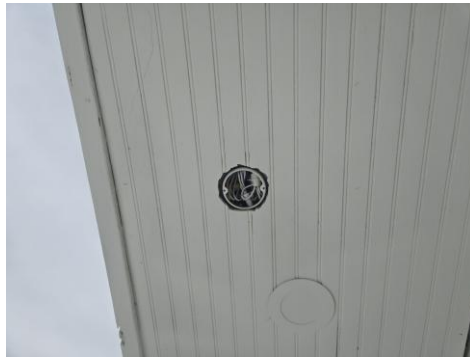
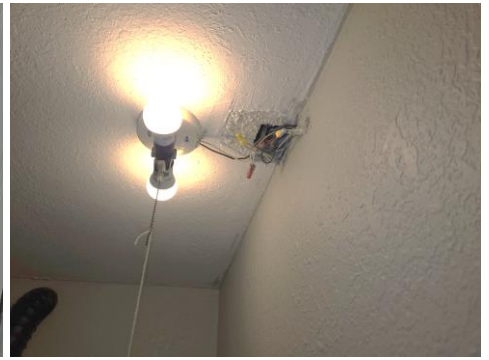
- The outlets in the primary kitchen, laundry area, rear patio, and efficiency bathroom do not have GFCI protection.
- One of the outlets in the primary living room area is not wired correctly and the other outlet is not secured to the wall.

- There are exposed wire connections in the Laundry room, these connections must be housed in a junction box, and the front porch light is missing.
