Presidential Golfview C.A.
SIRS Components
West Palm Beach, FL

Report #: 52810-0
Beginning: January 1, 2025
Expires: December 31, 2025

RESERVE STUDY
"Full"

December 24, 2024

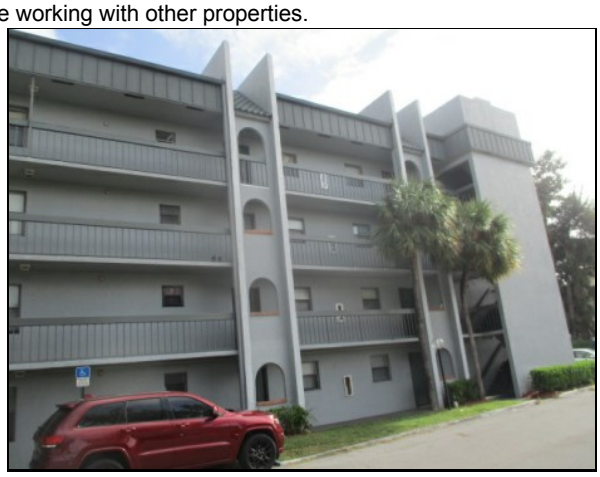
Comp #: 2341 Building Exterior - Restoration **Quantity: Lump Sum Allowance**

Location: Building exteriors

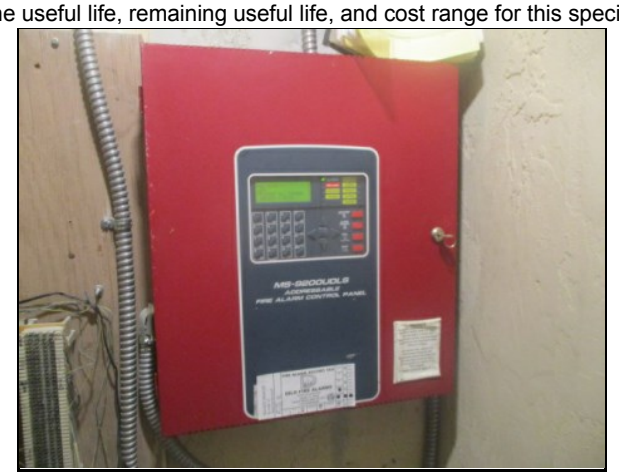
Comp #: 2557 Fire Alarm System (Bldg B) - Modernize **Quantity: (1) System**
Location: Throughout building B
Funded?: Yes.
History:
Comments: Approximate Device Count (Per NFPA Inspection Records):
(1) (MS 9200UDLS) Fire Alarm Control Panel
(8) Pull Stations
(2) Smoke Detectors
(8) Heat Detectors
(1) Waterflow Switch
(1) Supervisory Switch
(8) Horns
(8) Strobes

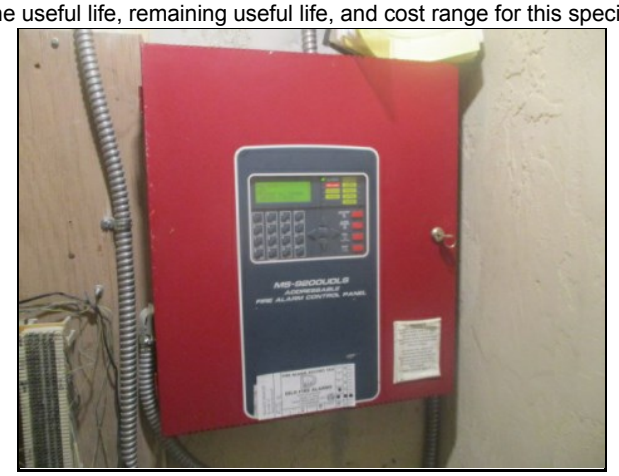
Comp #: 2557 Fire Alarm System (Bldg C) - Modernize **Quantity: (1) System**

Location: Throughout building C
Funded?: Yes.
History:
Comments: Approximate Device Count (Per NFPA Inspection Records):
(1) (MS 9200UDLS) Fire Alarm Control Panel
(8) Pull Stations
(2) Smoke Detectors
(8) Heat Detectors
(1) Waterflow Switch
(1) Supervisory Switch
(8) Horns
(8) Strobes

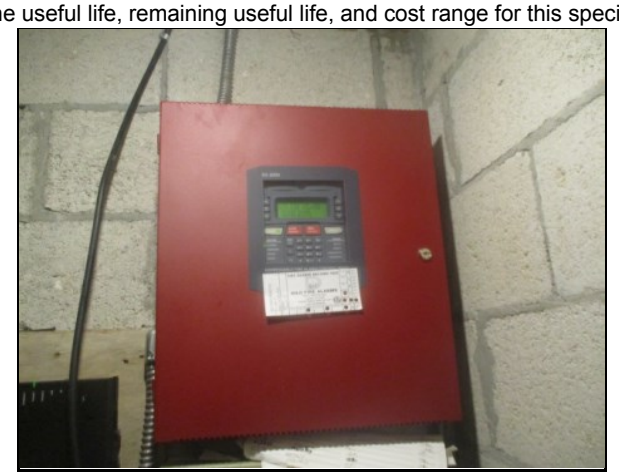
Comp #: 2557 Fire Alarm System (Bldg E) - Modernize **Quantity: (1) System**

Location: Throughout building E
Funded?: Yes.
History:
Comments: Approximate Device Count (Per NFPA Inspection Records):
(1) (Firelite ES-200X) Fire Alarm Control Panel
(8) Pull Stations
(2) Smoke Detectors
(8) Heat Detectors
(1) Waterflow Switch
(1) Supervisory Switch
(17) Horns
(4) Strobes

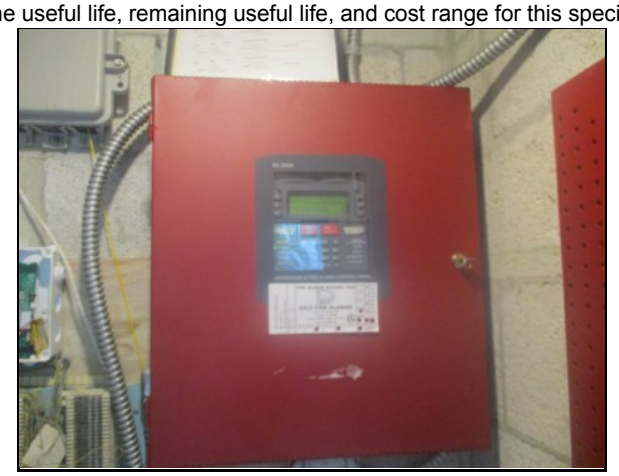
Comp #: 2557 Fire Alarm System (Bldg H) - Modernize **Quantity: (1) System**
Location: Throughout building H
Funded?: Yes.
History:
Comments: Approximate Device Count (Per NFPA Inspection Records):
(1) (Firelite ES-200X) Fire Alarm Control Panel
(8) Pull Stations
(1) Smoke Detector
(8) Heat Detectors
(1) Waterflow Switch
(1) Supervisory Switch
(26) Horns
(26) Strobes

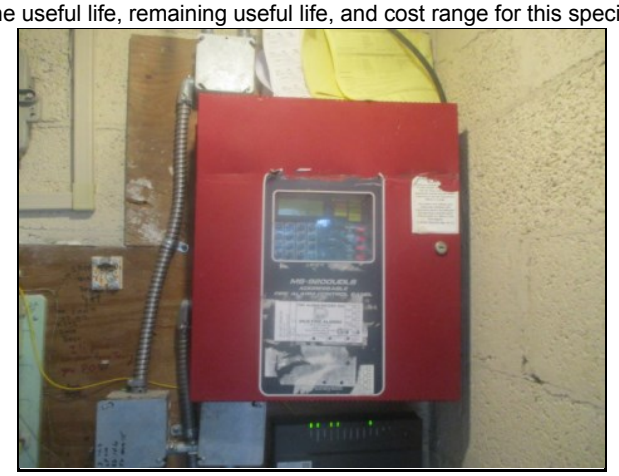
Comp #: 2557 Fire Alarm System (Bldg K) - Modernize **Quantity: (1) System**

Location: Throughout building K
Funded?: Yes.
History:
Comments: Approximate Device Count (Per NFPA Inspection Records):
(1) (Firelite MS 9200UDLS) Fire Alarm Control Panel
(8) Pull Stations
(2) Smoke Detectors
(8) Heat Detectors
(1) Waterflow Switch
(1) Supervisory Switch
(12) Horns
(3) Strobes
