Uniform Mitigation Verification Inspection Form

Inspection Date: **01/23/2025**			
Owner Information			
Owner Name:	**Ramiro and Constanza Rojas**		Contact Person: **Ramiro and Consta...**
Address:	**6928 Pisano Dr**		Home Phone:
City:	**Greenacres**	Zip: **33467**	Work Phone:
County:	**Palm Beach**		Cell Phone: **(614) 403-0849**
Insurance Company:			Policy #:
Year of Home:	**2005**	# of Stories: **1**	Email: **3rimprovements@gmail.com**

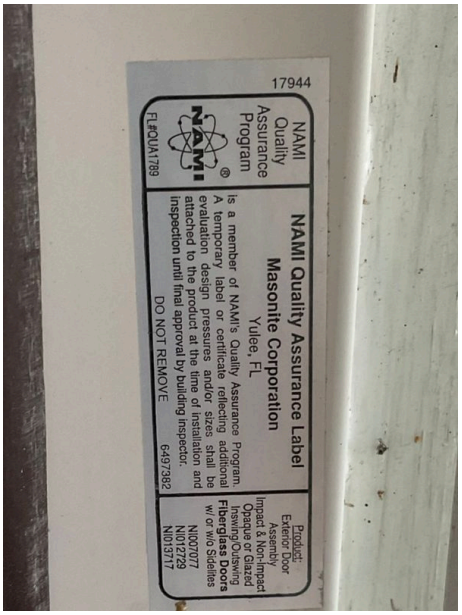
Protected With Shutters/ Protected With Impact

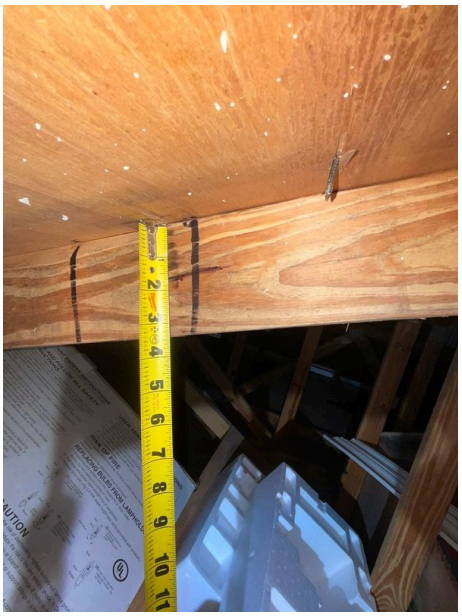
8d Nails
