**Uniform Mitigation Verification Inspection Form**

## Windstorm Mitigation Inspection

**1030 NW 32 ST, MIAMI FL 33127**

| INSPECTION DATE: 6/30/2026 | CONTACT PERSON: | Unit / Bldng |

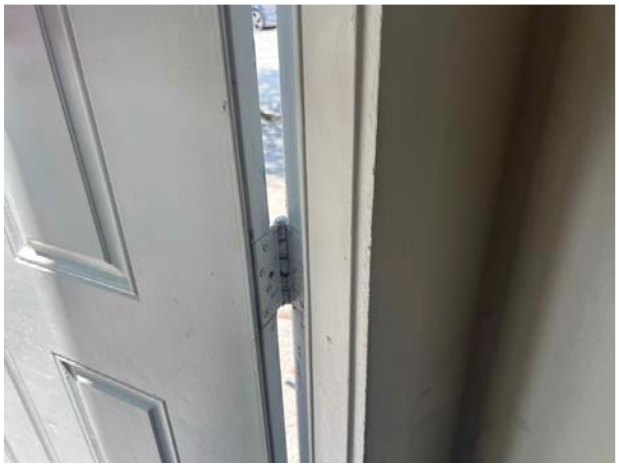
**UNGLAZED OPENINGS**

**Doors are unverifiable as impact rated.**
