**Corinthian Condominium  
Other Components  
*Fort Lauderdale, FL***

Report #: 48946-0  
Beginning: January 1, 2024  
Expires: December 31, 2024

**RESERVE STUDY**  
**"Full"**

February 10, 2024

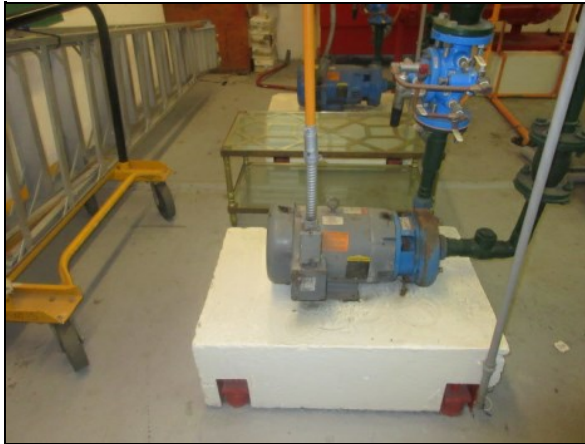
**Comp #: 2575 Domestic Water System - Replace**

Water pumps and control system should be inspected regularly and repaired as-needed by servicing vendor or maintenance staff to ensure proper function and optimal performance. Pumps should have an electronic controller or variable frequency drives to optimize output, minimize energy consumption and prolong life expectancy. Minor repairs such as pump motor replacements, electronic system parts, etc. should be considered an Operating expense. Plan to replace the entire system at the approximate interval shown below based on our experience and research with similar systems. Total life span can vary based on level of use, preventive maintenance, quality of materials and installation, etc. Minimal or no subjective/aesthetic value for this component. Useful life is based primarily on normal expectations for service/performance life in this location. Unless otherwise noted, remaining useful life expectancy is based primarily on original installation or last replacement/purchase date, our experience with similar systems/components, and assuming normal amount of usage and good preventive maintenance.

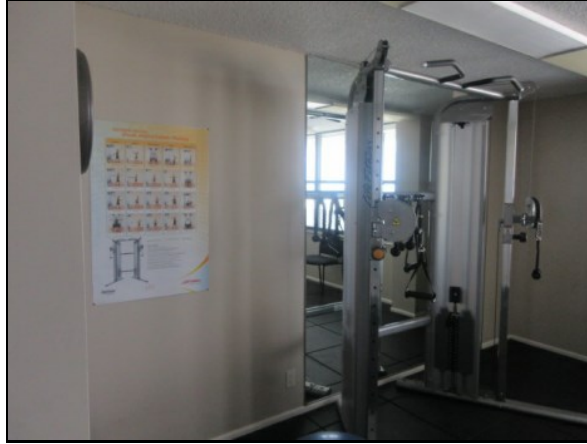
Comments: Fair condition: Interior areas determined to be in fair condition typically exhibit some minor, routine marks and scuffs, small sections of peeling paint, etc. Overall appearance is satisfactory.

Regular cycles of professional painting are recommended to maintain appearance. Small touch-up projects can be conducted as needed as a maintenance expense, but comprehensive painting of interior areas will restore a consistent look and quality to all areas. Best practice is to coordinate at same time as other interior projects (flooring, furnishings, lighting, etc.) whenever possible to minimize downtime and maintain consistent quality standard.

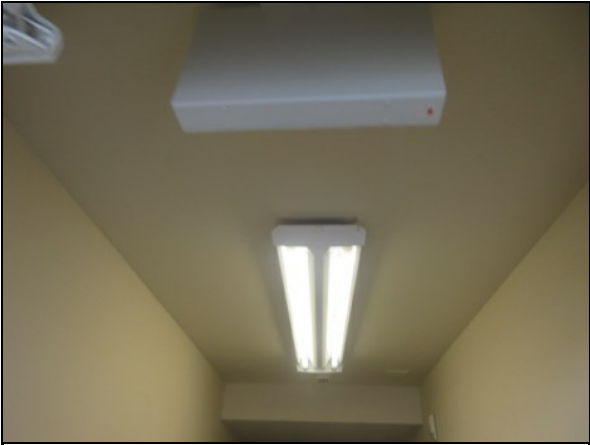
**Comp #: 2705 Interior Lights - Replace**

Comments: Fair condition: Interior lights determined to be in fair condition typically exhibit routine signs of age, if any. Style/type is still appropriate for the aesthetic standards of the property.

As routine maintenance, inspect, repair and change bulbs as needed. Best practice is to coordinate at same time as other interior projects (especially painting) whenever possible to minimize downtime and maintain consistent quality standard. Timing of replacements is ultimately subjective. Estimates shown here are based on our experience with similar properties and general aesthetic qualities. A wide variety of fixture styles is available; unless otherwise noted, funding recommendations are based on replacement with comparable quality fixtures.

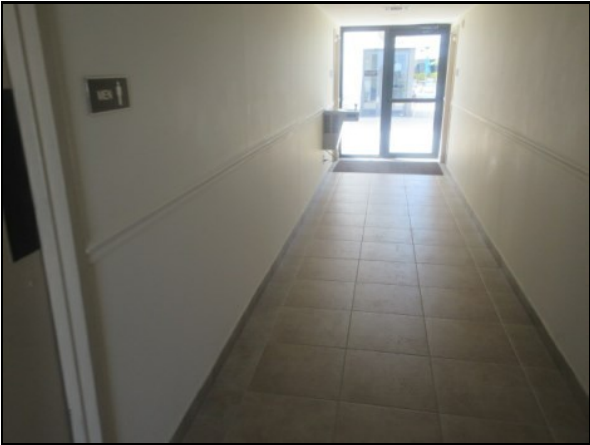
**Comp #: 2709 Tile Flooring - Replace**

Comments: Fair condition: Interior tile flooring determined to be in fair condition typically exhibits some routine signs of wear and age, possibly including sporadic cracks and damaged grout. Style is still appropriate, but tile is showing more noticeable signs of deterioration.

As part of ongoing maintenance program, inspect regularly and repair or replace damaged sections as needed. If available, best practice is to keep a collection of replacement tiles on hand for partial replacements. With ordinary care and maintenance, tile in interior locations can last for an extended period of time, but replacement is often warranted eventually to enhance and restore aesthetic appeal in the common areas. Replacement costs can vary greatly depending on size and type of tiles selected. Our recommendation is to replace at the approximate schedule shown here.

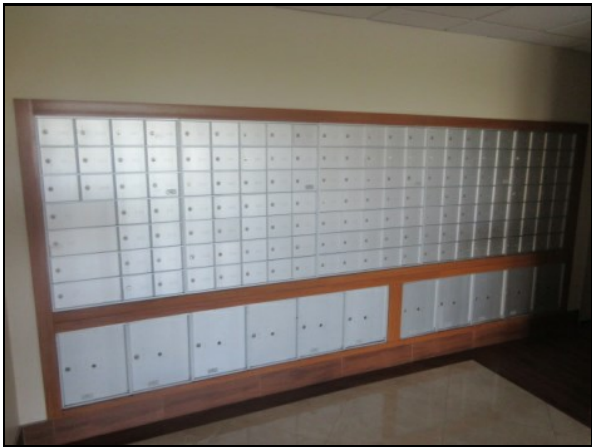
**Comp #: 2721 Mailboxes - Replace**

Comments: Poor condition: Mailboxes determined to be in poor condition typically exhibit more advanced signs of wear and age, and in some cases, issues with boxes not closing and locking properly. Even if physical conditions are satisfactory, severely outdated types should be considered for replacement for aesthetic reasons.

Clean and inspect regularly, change lock cylinders, lubricate hinges and repair as needed from Operating budget. Metal mailbox structures located inside protected interior areas can have very long life expectancies. In our experience, it is prudent to expect replacement at the approximate interval shown below in order to maintain good appearance consistent with other interior areas. Timing of replacements is ultimately subjective. Best practice is to coordinate with other interior projects such as lobby remodeling or replacement of other FF&E.

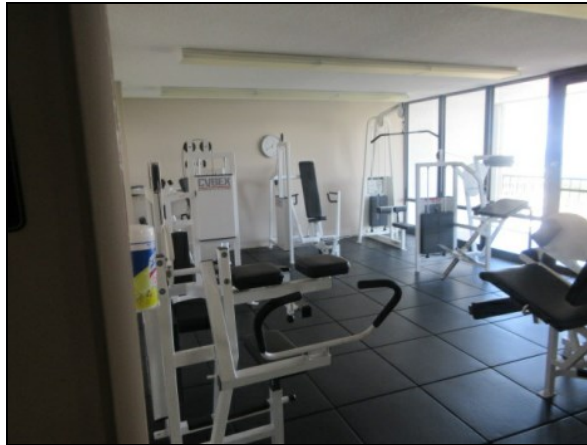
Fair condition: Fitness rooms determined to be in fair condition typically exhibit routine signs of wear and age. Flooring typically shows some deterioration, but remains consistent overall and provides good cushion/support for users. Furnishings may be slightly dated at this stage but are still functional and serviceable.

Fitness room should be remodeled at the approximate interval shown here in order to maintain good appearance and functionality. In our experience, the scope of work for remodeling may include replacement or addition of some or all of the following: flooring, lighting, mirrors, water fountains, TVs, etc. Unless otherwise noted, costs are based on replacement of like kind and quantity, and does not factor in any major structural or other sub-surface changes. In our experience, best practice is often to coordinate remodeling with other projects, such as remodeling of other amenity areas, or with replacement of exercise equipment.
