**HORIZONS WEST**

**The Horizons West Condominium #9**  
**SIRS Components**  
***Miami, FL***

Report #: 50193-0  
Beginning: January 1, 2025  
Expires: December 31, 2025

**RESERVE STUDY**  
**"Full"**

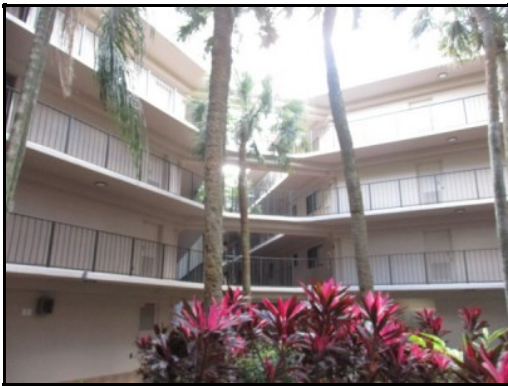
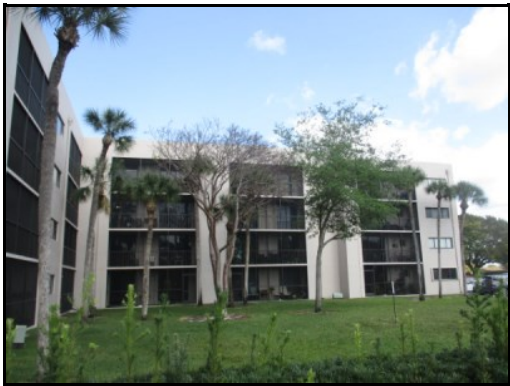
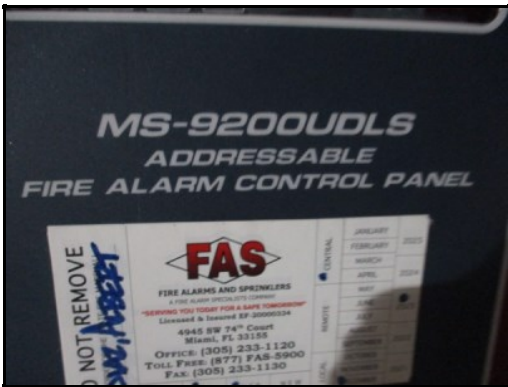
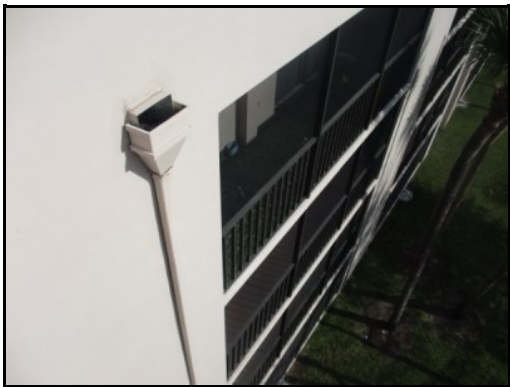
Site Inspection Notes

During our site visit on 3/26/2024, we started with a brief meeting. We thank everyone for their assistance and input during this process. During our inspection, we visually inspected all common areas, amenities, and other components that are the responsibility of the Client. Please refer to the Component Details section at the end of this document for additional photos, observations and other information regarding each component.
