# STRUCTURAL ASSESSMENT

3809 NE 170<sup>th</sup> Street,  
North Miami Beach, FL 33160  
Project Number: 223510

## Inspection Report

April 28, 2022

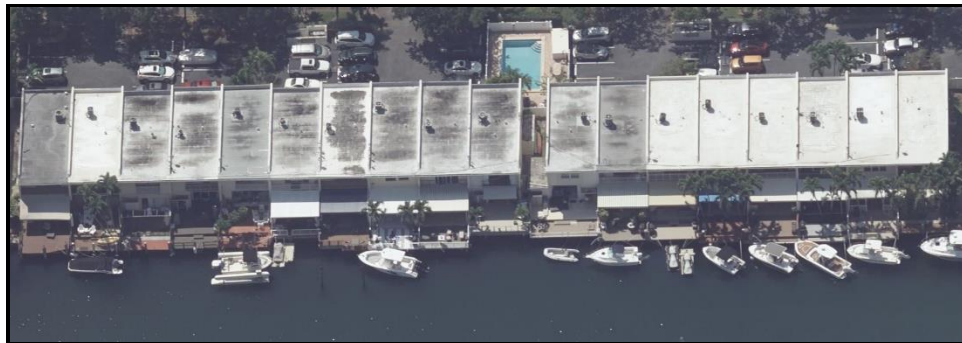
**Site Photo**

1. Approximately 400-ft of shoreline stabilized by a seawall consisting of concrete T-piles, pre-cast wall panels, and a poured in place concrete cap.
2. A sheet pile concrete and a cement bag footer were installed along the base of the seawall. These items are installed to stabilize and protect the base of the seawall against undermining.
3. Timber docks of varying sizes and constriction methods were installed at each unit. Docks were framed over seawalls, preventing a full visual assessment of the seawall caps.
