**Miller Gardens Condominium**  
**Non-SIRS Components**  
***Miami, FL***

Report #: 52032-0  
Beginning: July 1, 2026  
Expires: June 30, 2027

**RESERVE STUDY**  
**"Full"**

June 4, 2025

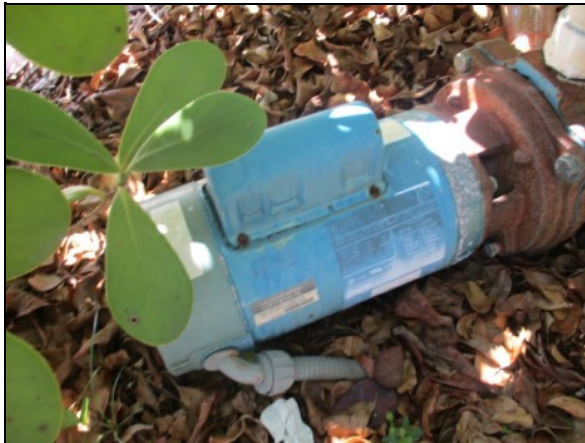
**Comp #: 2585 Irrigation Pump #3 - Replace****Approx Quantity: 1 Pump****Location:** Between residential buildings #5900 and #5800**Funded?:** Yes.**History:****Comments:** Control Manufacturer: Centri Pro

Please refer to the prior component (#2585) in this series for more general information and commentary on irrigation pump replacement. The useful life, remaining useful life, and cost range for this specific component are provided below.

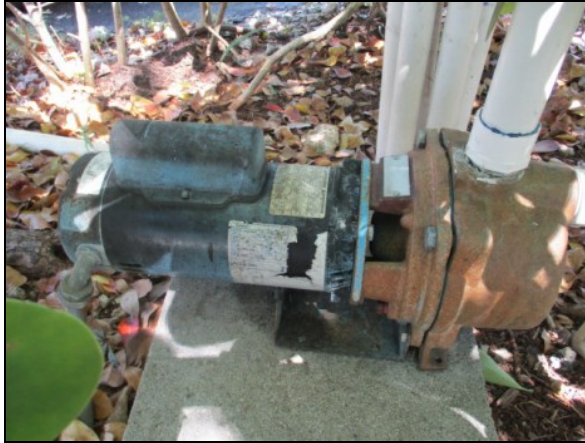
**Comp #: 2585 Irrigation Pump #4 - Replace****Approx Quantity: 1 Pump****Location:** Between residential buildings #5900 and #5700**Funded?:** Yes.**History:****Comments:** Control Manufacturer: Century

Please refer to the prior component (#2585) in this series for more general information and commentary on irrigation pump replacement. The useful life, remaining useful life, and cost range for this specific component are provided below.

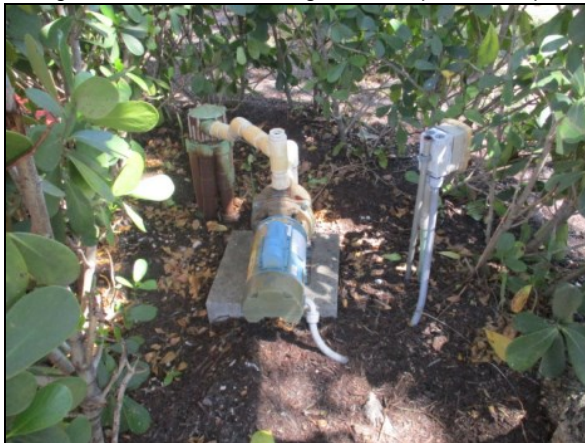
**Comp #: 2585 Irrigation Pump #5 - Replace****Approx Quantity: 1 Pump****Location:** Adjacent to Office**Funded?:** Yes.**History:****Comments:** Control Manufacturer: Century

Please refer to the prior component (#2585) in this series for more general information and commentary on irrigation pump replacement. The useful life, remaining useful life, and cost range for this specific component are provided below.

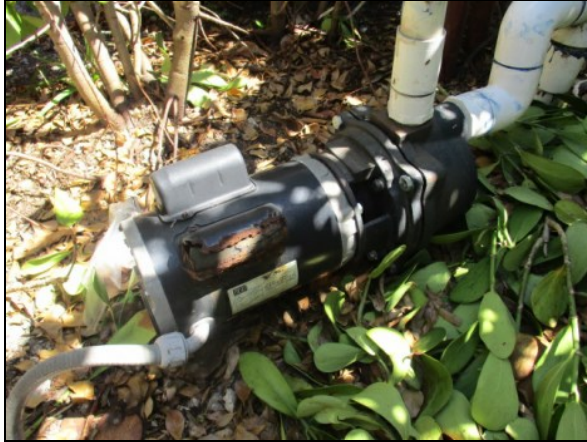
**Comp #: 2585 Irrigation Pump #6 - Replace****Approx Quantity: 1 Pump****Location:** Adjacent to residential building #5700**Funded?:** Yes.**History:****Comments:** Control Manufacturer: WEG

Please refer to the prior component (#2585) in this series for more general information and commentary on irrigation pump replacement. The useful life, remaining useful life, and cost range for this specific component are provided below.

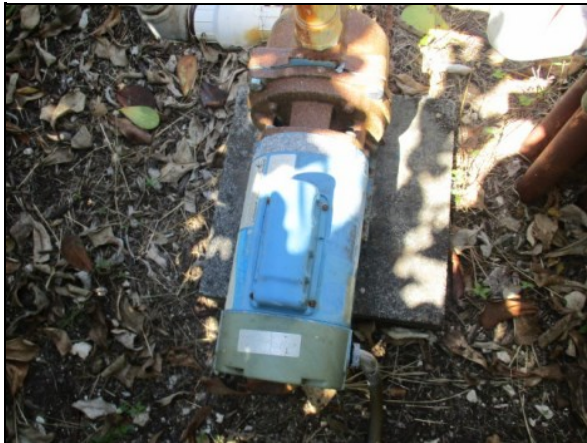
**Comp #: 2585 Irrigation Pump #7 - Replace****Approx Quantity: 1 Pump****Location:** Adjacent to residential building #5700**Funded?:** Yes.**History:****Comments:** Control Manufacturer: Centri Pro

Please refer to the prior component (#2585) in this series for more general information and commentary on irrigation pump replacement. The useful life, remaining useful life, and cost range for this specific component are provided below.

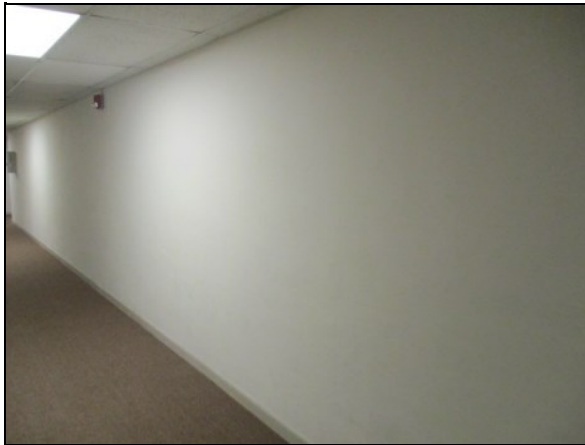
**Comp #: 2701 Interior Surfaces - Repaint****Approx Quantity: 163,000 GSF****Location:** Interior common hallways**Funded?:** Yes.**History:** Building interiors painted in approximately 2018 and maintained by the Association (per information provided). Remaining useful life extended based on condition observed.**Comments:** Fair condition: Interior areas determined to be in fair condition typically exhibit some minor, routine marks and scuffs, small sections of peeling paint, etc. Overall appearance is satisfactory.

Regular cycles of professional painting are recommended to maintain appearance. Small touch-up projects can be conducted as needed as a maintenance expense, but comprehensive painting of interior areas will restore a consistent look and quality to all areas. Best practice is to coordinate at same time as other interior projects (flooring, furnishings, lighting, etc.) whenever possible to minimize downtime and maintain consistent quality standard. Based on evident conditions and/or project history provided during this engagement, we recommend repainting at the approximate interval shown below. Unless otherwise noted, cost estimates below are intended for painting only and not inclusive of any extensive wall repairs/renovations (such as trim work, etc.).

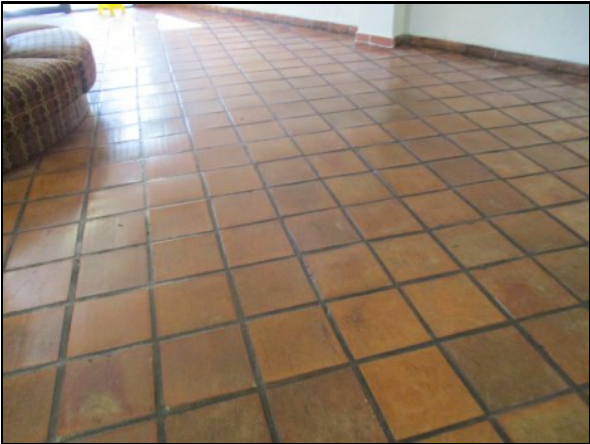
**Comp #: 2709 Tile Flooring - Replace**  
**Location:** Lobbies and elevator landings  
**Funded?:** Yes.

**History:**  
**Comments:** Fair condition: Interior tile flooring determined to be in fair condition typically exhibits some routine signs of wear and age, possibly including sporadic cracks and damaged grout. Style is still appropriate, but tile is showing more noticeable signs of deterioration.

As part of ongoing maintenance program, tile should be inspected regularly and damaged sections repaired/replaced as needed. Best practice is to keep a collection of replacement tiles on hand for partial replacements. With ordinary care and maintenance, tile in interior locations can last for an extended period of time, but replacement is often warranted eventually to enhance and restore aesthetic appeal throughout the common areas. Based on evident conditions, original installation, and project history provided by the Client, we recommend planning for replacement at the approximate interval shown below. Replacement costs can vary greatly depending on size, material, and design of tiles selected. Unless otherwise noted, cost estimates below assume replacement with similar quantity and quality as existing.

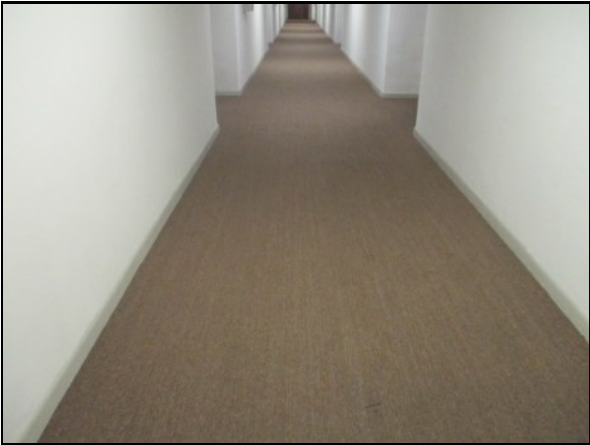
**Comp #: 2711 Carpeting - Replace**

**History:** Hallways carpet replaced in 2021 (per information provided)

**Comments:** Fair condition: Carpeting determined to be in fair condition typically exhibits light to moderate signs of age, such as fraying, stains and fading. Deterioration may be more noteworthy at higher-traffic areas.

As part of ongoing maintenance program, vacuum regularly and professionally clean as needed. Over time, replacement will be warranted due to excessive wear (stains, fading, discoloration, etc.). Best practice is to coordinate at same time as other interior projects whenever possible to minimize downtime and maintain consistent quality standard. Based on evident conditions, original installation, and project history provided by the Client, we recommend planning for replacement at the approximate interval shown below. Replacement costs can vary greatly depending on quantity, material, and design selected. Unless otherwise noted, cost estimates below assume replacement with similar quantity and quality as existing.

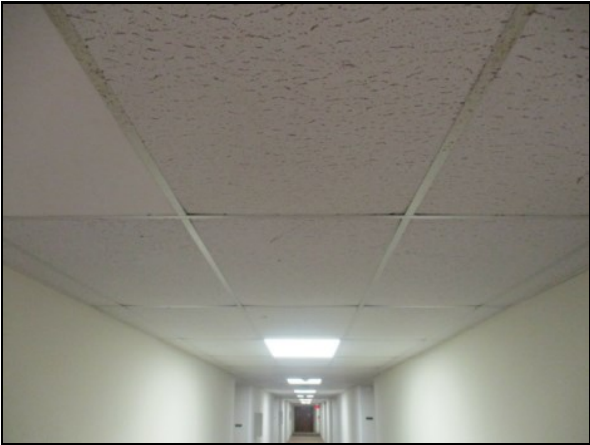
**Comp #: 2719 Suspended Ceilings - Replace**

**Comments:** Fair condition: Suspended ceiling systems (AKA “drop” ceilings) determined to be in fair condition typically exhibit only routine signs of physical deterioration. Appearance is generally consistent in all areas.
