**Uptown Lofts C.A., Inc.**  
**Non-SIRS Components**  
***Miami, FL***

Report #: 24746-1  
Beginning: January 1, 2025  
Expires: December 31, 2025

**RESERVE STUDY**  
**Update "With-Site-Visit"**

July 9, 2024

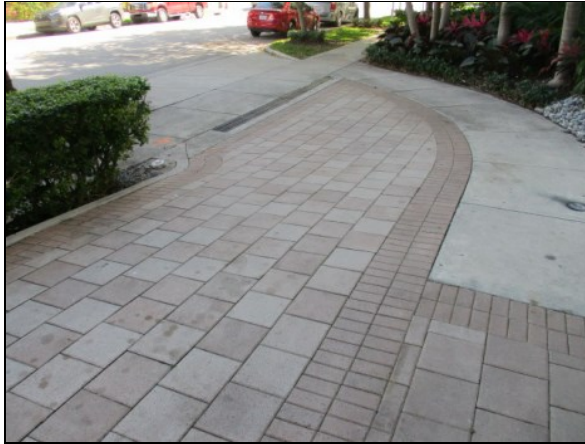
Useful Life:  
40 years

Remaining Life:  
20 years

Best Case: \$ 10,600

Worst Case: \$ 13,000

| # Component | Useful Life<br>(yrs) | Rem.<br>Useful Life<br>(yrs) | Current<br>Average<br>Cost |
|---|---|---|---|
| 2119 Pavers (Roadways) - Replace | 40 | 20 | \$11,800 |

| # | Component | Current Cost Estimate | X | Effective Age | / | Useful Life | = | Fully Funded Balance |
|---|---|---|---|---|---|---|---|---|
| 2119 | Pavers (Roadways) - Replace | \$11,800 | X | 20 | / | 40 | = | \$5,900 |

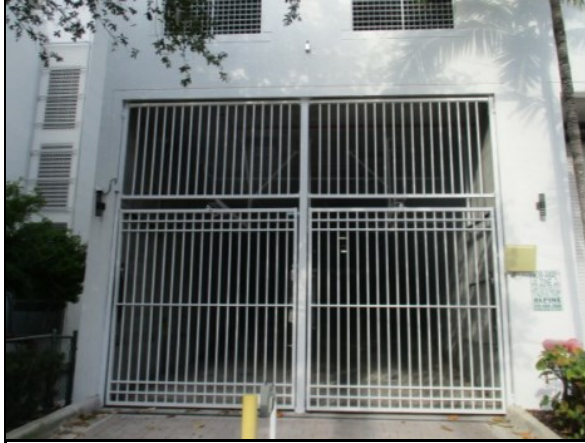
Useful Life:  
25 years

Remaining Life:  
5 years

Best Case: \$ 41,900

Worst Case: \$ 51,300

| # Component | Useful Life<br>(yrs) | Rem.<br>Useful Life<br>(yrs) | Current<br>Average<br>Cost |
|---|---|---|---|
| 2144 Garage Gates - Replace | 25 | 5 | \$46,600 |

| # | Component | Current Cost Estimate | X | Effective Age | / | Useful Life | = | Fully Funded Balance |
|---|---|---|---|---|---|---|---|---|
| 2144 | Garage Gates - Replace | \$46,600 | X | 20 | / | 25 | = | \$37,280 |

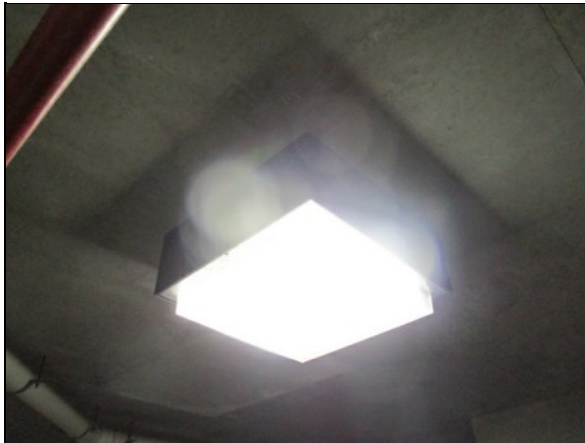
Useful Life:  
20 years

Remaining Life:  
0 years

Best Case: \$ 9,770

Worst Case: \$ 11,900

| # Component | Useful Life<br>(yrs) | Rem.<br>Useful Life<br>(yrs) | Current<br>Average<br>Cost |
|---|---|---|---|
| 2305 Garage Lights - Replace | 20 | 0 | \$10,835 |

| # | Component | Current Cost Estimate | X | Effective Age | / | Useful Life | = | Fully Funded Balance |
|---|---|---|---|---|---|---|---|---|
| 2305 | Garage Lights - Replace | \$10,835 | X | 20 | / | 20 | = | \$10,835 |
