**Miller Gardens Condominium**  
**SIRS Components**  
***Miami, FL***

Report #: 52032-0  
Beginning: July 1, 2026  
Expires: June 30, 2027

**RESERVE STUDY**  
**"Full"**

June 4, 2025

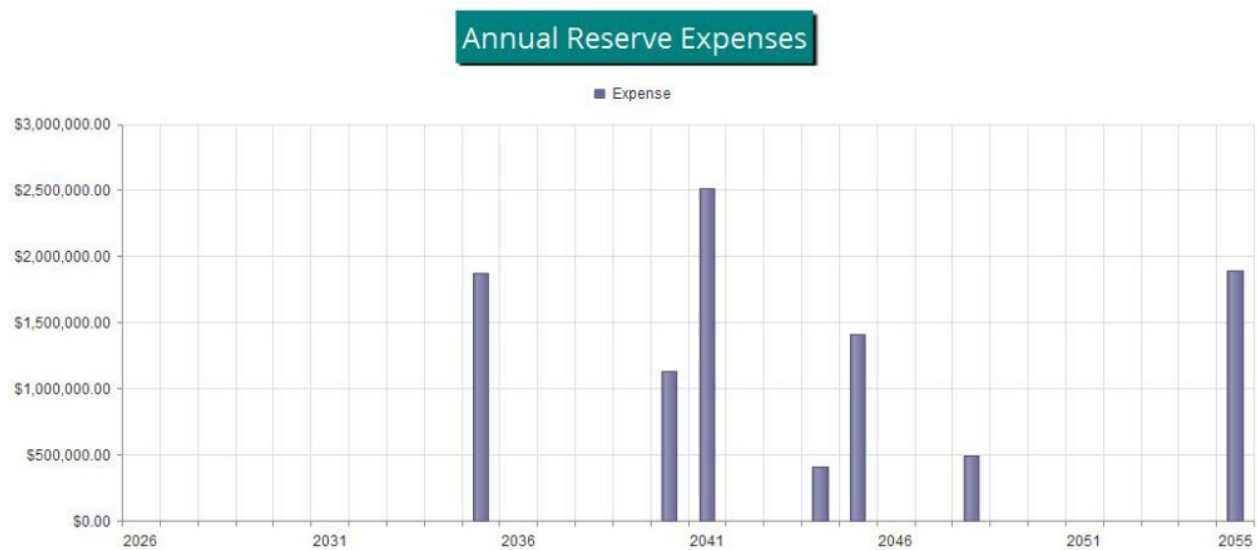
Figure 1

While this Reserve Study looks forward 30 years, we have no expectation that all these expenses will all take place as anticipated. This Reserve Study needs to be updated annually because we expect the timing of these expenses to shift and the size of these expenses to change. We do feel more certain of the timing and cost of near-term expenses than expenses many years away. Please be aware of your near-term expenses, which we are able to project more accurately than the more distant projections. The figure below summarizes the projected future expenses as defined by your Reserve Component List. A summary of these components are shown in the Component Details table, while a summary of the expenses themselves are shown in the 30-yr Cash Flow Detail table.

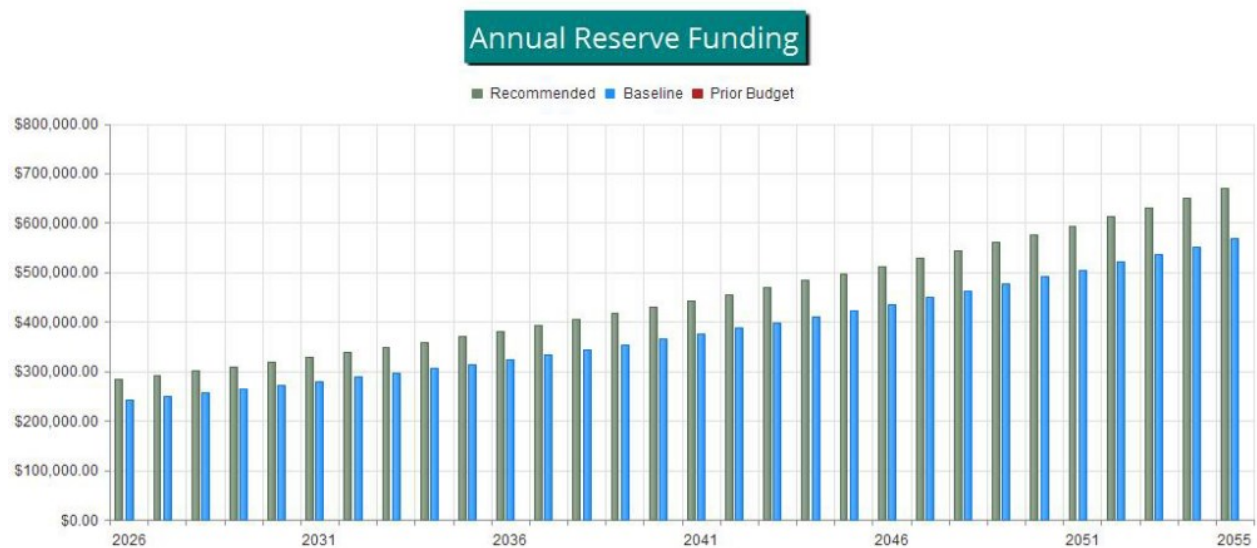
Figure 2

Based on your current Percent Funded and your near-term and long-term Reserve needs, we are recommending budgeted funding of \$284,000 in the upcoming fiscal year. At minimum, the Association must budget \$241,500 for Reserves in the upcoming year. The overall 30-yr plan, in perspective, is shown below. This same information is shown numerically in both the 30-yr Summary and the Cash Flow Detail tables.

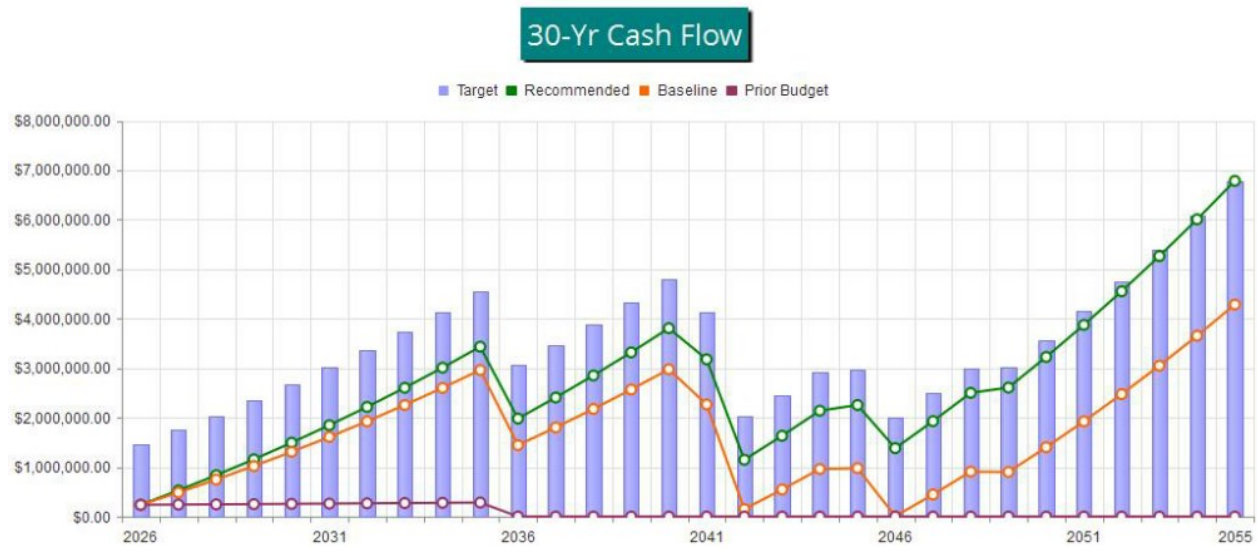
Figure 3

The following chart shows your Reserve balance under our recommended plan, the minimum funding plan and at the Association’s current funding rate, all compared to your always-changing Fully Funded Balance target.

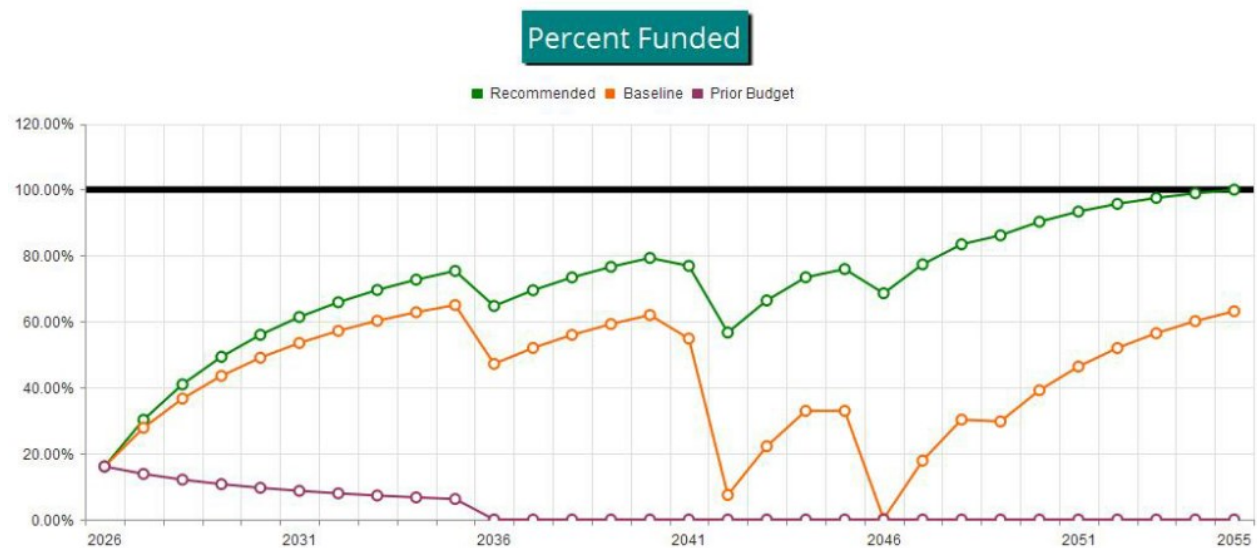
Figure 4

This figure shows the same information described above, but plotted on a Percent Funded scale. It is clear here to see how your Reserve Fund strength approaches the 100% Funded level under our recommended multi-yr Funding Plan.

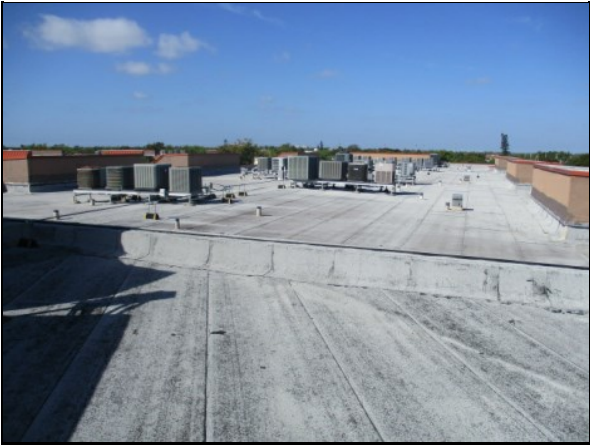
**Useful Life:**  
20 years

**Remaining Life:**  
15 years

| <b>Lower Estimate:</b> | \$ 621,000 | <b>Higher Estimate:</b> | \$ 759,000 |

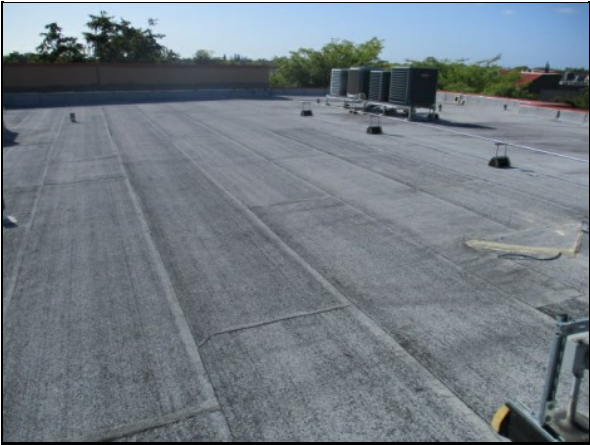
**Useful Life:**  
20 years

**Remaining Life:**  
14 years

| <b>Lower Estimate:</b> | \$ 671,000 | <b>Higher Estimate:</b> | \$ 821,000 |

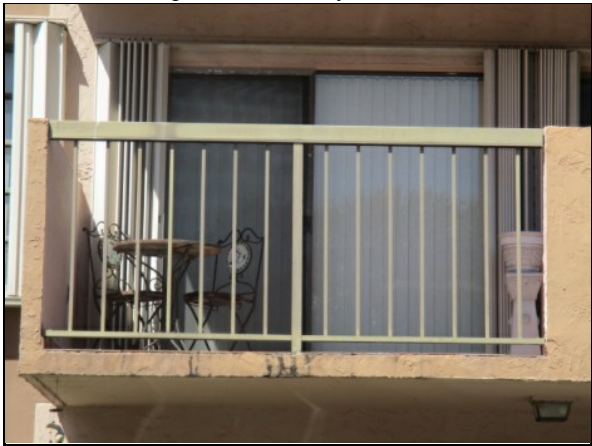
Useful Life:  
40 years

Remaining Life:  
9 years

Lower Estimate: \$ 207,000 Higher Estimate: \$ 252,000
