# STRUCTURAL INTEGRITY RESERVE STUDY

## Peninsula II Condominium

Aventura, FL

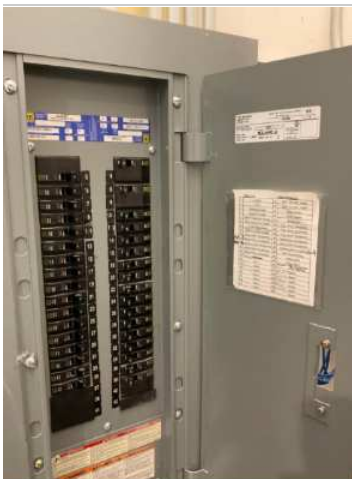
On the date of inspection, it was observed that the electrical service was in good working condition. This fund provides monies for the as needed repairs and eventual partial replacements of the electrical systems over a standard market observed 45-year life cycle.

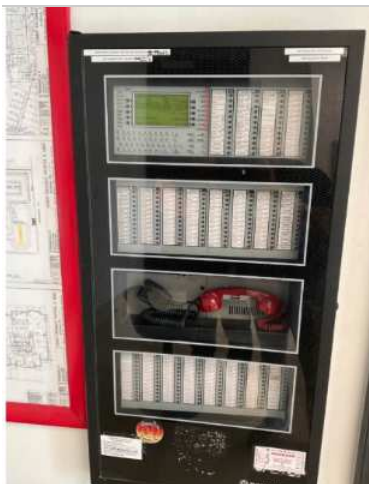
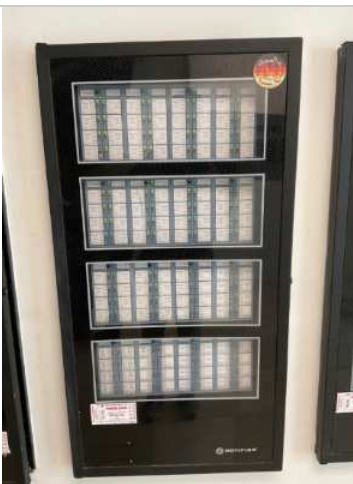
# 002 - Fire Alarm Control Panel & Ancillary Devices

This fund provides monies for the as needed repairs and eventual replacement of the Fire Alarm system over a standard market observed 30-year life cycle.

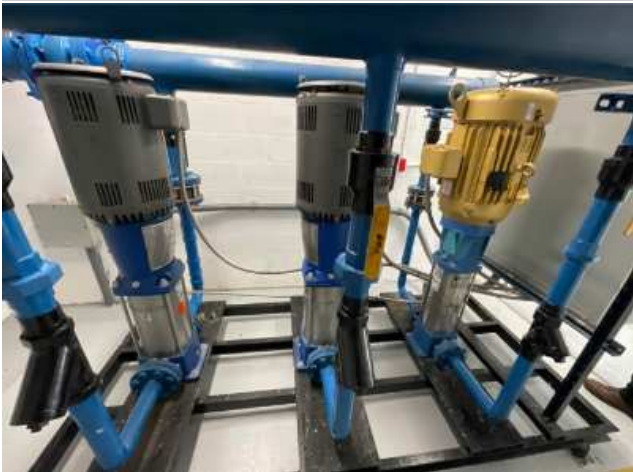
# 003 - Domestic Water Pump System

This fund provides monies for the as needed repairs and eventual replacement of the domestic water pump system over a 25-year life cycle.

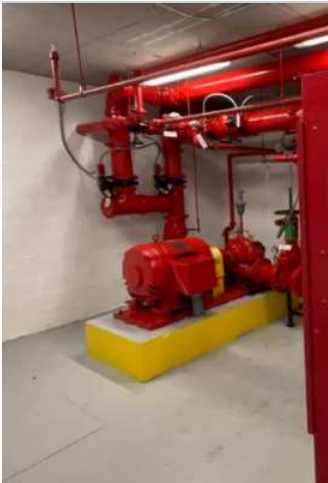
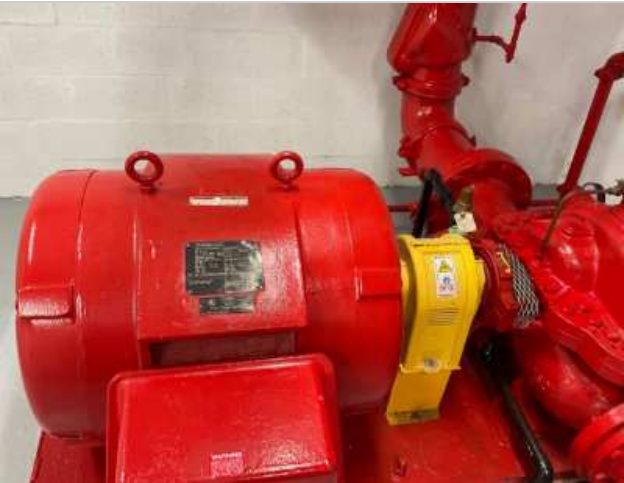
# 004 - Fire Pump & Controller

This fund provides monies for the as needed repairs and eventual replacement of the Fire Pump system over a 40-year life cycle. The current cost estimate includes the pump, controller panel and ancillary equipment.

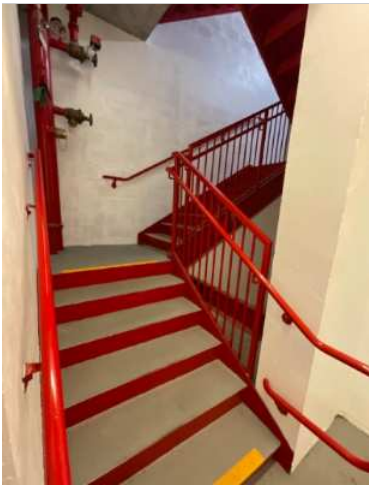
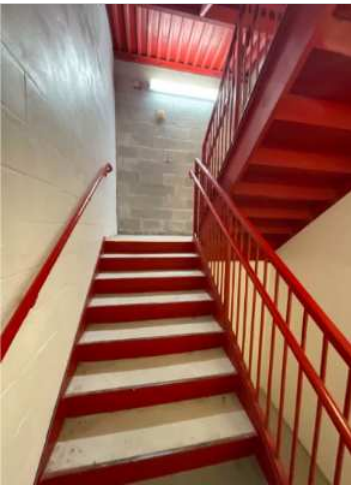
# 005 - Concrete Restoration, Staircases

On the date of inspection it was observed that the concrete staircases were in good conditon. This fund provides monies for the as needed repairs to eventual major refurbishment of the staircases.

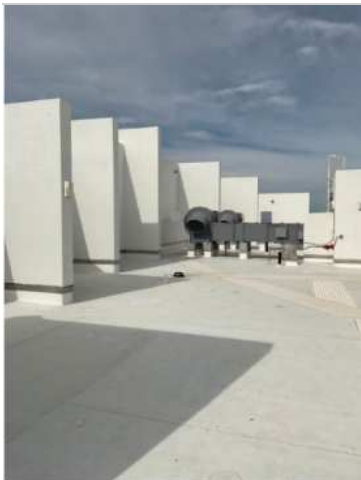
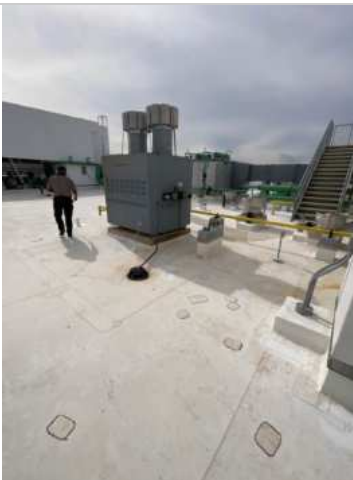
# 008 - Roofs, Flat, Modified Bitumen

On the date of inspection it was noted the current roof is original and in good condition with no reported issues of leaks or apparent deterioration.

It was noted on the date of inspection that some ares of the flat roofs are beginning to exhibit sing of deterioration. It is recommended that the association take action calendar year 2027 to replace the affected areas and re-roof the affected areas to prevent further damage associated with this component.

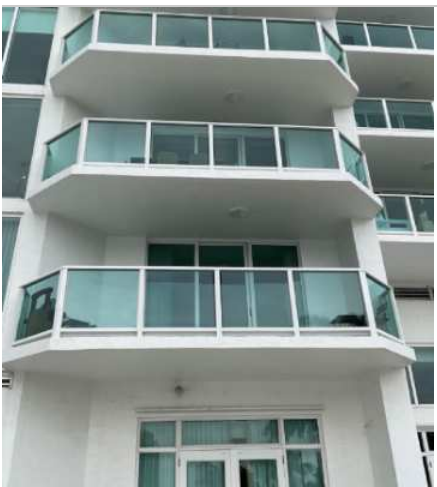
# 009 - Railings, "Key-West" Glass Panel

This fund provides monies for the as needed repairs and eventual replacement of the railings over a 55-year life cycle.

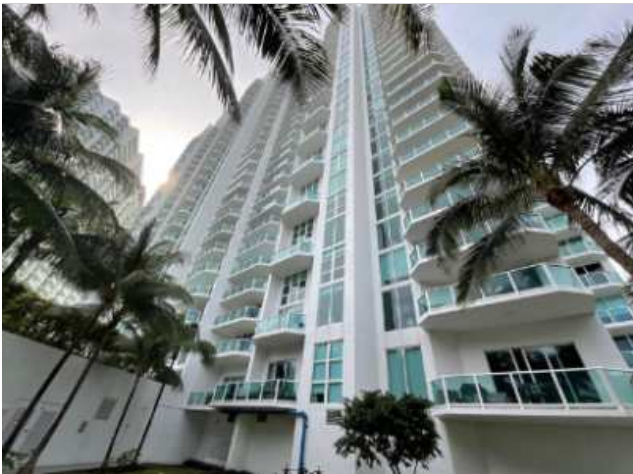
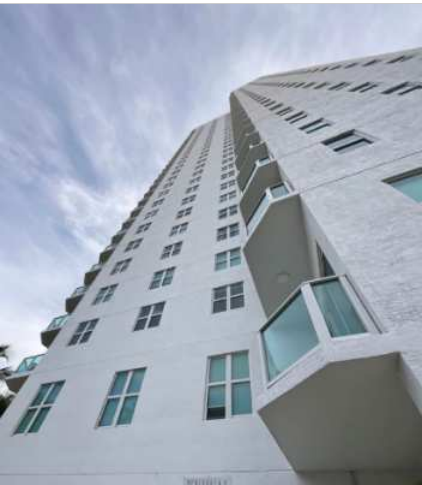
# 011 - Painting, Waterproofing & Stucco Repairs

On the date of inspection it was observed that the paint & waterproofing were in excellent conditon and recently reapplied. This fund provides monies for the reapplication of paint & waterproofing layers to the building based on a 10-year life cycle.

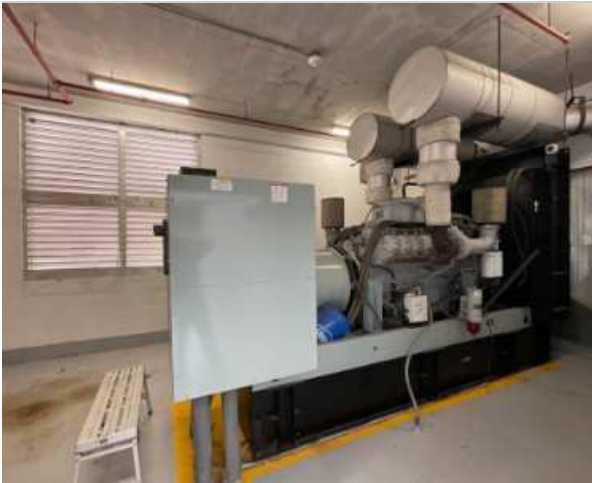
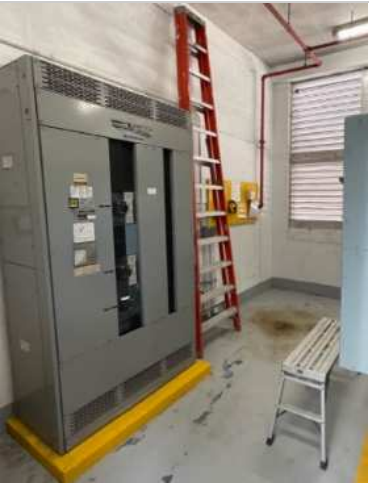
# 012 - Generator & Controller, Diesel

On the date of inspection, it was observed that the electrical generator was in good working condition. This fund provides monies for the as needed repairs and eventual replacement of the electrical generator over a standard market observed 45-year life cycle.
